**A HISTORIC STRUCTURE ASSESSMENT
OF
THE ZEINE CABIN,
WILDLIFE PRAIRIE STATE PARK,
PEORIA COUNTY, ILLINOIS**

by
Christopher Stratton

Fever River Research
Springfield, Illinois

December 2001

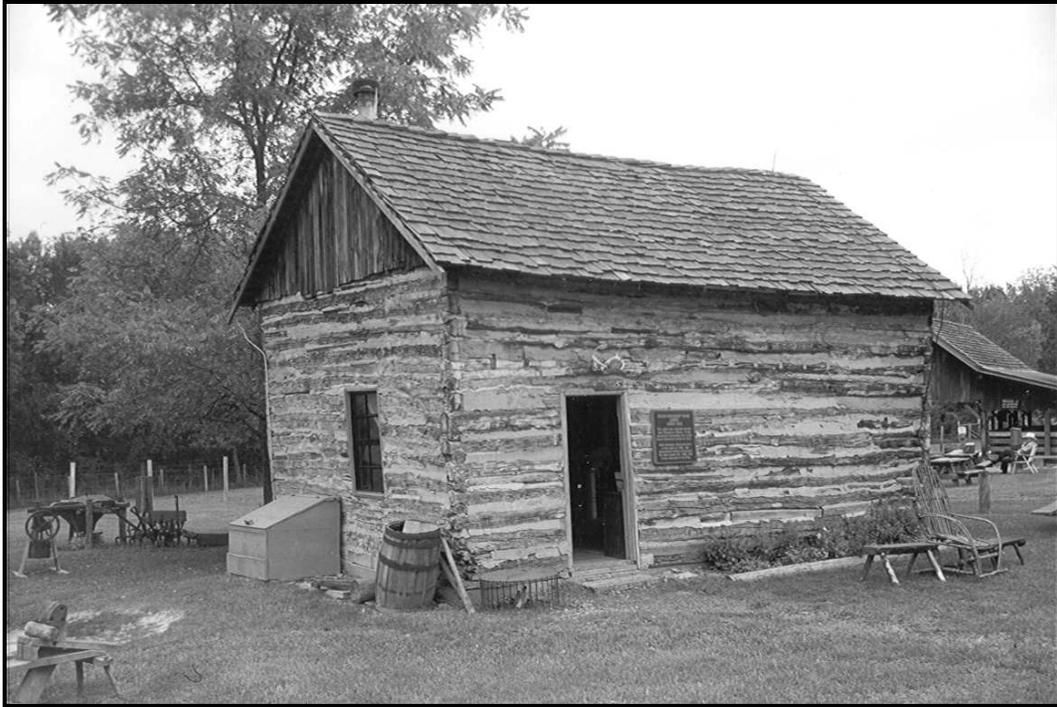
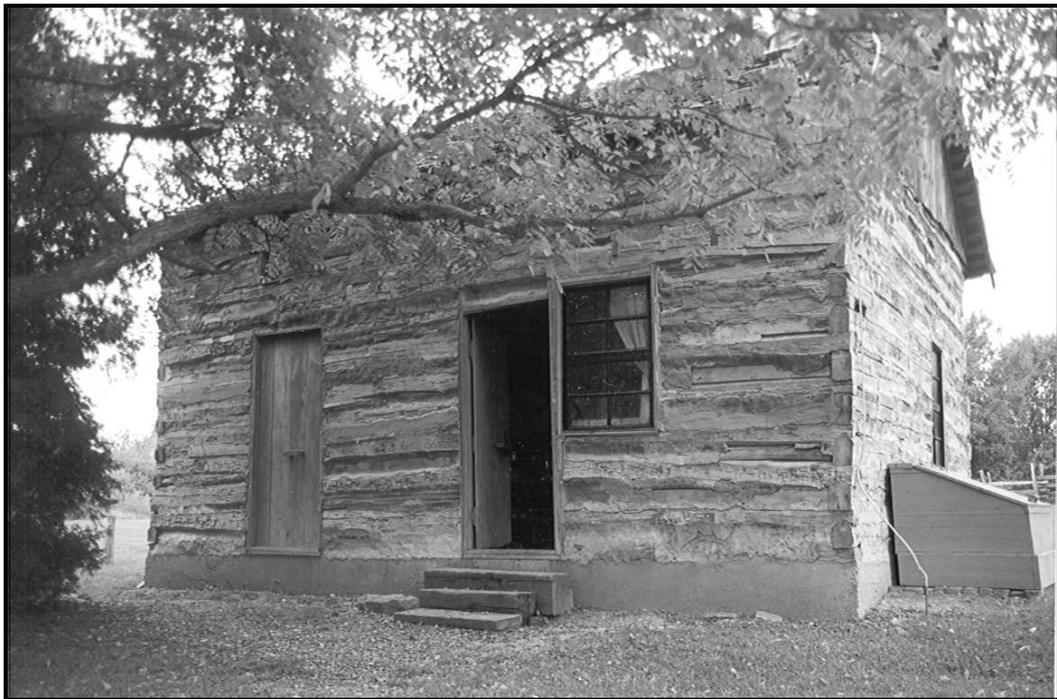
Figure 3. (Top) Oblique view, showing the west and north elevations of the cabin. (Bottom) View of the east elevation. The presence of two doorways here suggests that an addition may have once been present on this side of the dwelling, as was the case on the opposing elevation (FRR September 2001).

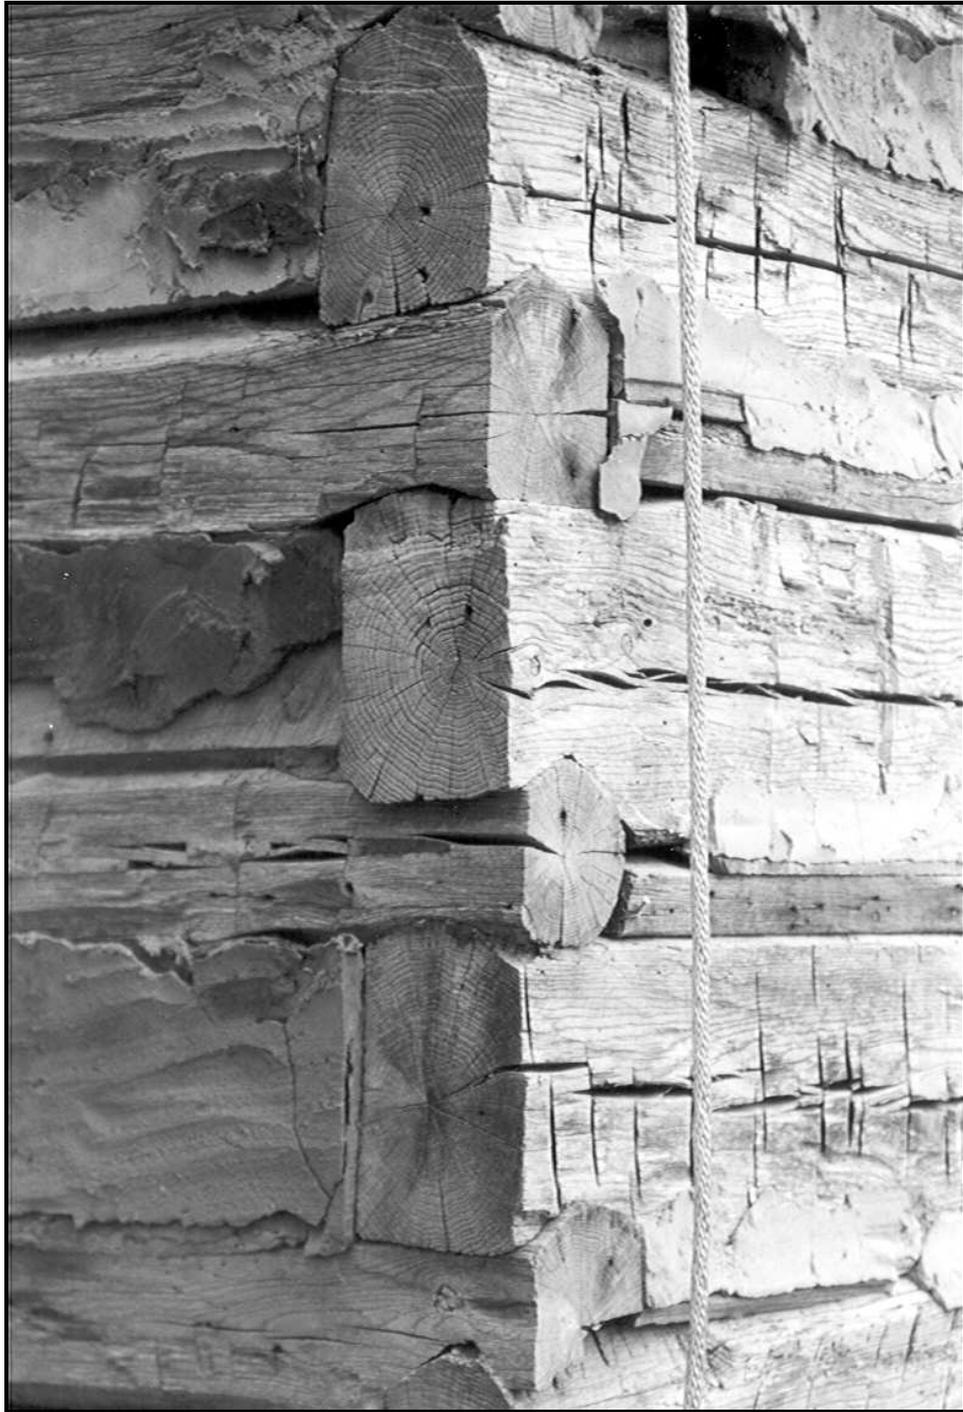
The Zeine Cabin is a 1-1/2-story, single-pen log dwelling that measures 24'-0" (north/south) by 16'-2" (east/west) on its exterior. The walls of the dwelling are constructed with hewn hardwood (oak or hickory) logs that generally measure 6" in thickness and are joined at the corners with V-notching (see Figure 4). The logs are relatively small in diameter – something that is indicative of the cabin's later date of construction.¹ As originally constructed, the cabin had only one room on its first floor and an open, possibly unfinished loft on the upper

Figure 4. Detail of the northeast corner, showing the corner notching and hewing methods utilized in the construction of the cabin (FRR September 2001).

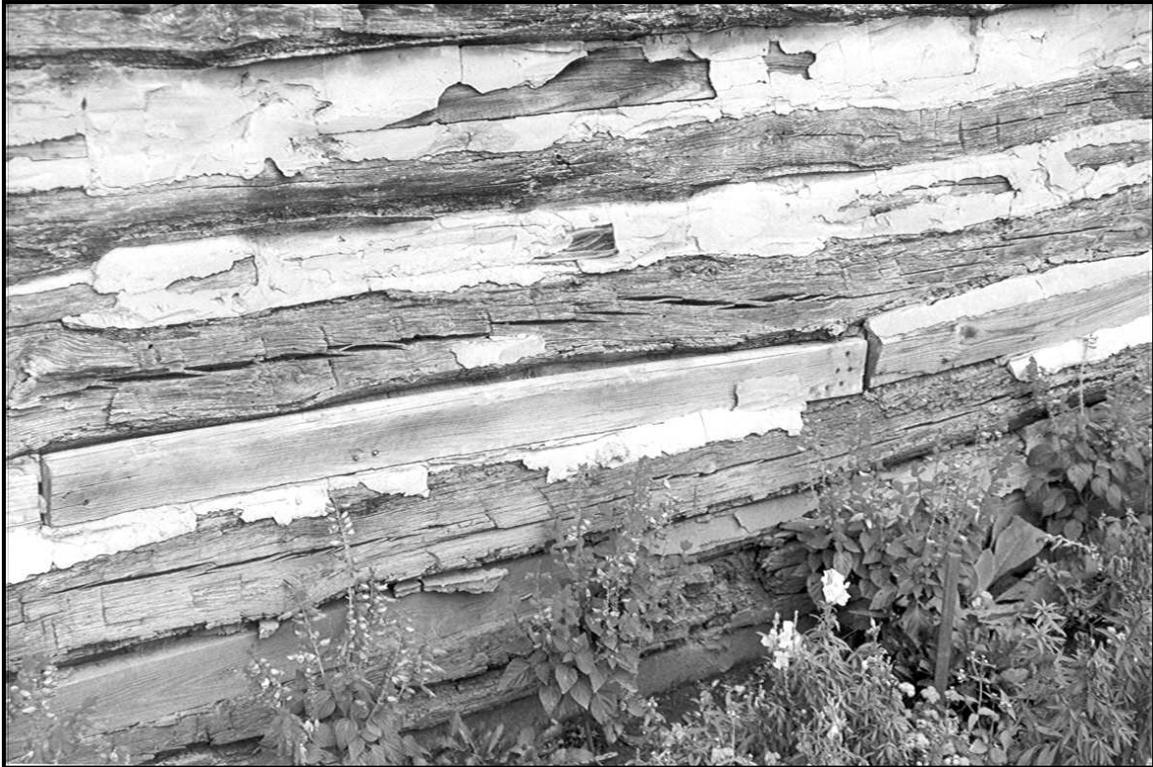
Overall, the wall logs of the Zeine Cabin generally are in good condition, in spite of the fact that they have been exposed to the elements for over twenty years. However, a number of logs have started to rot away. This deterioration is most pronounced on the lower logs, which are comparatively more exposed to moisture (rain and snow) and tend to be the last to dry out. The west elevation and northwest corner, in particular, have suffered from weathering, and the replacement lumber has had to be scabbed in at a number places where the logs have rotted out (see Figure 7 and 8). The continued deterioration of the lower logs will inevitably lead to a general structural failure of the cabin, since the wall logs are largely held in place by their own weight. The fact that the logs are relatively thin (6") and small in diameter gives the cabin's walls more flexibility than might otherwise be the case with a dwelling having larger logs. As it is, the east and west walls, which are the long walls of the cabin, have a pronounced bow or deflection to them (see Figure 8).

The chinking on the cabin also is in poor condition. When the building was reconstructed, the interstices between the logs were filled with sawn lumber and Portland-cement-based mortar. The lumber was used backing, while the mortar served as the facing material. Over the years, the mortar has cracked and, in some places, completely fallen away; this is not surprising, considering that the logs naturally expand and contract, whereas the harder mortar will not (Indeed, even historic chinking and daubing required constant attention and maintenance when it was unprotected by siding). Where the chinking has fallen away, the logs are even more susceptible to water damage, since water has the opportunity to collect in recesses where it cannot easily drain away, thus accelerating the rate the logs' deterioration.

Figure 7. Detail of the west wall of the cabin, illustrating the variety of problems facing the cabin. Note the deteriorated conditions of the lower logs, the modern replacement materials that have been used to stabilize the cabin, and the failed chinking (FRR September 2001).

The structural problems observed during the field investigation are largely linked to the fact that the exterior logs of the cabin are exposed and unprotected. Therefore, we strongly recommend that the exterior of the cabin be covered with horizontal weatherboard. This recommendation not only has a firm historical basis, but also has practical merits as well. The photographs that were taken during the dwelling's dismantlement in 1974 provide documentary evidence for the cabin having been covered with weatherboard previously. We also have physical evidence for the siding in the form of the nail patterns that were left behind after the furring strips for the siding were removed (see Figure 9). The nails used to attach the furring strips were machine cut, rather than wiredrawn, which strongly connotes a pre-1900 date for the siding.

We recommended that the exterior of the cabin be covered with beveled horizontal weatherboard with a 4-1/2" exposure. This siding appears to be similar to that originally used on the cabin and also would be appropriate for the period of construction. The siding should be nailed to vertical furring strips in the same manner as was originally utilized on the cabin. Figure 11 provides representative illustrations of the application of horizontal siding on two other log houses. The vertical plank siding now in place on the gable ends should be removed and

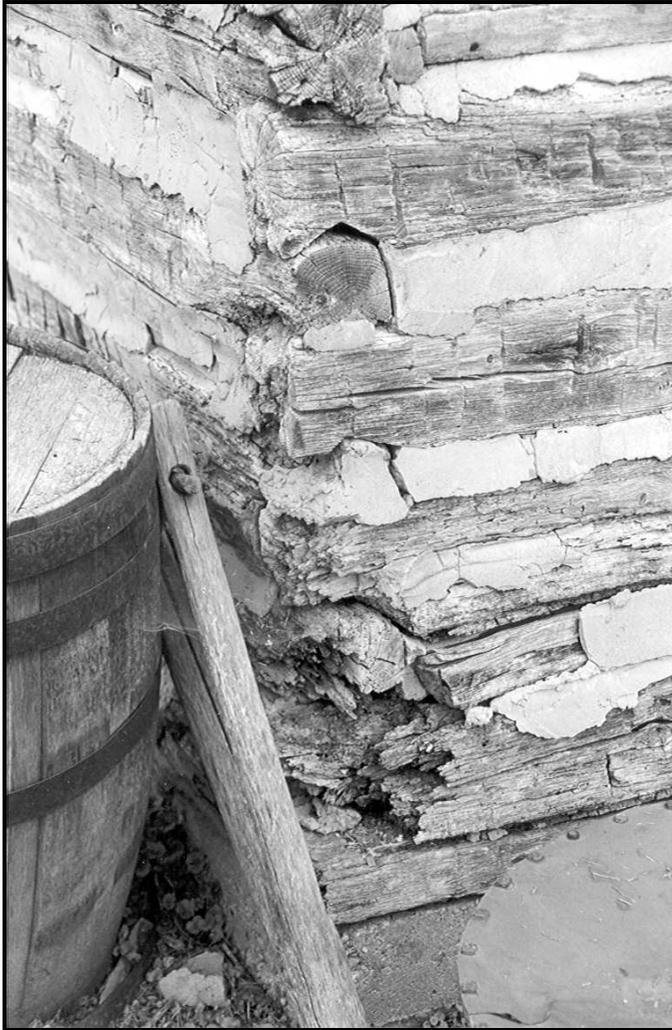
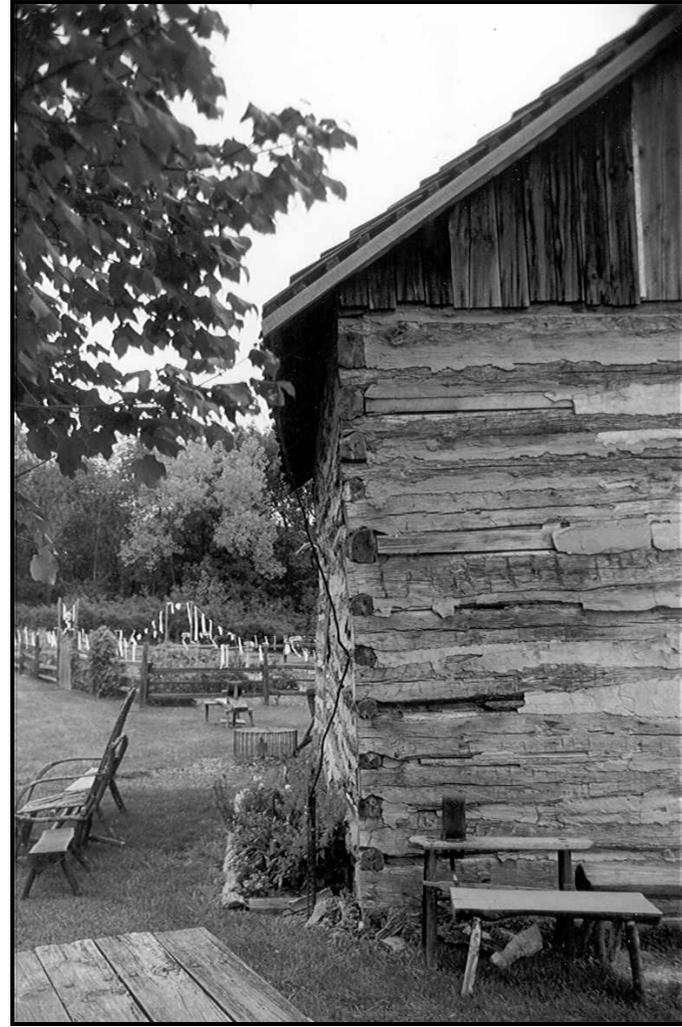
Figure 8. (Left) View of the northwest corner of the cabin, which is badly weathered. (Right) View down the west wall of the cabin (looking north), showing the deflection in the wall (FRR September 2001).

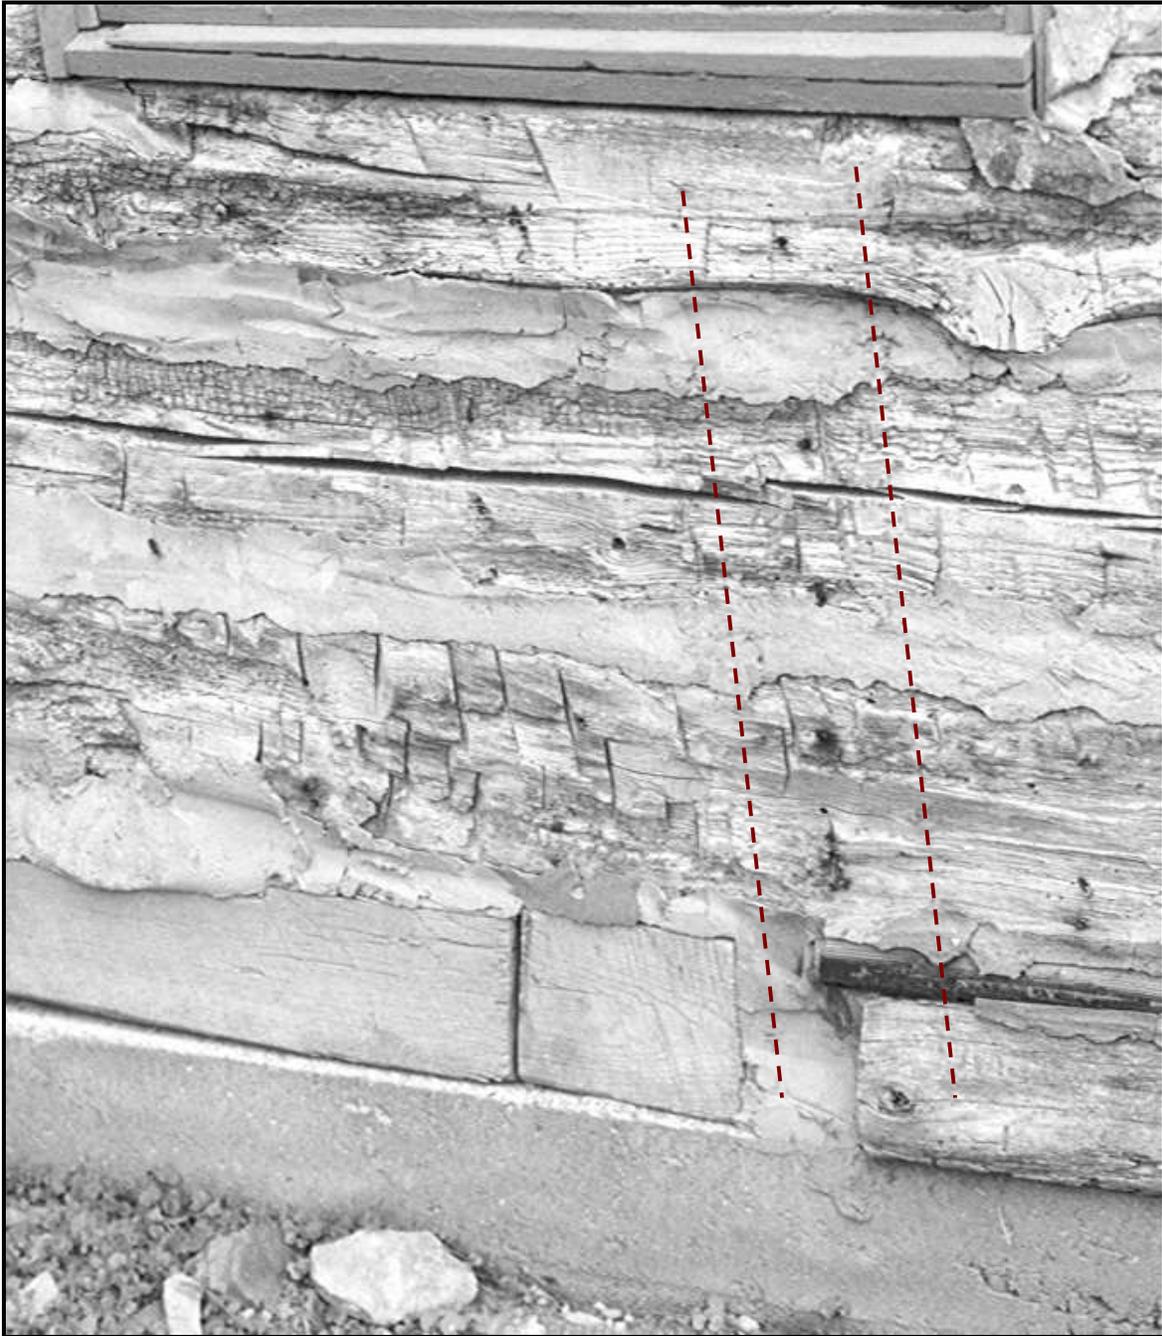
Figure 9. Nail pattern indicating the location of one of the furring strips to which the original exterior siding on the cabin was attached. The dashed lines represent the approximate edges of the furring strip (FRR September 2001).

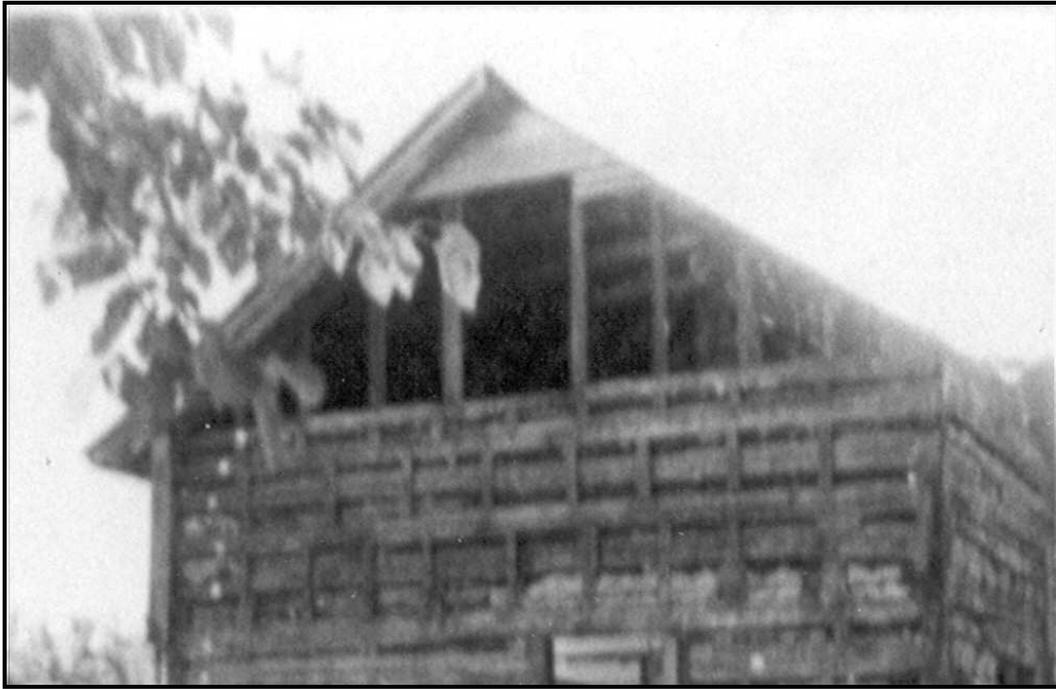
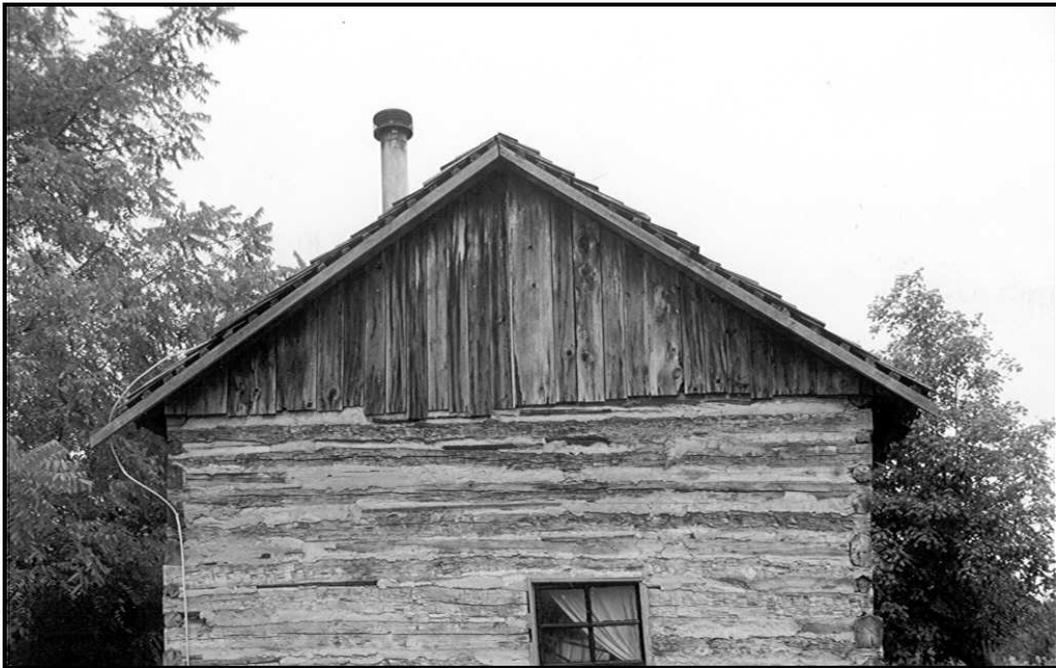
Figure 13. (Top) Detail of an 1974 photograph of the Zeine Cabin, showing the remnants of the horizontal siding originally used to enclose the north gable (WPSP August 1974). (Bottom) View of the vertical plank siding that currently encloses the north gable (FRR September 2001). It is recommended that the vertical planking be replaced with horizontal siding in event that the exterior of the cabin is sided.

replaced with horizontal weatherboard, as was the case prior to the cabin's dismantlement (see Figure 12). It would be appropriate to finish out the corners and openings with flat trim boards, perhaps 1"x4" or 1"x5" stock. The exterior siding should be primed and painted.
