**ILLINOIS DEPARTMENT OF NATURAL RESOURCES
CULTURAL RESOURCE MANAGEMENT PROGRAM
ABANDONED MINED LANDS RECLAMATION
CULTURAL RESOURCES EVALUATION**

**U. S. FUEL COMPANY, BUNSENVILLE MINE
BUNSENVILLE, ILLINOIS**

May 2002

Project Type/Title: Phase II archaeological survey of U. S. Fuel Company Bunsenville Mine reclamation project (AML-GveE-0107).

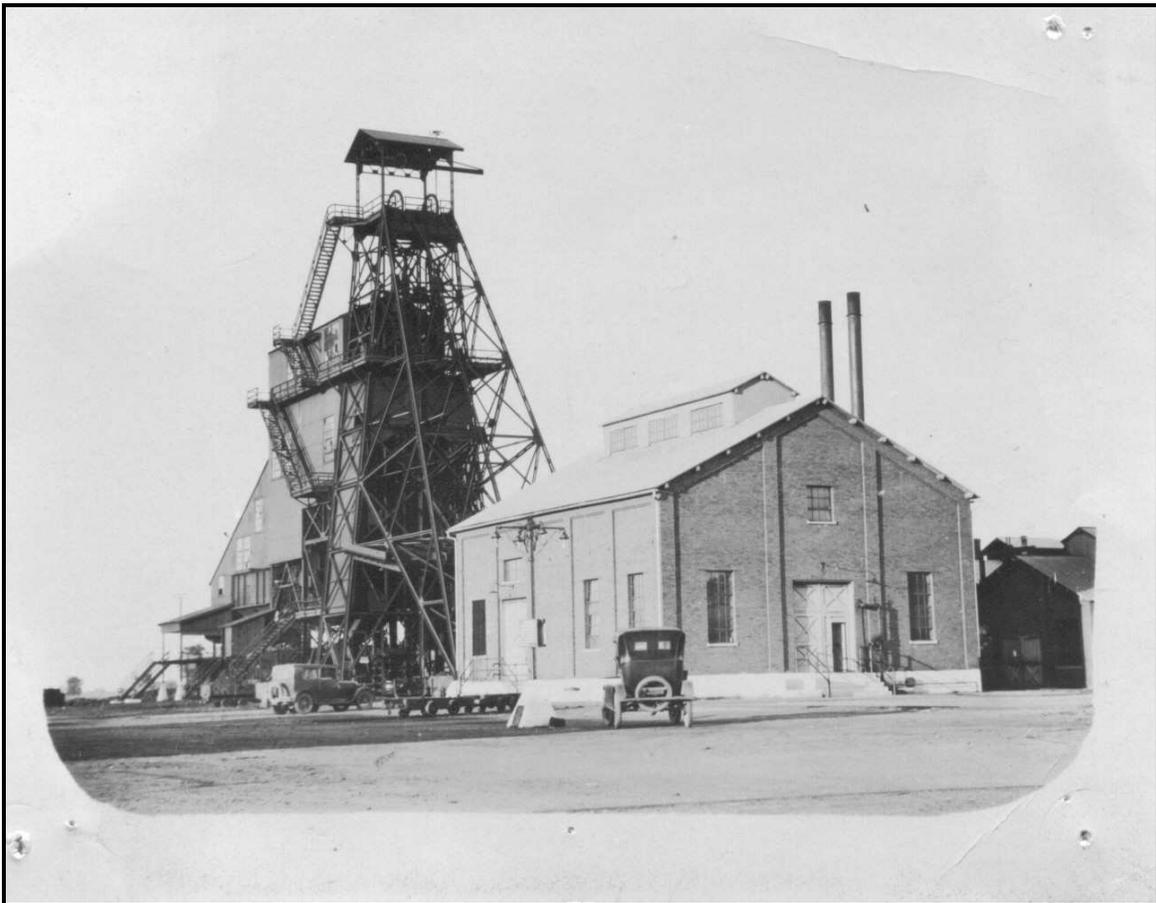
Figure 18. A photograph of the Bunsenville Mine, taken during the early 1920s. The brick building in the foreground is the hoist/power house. Also shown, on the extreme right, is a repair shop. The smokestacks belong to the boiler house, which is hidden from view (Westville Historical Society).

The surface complex at the Bunsenville Mine was quite large and modern in character. There are no known Sanborn maps of the mine, but we do have a map of its underground working that also illustrates buildings on the surface. The building and structures illustrated include a large tipple structure (consisting of both hoist shaft and shakers), a boiler house, combination hoist room and electrical substation, a blacksmith shop, a shop of unknown function, a car repair shop, another substation, a bathhouse,³ a check house, a fan house, an office, a garage, a water tower, a pump house, a combination store room/office/hospital, an oil house, a cement house, a stable, a sand drier, a water softener, and a powder house (see Figures 16 and 17). In contrast to the earlier generation of mines, whose structures mostly were of frame construction, the majority of the buildings at the Bunsenville Mine were of masonry construction. Many of the buildings were brick, though some (such as the fan house and powder house) were built entirely of reinforced concrete, while others (like the tipple and water tower) were of steel construction. Several smaller buildings, like the garage and cement house, were frame with steel siding. The mine was connected to the C&EI Railroad by means of spur line that ran along the north side of the site. Four separate tracks passed beneath the tipple, while several other tracks serviced different sections of the mine site (DMM 1947b). Waste hauled from the mine was deposited in a dump located immediately east of the surface complex. Electrical and hoisting power for the mine was supplied on site and was steam generated. Several historic photographs of the surface complex,

taken during the period that the mine was in operation, have been attached as Figures 18 through 20.

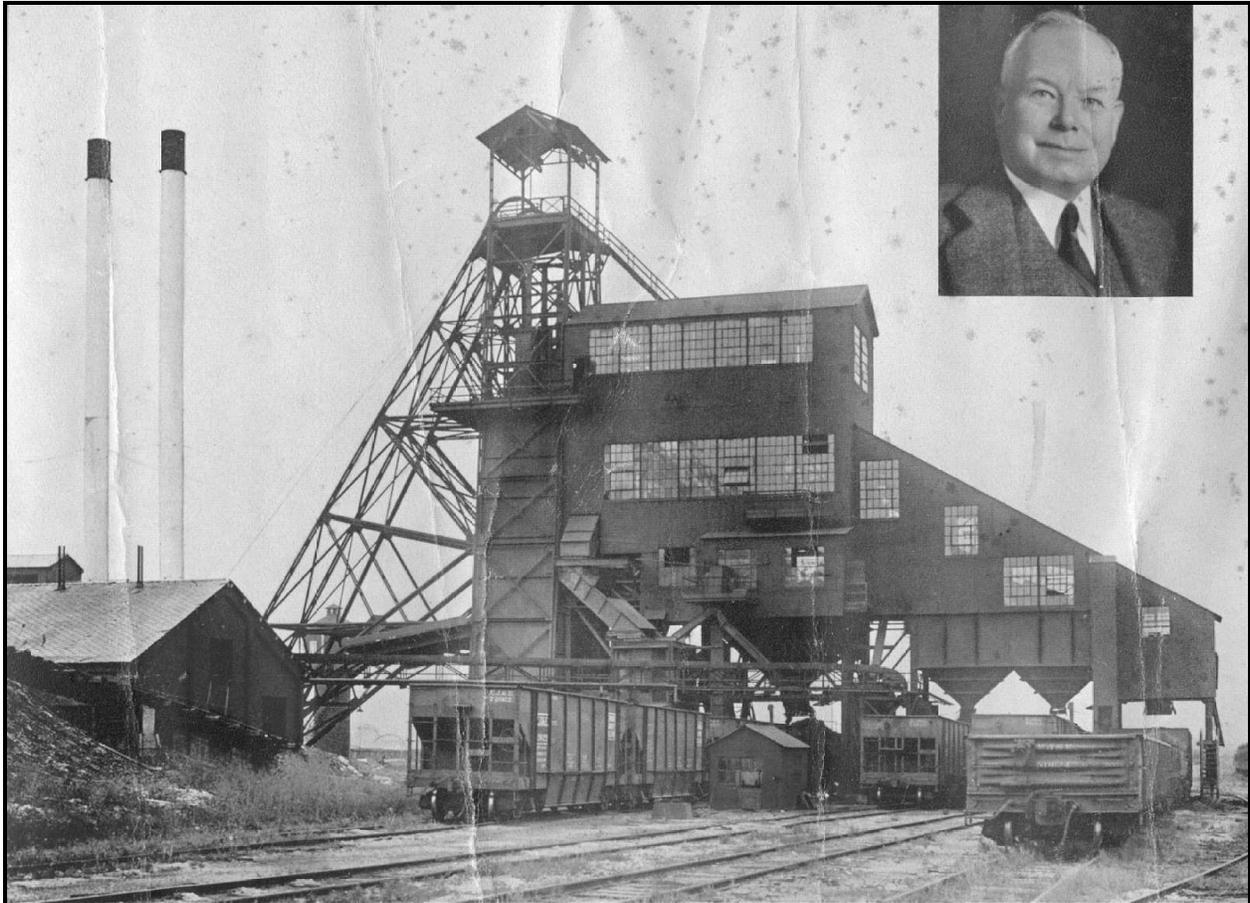
Figure 19. This photograph is neither labeled or dated, but is believed to be of the Bunsenville Mine post-1927. The man pictured in the upper right is Tom Moses, who became general superintendent of the U. S. Fuel Company in 1927. This image provides an excellent view of the east side of the tippie, and also shows a portion of the boiler house and water tower at the mine . The trestle shown on the left of the photograph is ascending the gob pile and was used to haul away waste brought up from the mine. Note the two different types of coal cars; on the far right is an older type of low-sided coal car, while to the left is a line of more modern cars with high sides and tapered bases, which could be unloaded from below (Westville Historical Museum).

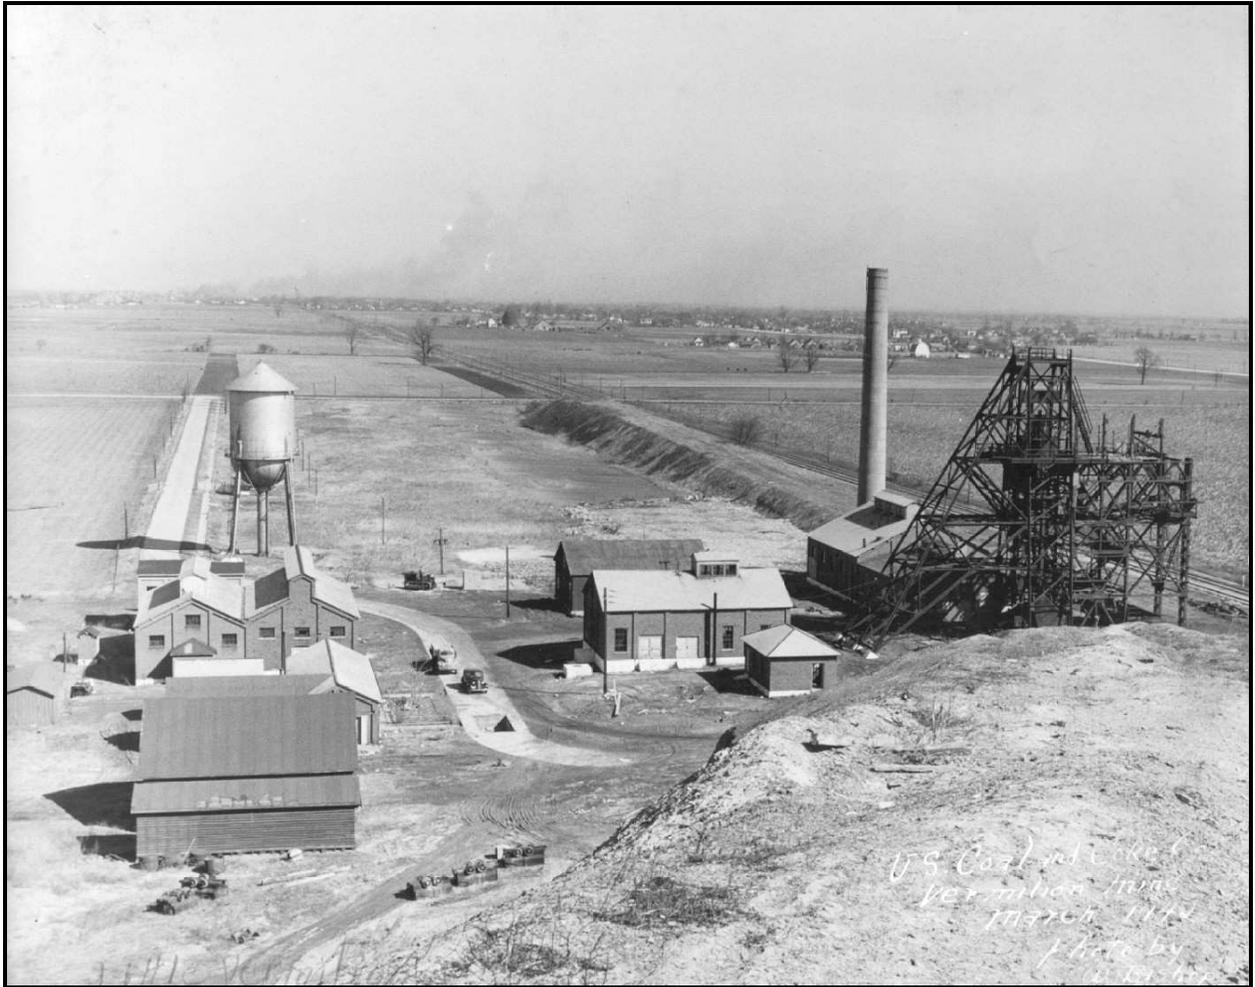
Figure 23. Photograph of the Vermilion Mine during the course of its dismantlement in 1942. Vermilion Mine was U. S. Fuel's largest producer in Vermilion County, until Bunsenville surpassed it in 1924-1925. The mine was closed in 1932, during the depths of the Great Depression. It was one of several shipping mines shut down in the county during this period. The buildings at the Vermilion Mine were similar to those at Bunsenville, in respect to their design and type of construction. The mine originally had a frame tibble but this eventually was replaced with one built of steel (Westville Historical Museum).

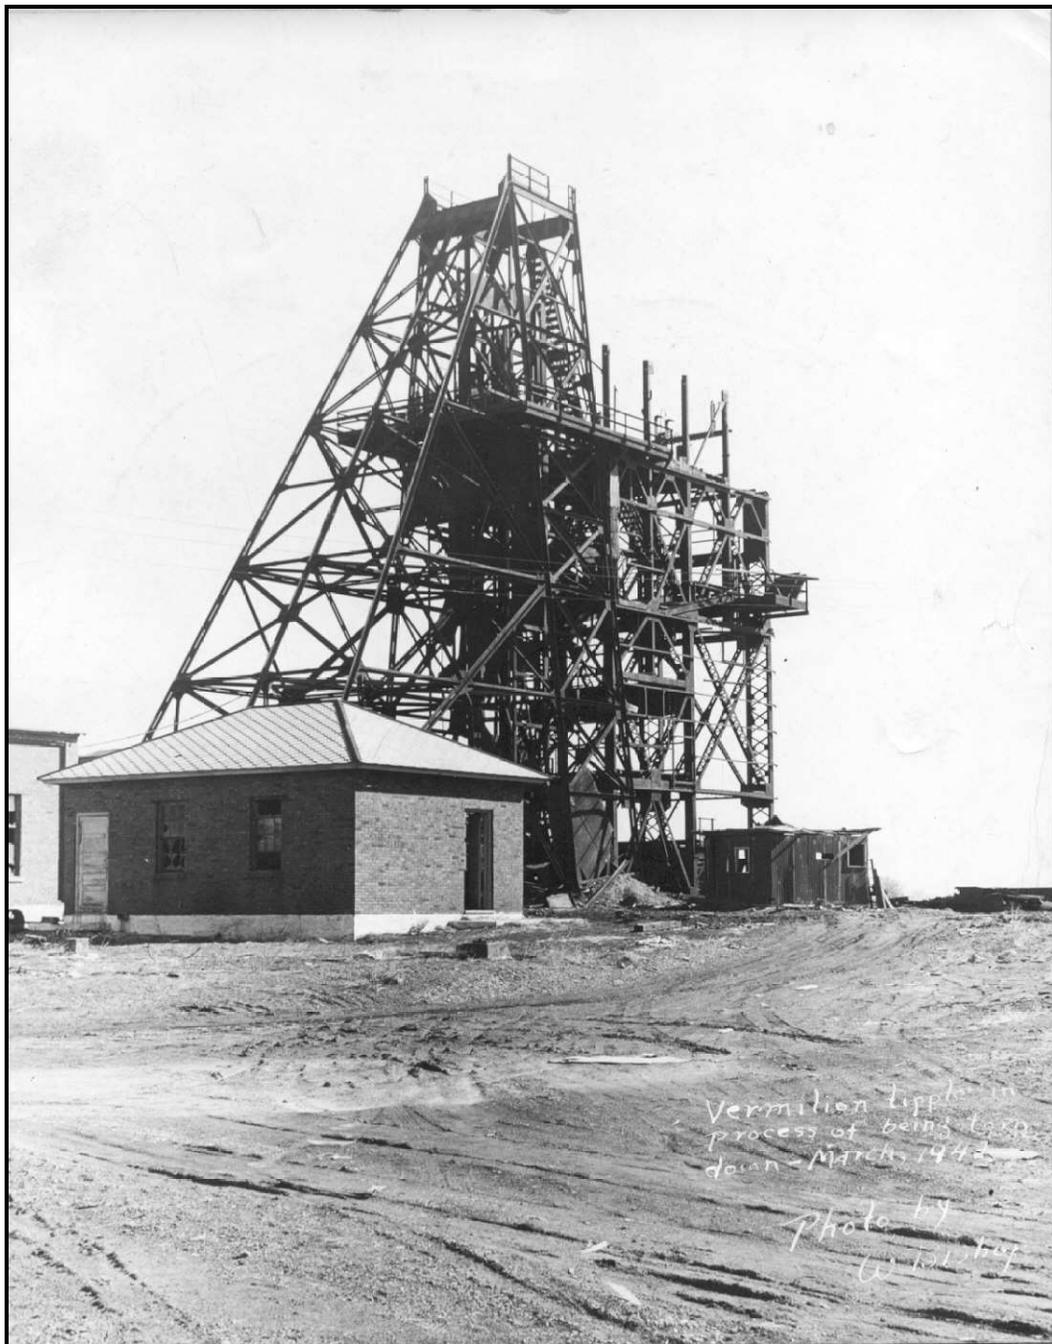
Figure 24. The tippel at the Vermilion Mine being dismantled in 1942. This photograph provides a good illustration of the manner of construction of a steel tippel. The brick building shown in the foreground is the mine check house, which is similar in size and design to the one at Bunsenville (Westville Historical Museum).

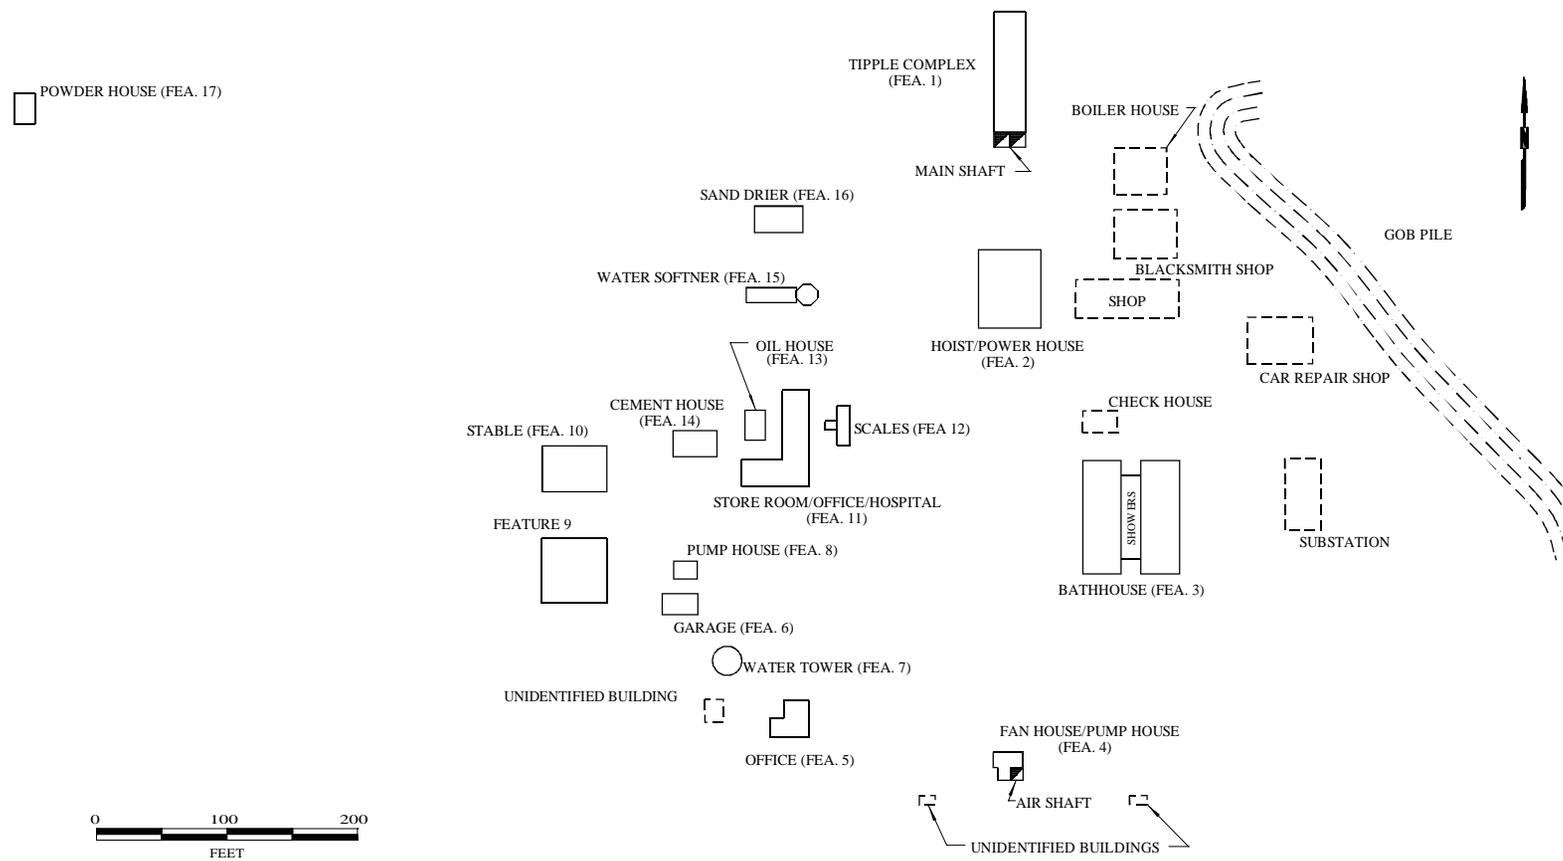
Figure 27. Site plan of the Bunsenville Mine, showing the locations of the features identified during the survey. Dashed lines indicate buildings not recorded in the survey, due to absent or limited surface remains. This figure is based off the 1947 map of the mine (DMM 1947b), used in conjunction with data gathered during the field investigation.

Sites/Features Found: The survey identified multiple sets of building foundations, a number of piers/footings, and several landscape features associated with the Bunseville Mine. There are no extant buildings left at the site. Building remains have been assigned feature numbers, whereas the piers/footings have not. See Figure 27 for a site plan.

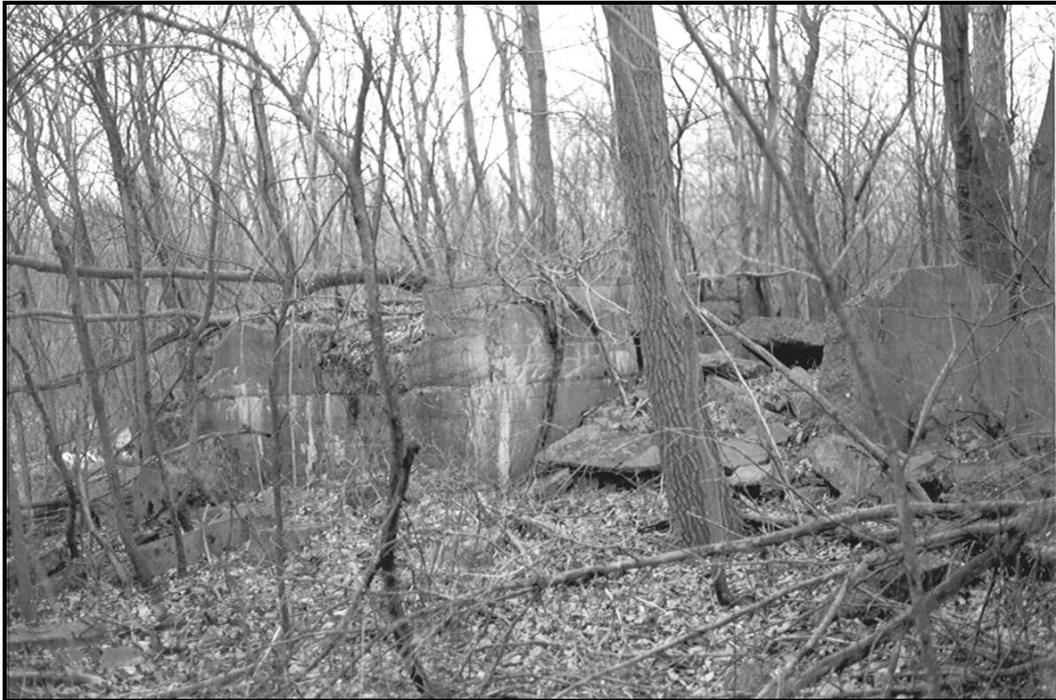
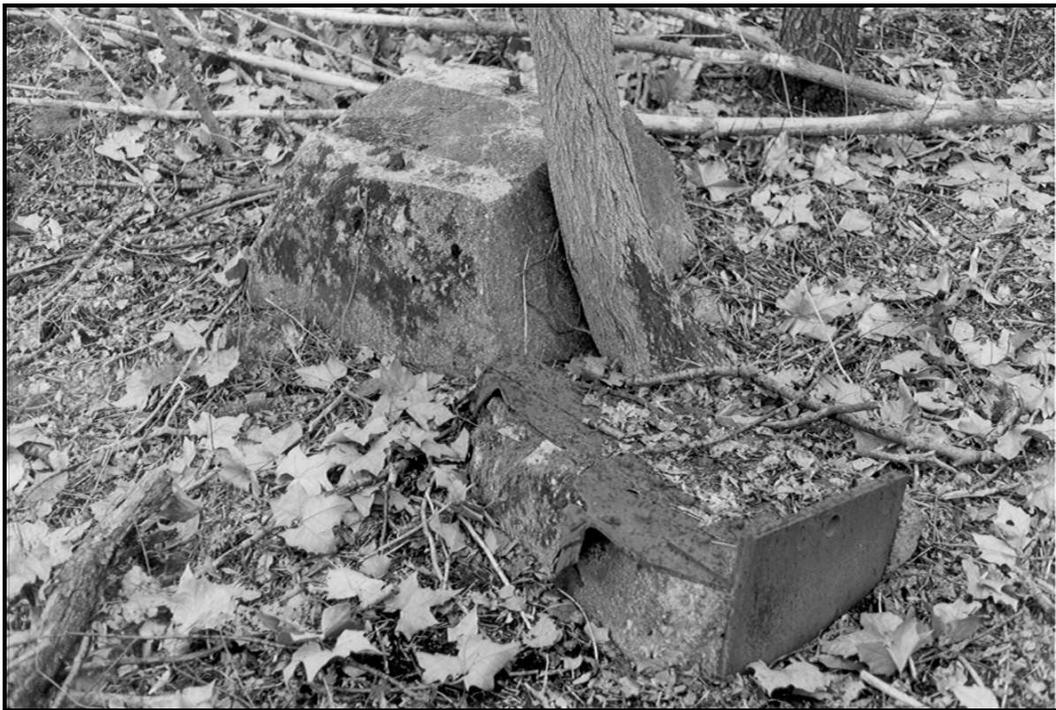
Figure 28. (TOP) View of the hoist shaft foundations, looking southwest. (BOTTOM) One of the footings of the mine tippie, illustrating their two-piece construction (FRR March 2002).

Feature 1 is a series of concrete foundations and piers that represent the remains of the tipple complex at the mine. The superstructure of the tipple was of steel-frame construction and was comprised of a hoist shaft and a series of shakers that sorted coal by size. After being sorted, the coal was fed through hoppers into rail cars for shipment. When the mine was dismantled, the mechanicals within the tipple were removed and its steel structure was salvaged down to its foundations. Pictures of the Feature 1 have been attached as Figures 28 and 29.

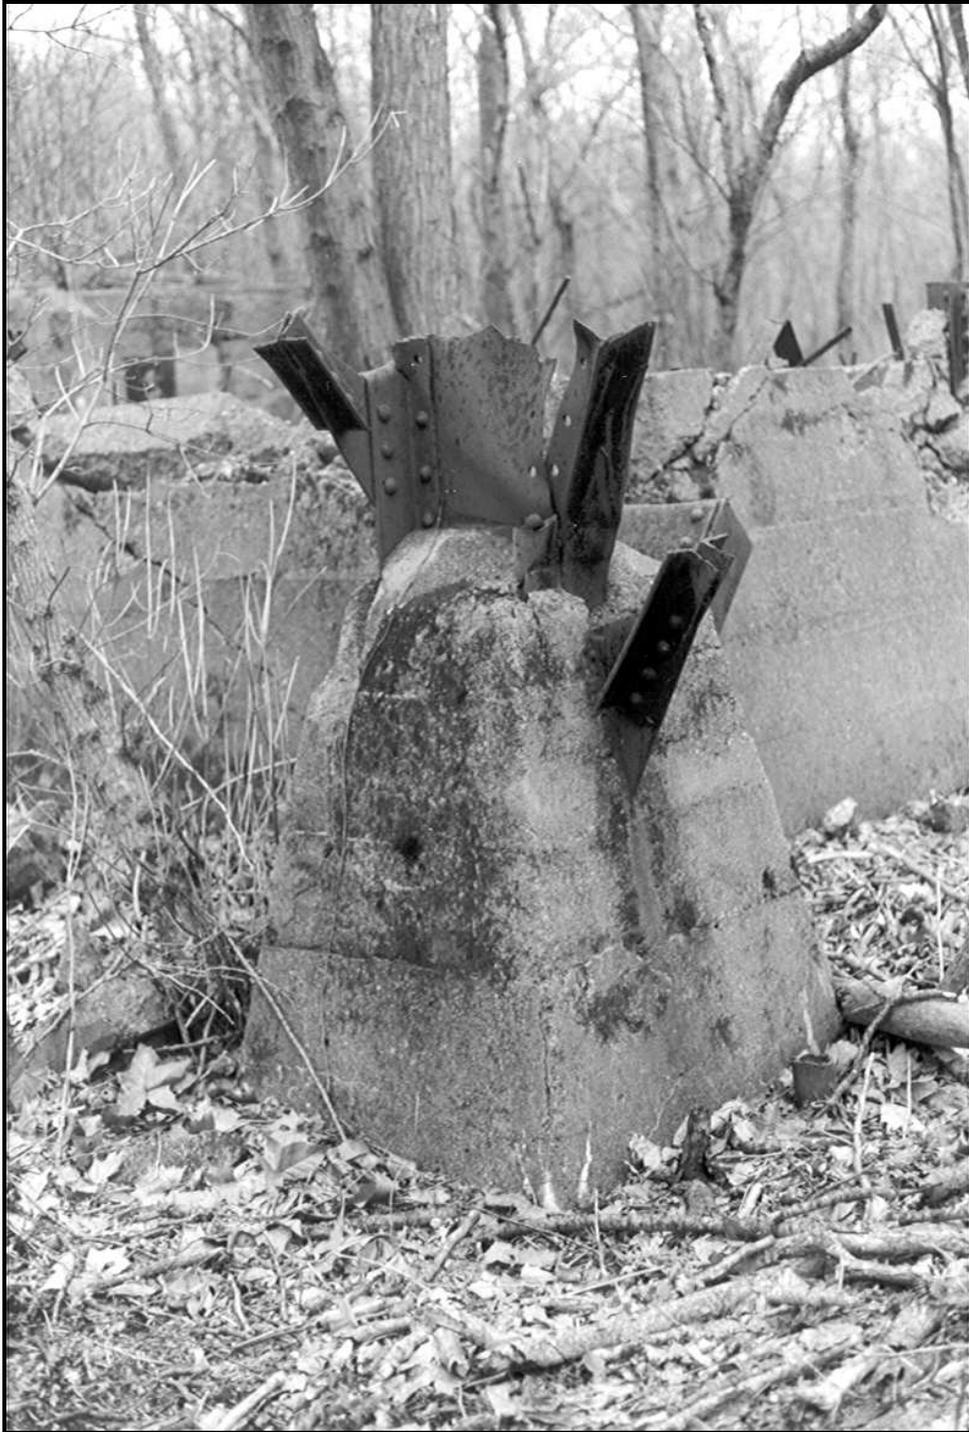
Figure 29. Another tipple footing. Note the manner in which the steel is encased in concrete (FRR March 2002).

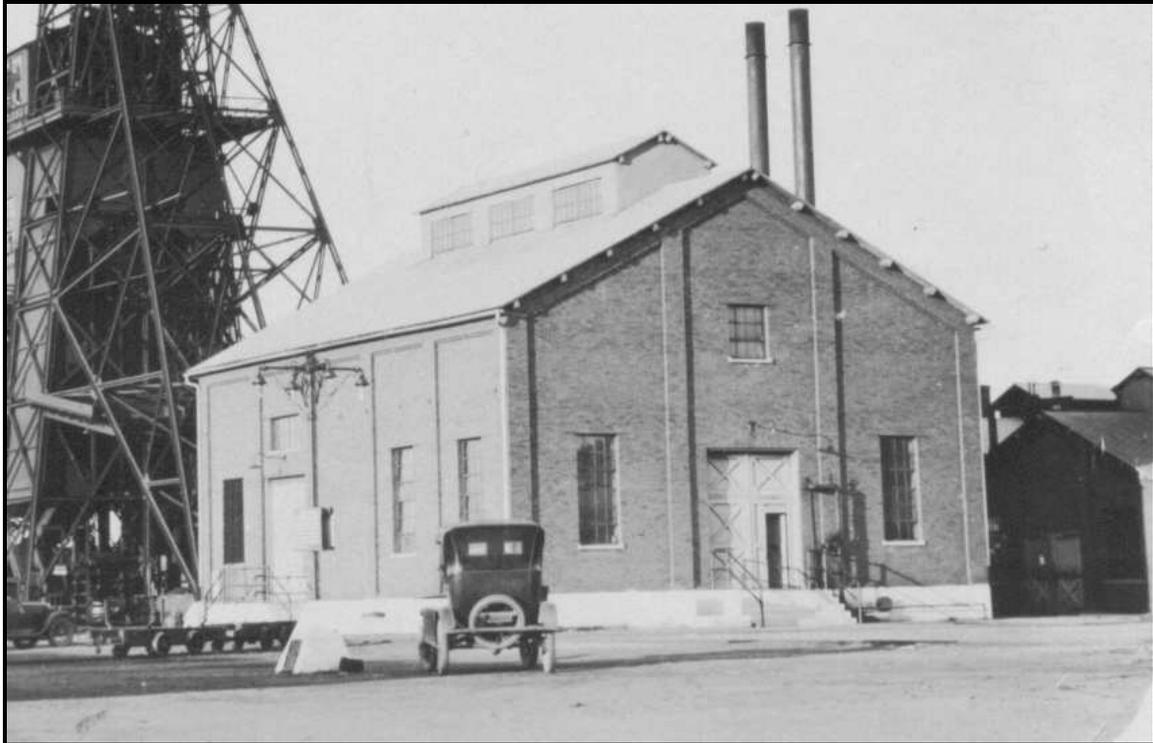
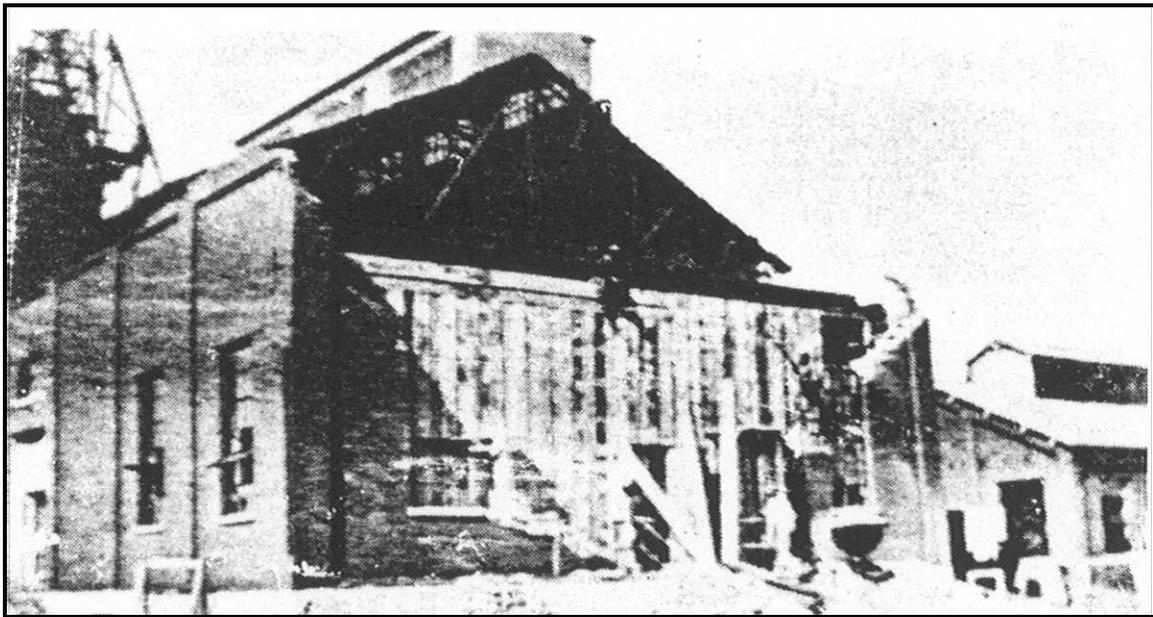
Figure 30. Historic photographs of the hoist/engine house (Feature 1) at the Bunsenville mine. (TOP) Ca. 1920s photograph showing the building during the mine's early years of operation (Westville Historical Museum). (BOTTOM) Damage caused to the building after a tornado hit, causing the south wall to collapsed (Stark and Brown 1977:238).

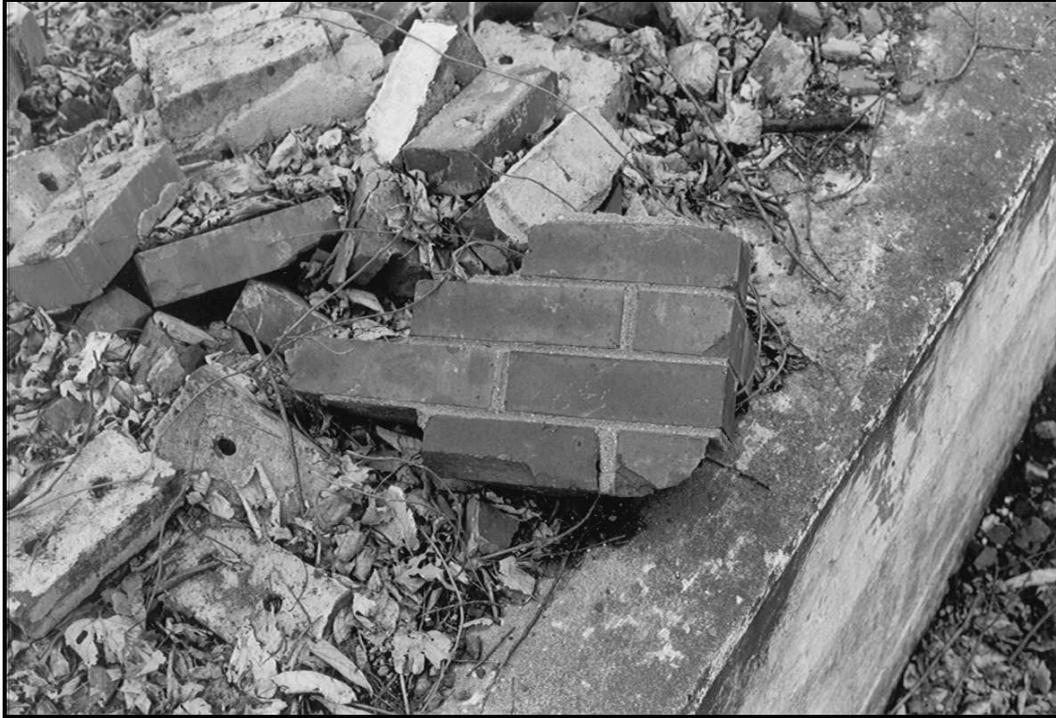
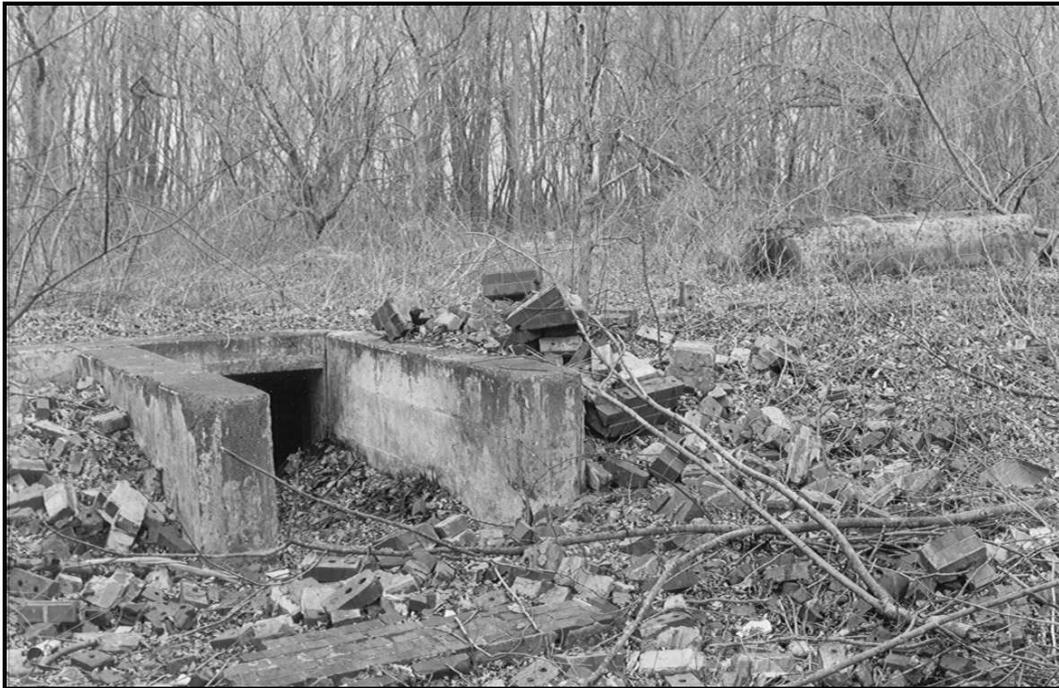
Figure 31. (TOP) Representative examples of the brick with which the walls of the hoist/power house (Feature 2) were constructed. (BOTTOM) Feature 2, looking northeast and showing southern half of the building, which served as an electrical substation. The bulkhead in the foreground allows access to the basement of the building. (FRR March 2002).

Feature 2 is the combination power and engine house for the mine. This building was a large, front-gabled, brick structure, which measured 63'-2" (north/south) by 50'-0" (east/west). It was one of the key buildings at the mine and is documented in several historic photographs (see Figure 30). Like most of the other structures at the site, the engine/power house has been demolished down to its concrete foundations. The north half of the building served as the hoist room and housed the engine that powered the cage in the main shaft. The engine has been removed, but the mountings for it are still evident on the floor. The south half of the building served as a powerhouse, or substation, generating electrical power for the mine. A basement extends beneath most of the building, but this area was filled with water at the time of the field investigation, making it inaccessible. We have very little evidence of the exact workings of the powerhouse,

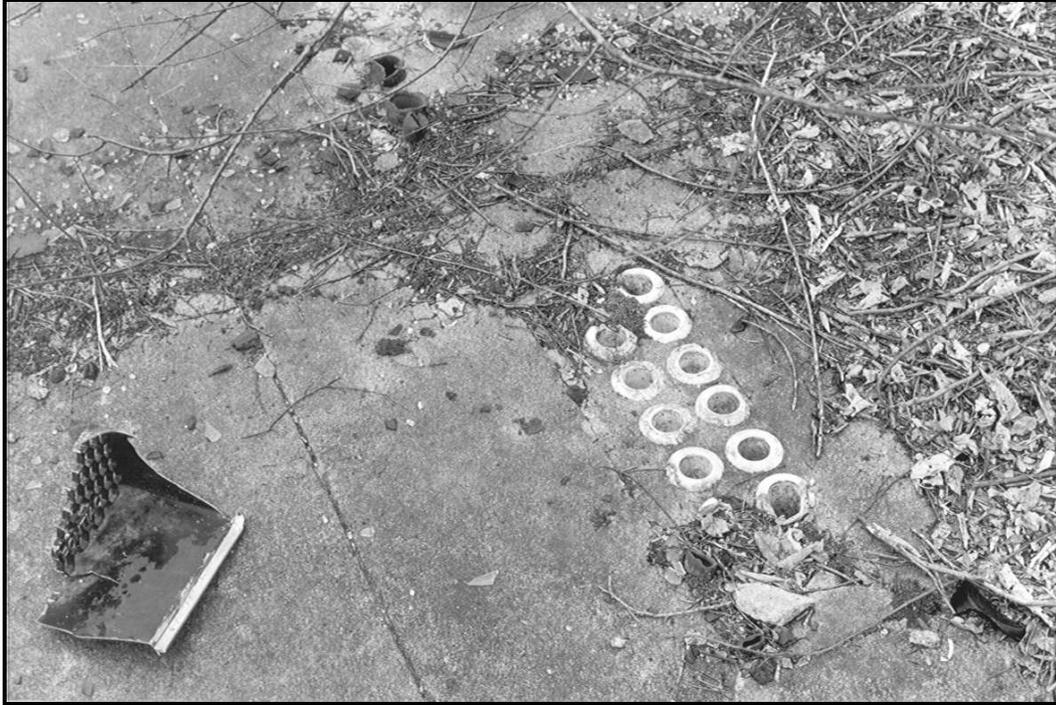
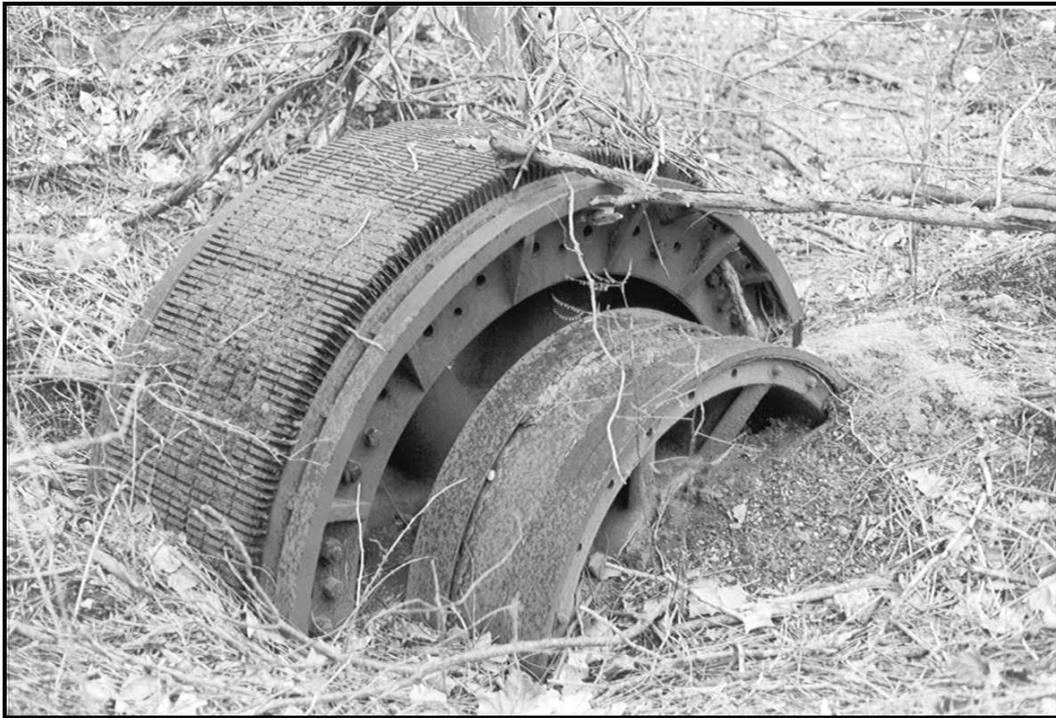
Figure 32. (TOP) Floor in the substation room, showing porcelain insulators embedded in the floor, presumably for electrical wiring. (BOTTOM) Piece of equipment lying north of the hoist/power house, possibly from a dynamo or the hoist engine (FRR March 2002).

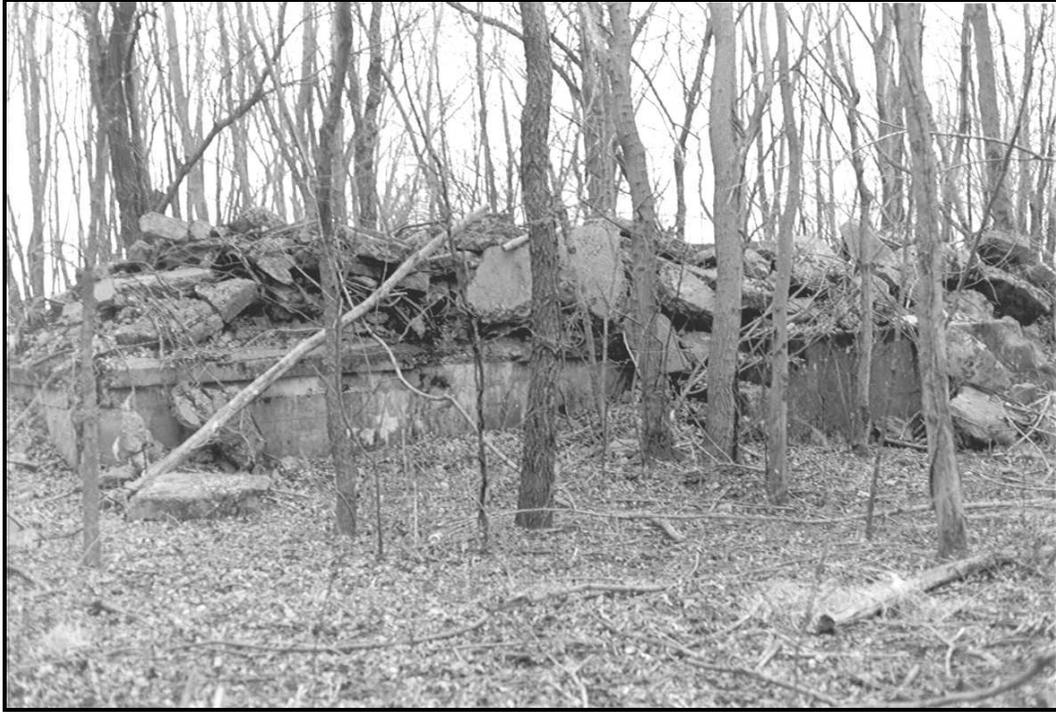
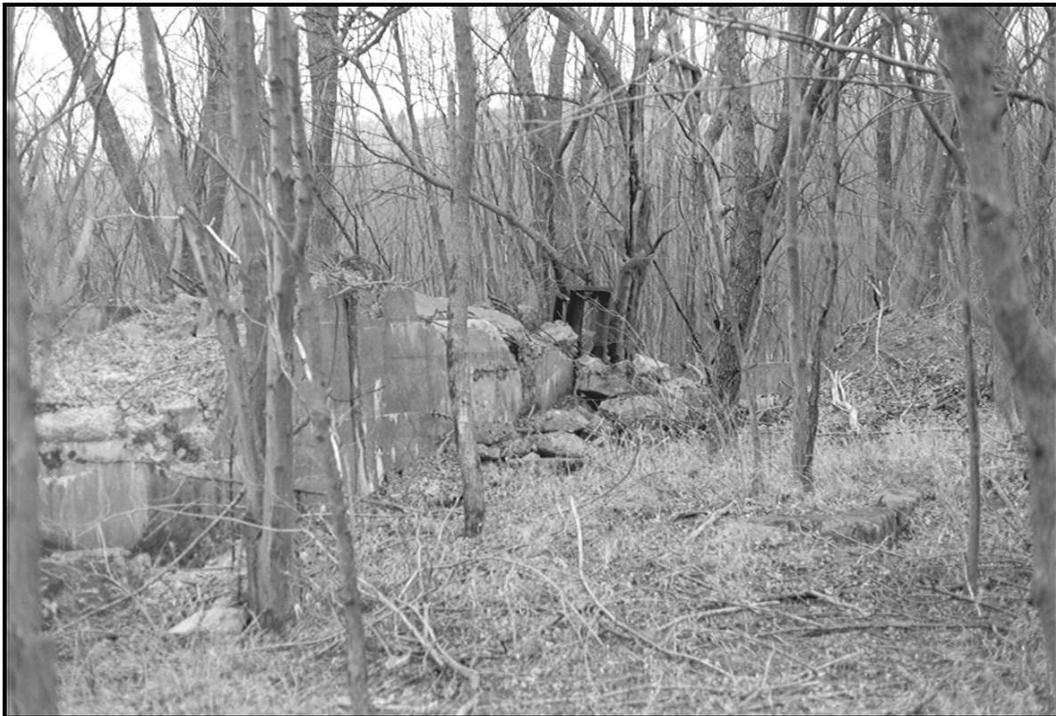
Figure 34. (TOP) The remains of the fan house (Feature 4), looking southwest. Note the stairway leading to the raised engine room section of the building. (BOTTOM) The fan house, looking northeast. The fan room is located nearly at grade (FRR March 2002).

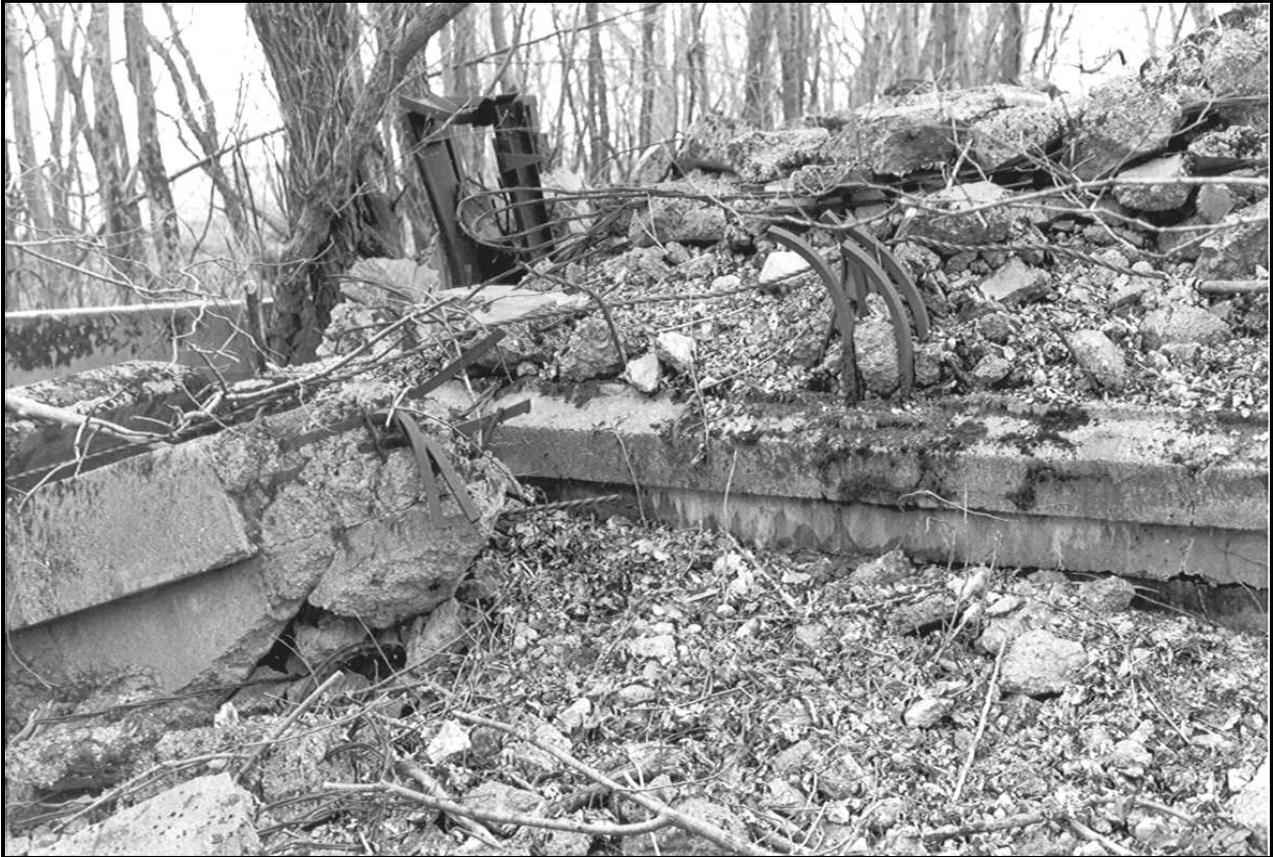
Figure 35. The walls of the engine room section of the fan house were constructed with reinforced concrete. Though very utilitarian in function, the building did have some aesthetic touches, including a concrete watertable (shown above) and pilasters. The pilasters were strengthened with 1" re-bar (FFR March 2002).

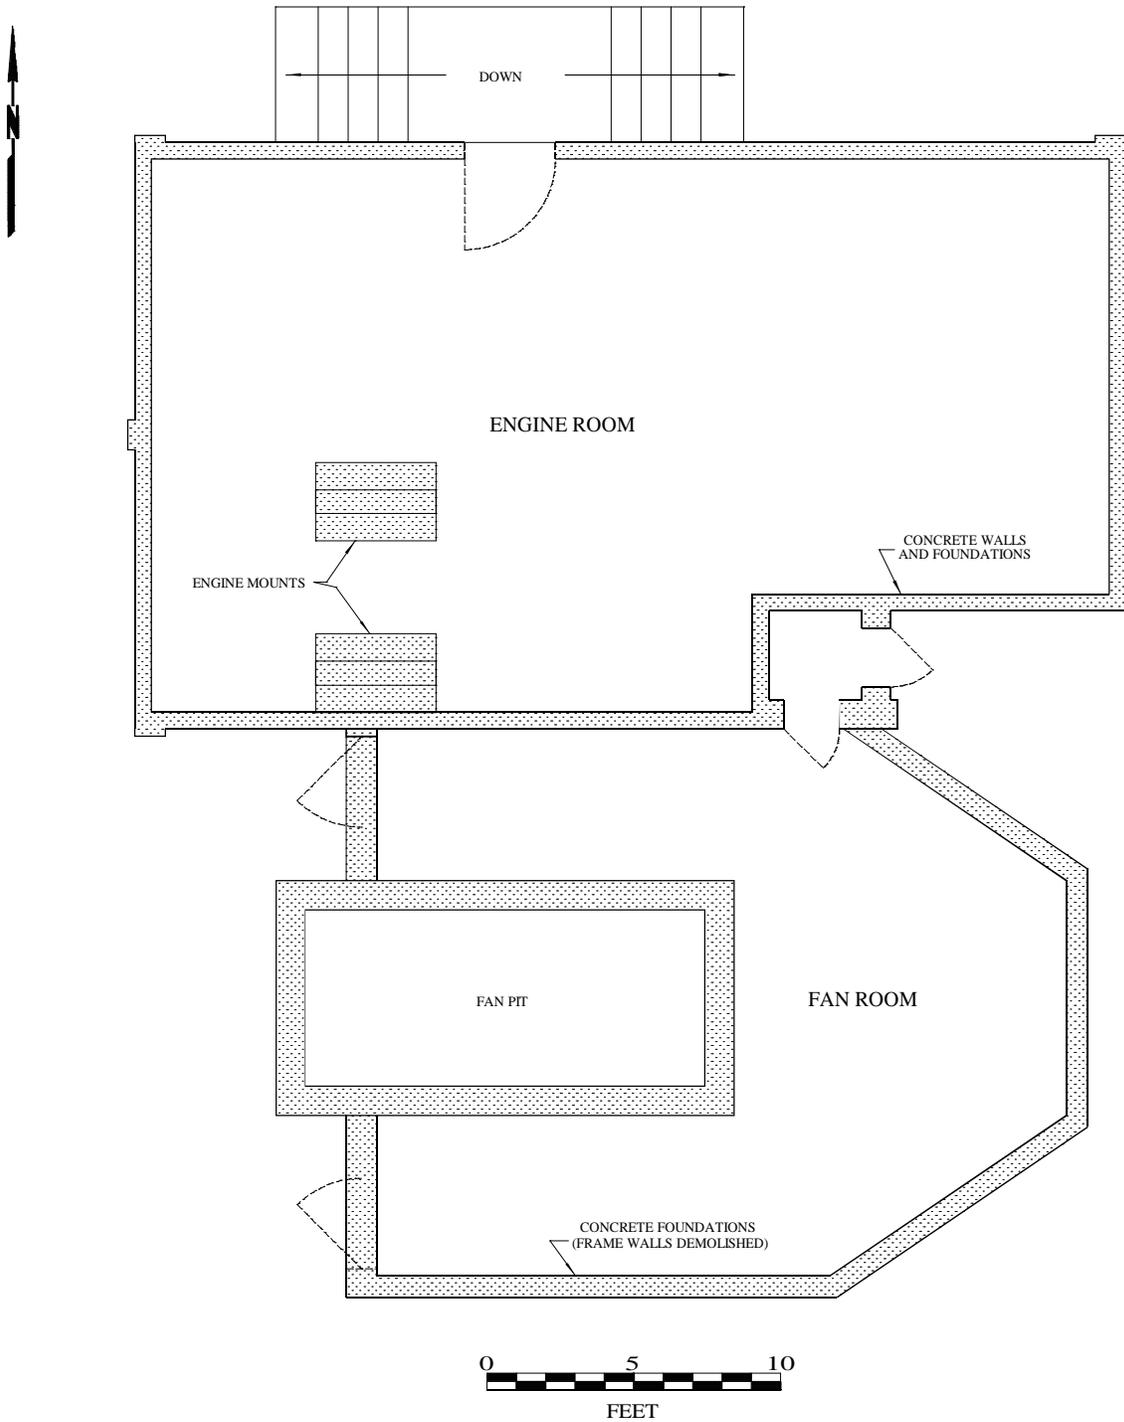
Figure 37. (TOP) Plan of the fan house (Fea. 4), showing existing conditions (FRR 2002).

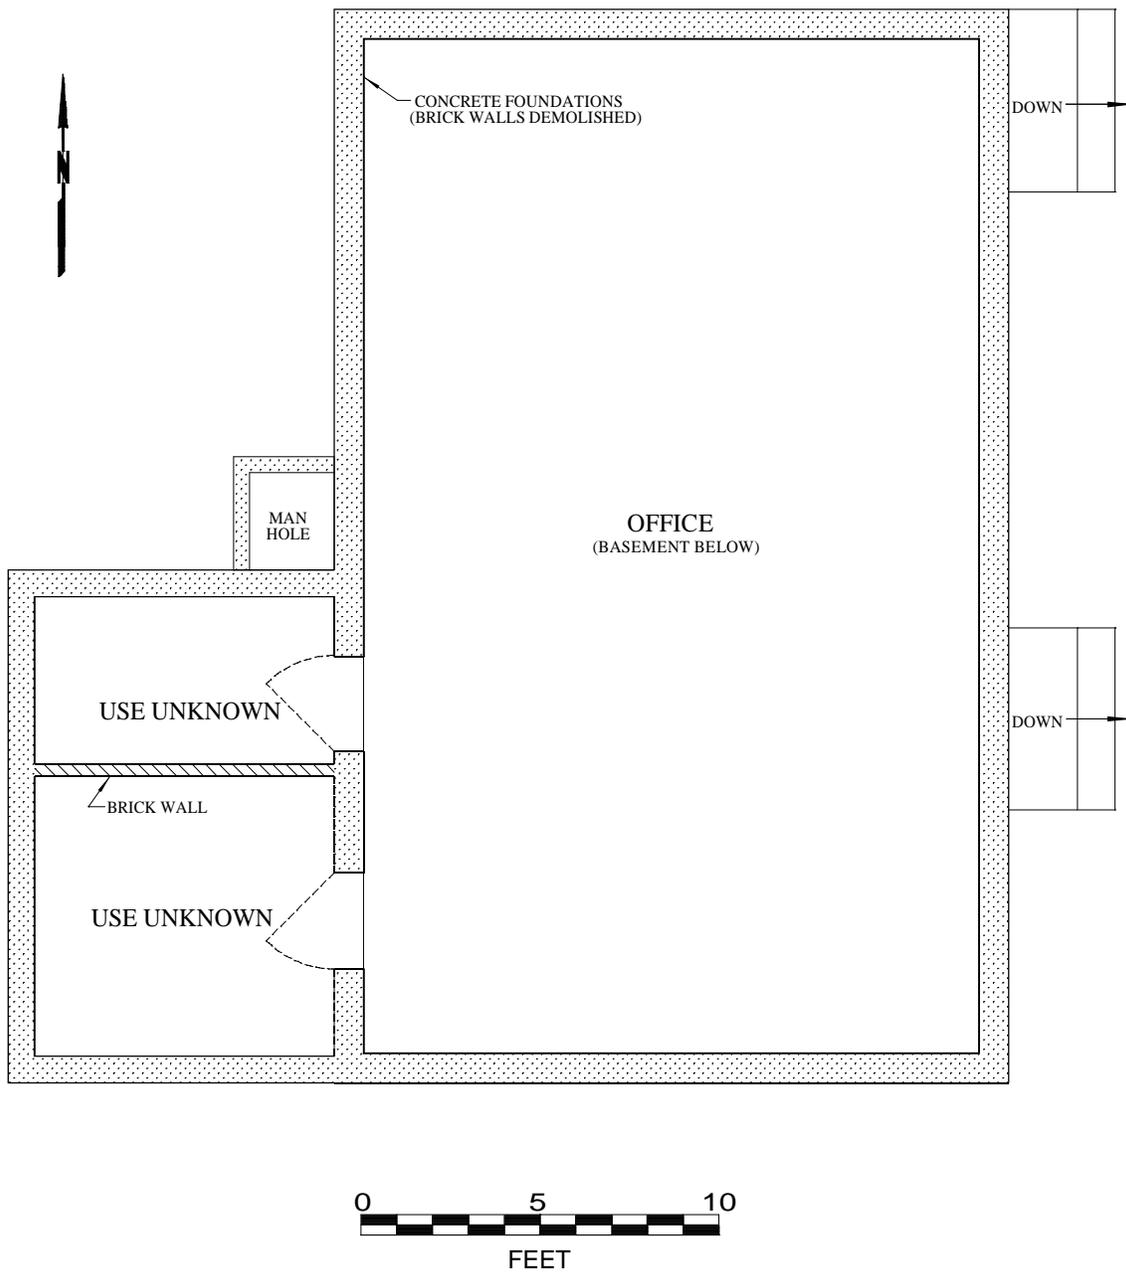
Figure 38. Plan view of the office building (Feature 5) at the mine site, showing existing conditions (FRR 2002).
