**ILLINOIS DEPARTMENT OF NATURAL RESOURCES
CULTURAL RESOURCE MANAGEMENT PROGRAM
ABANDONED MINED LANDS RECLAMATION
CULTURAL RESOURCES EVALUATION**

**U. S. FUEL COMPANY, BUNSENVILLE MINE
BUNSENVILLE, ILLINOIS**

May 2002

Project Type/Title: Phase II archaeological survey of U. S. Fuel Company Bunsenville Mine reclamation project (AML-GveE-0107).

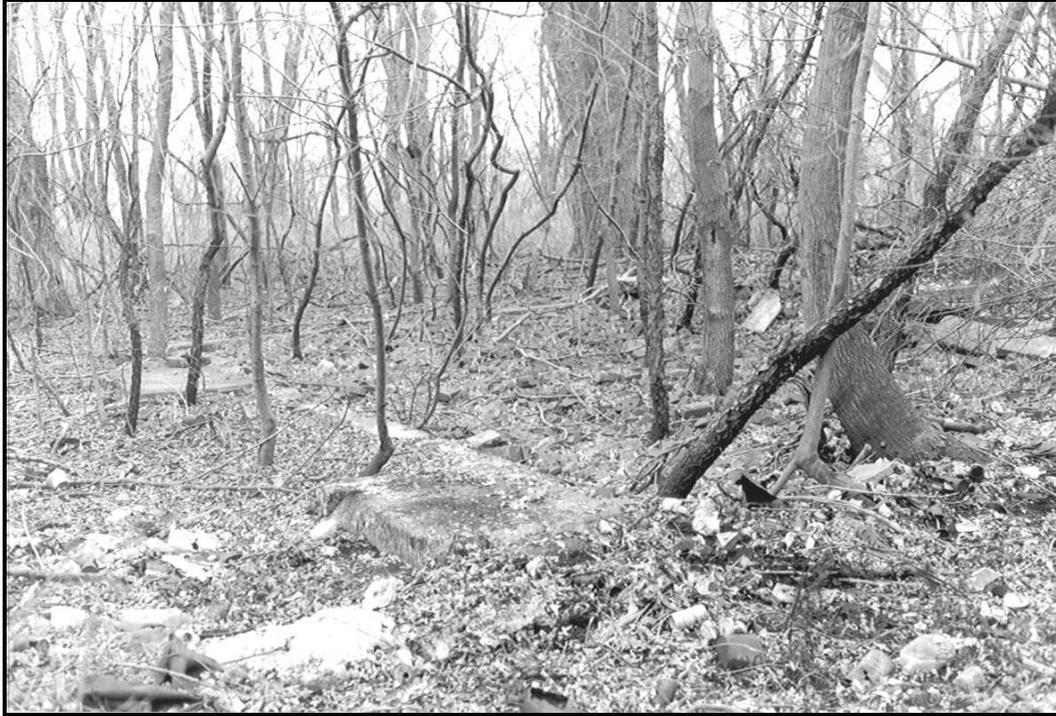
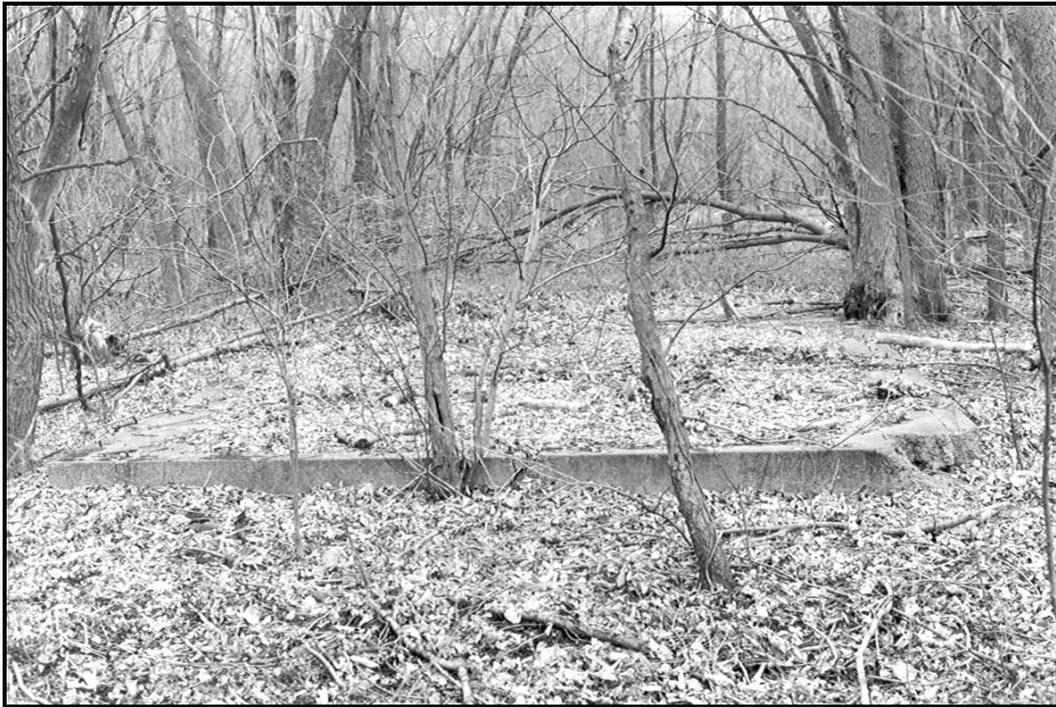
Figure 39. (TOP) View of the remains of the mine office (Feature 5), looking southwest. When the building was demolished, the bricks from its walls were pushed into the basement. (BOTTOM) View of the foundations for the steel-sided, frame garage (Feature 6) at the site (FRR February 2002).

Feature 6 is the foundations of a garage measuring 12'-1" (north/south) by 12'-6" (east/west). Now razed down to its concrete foundations, the garage appears to have been of frame construction (based on the presence of sill bolts), and the 1947 mine map indicates that it had steel siding (see Figure 39).

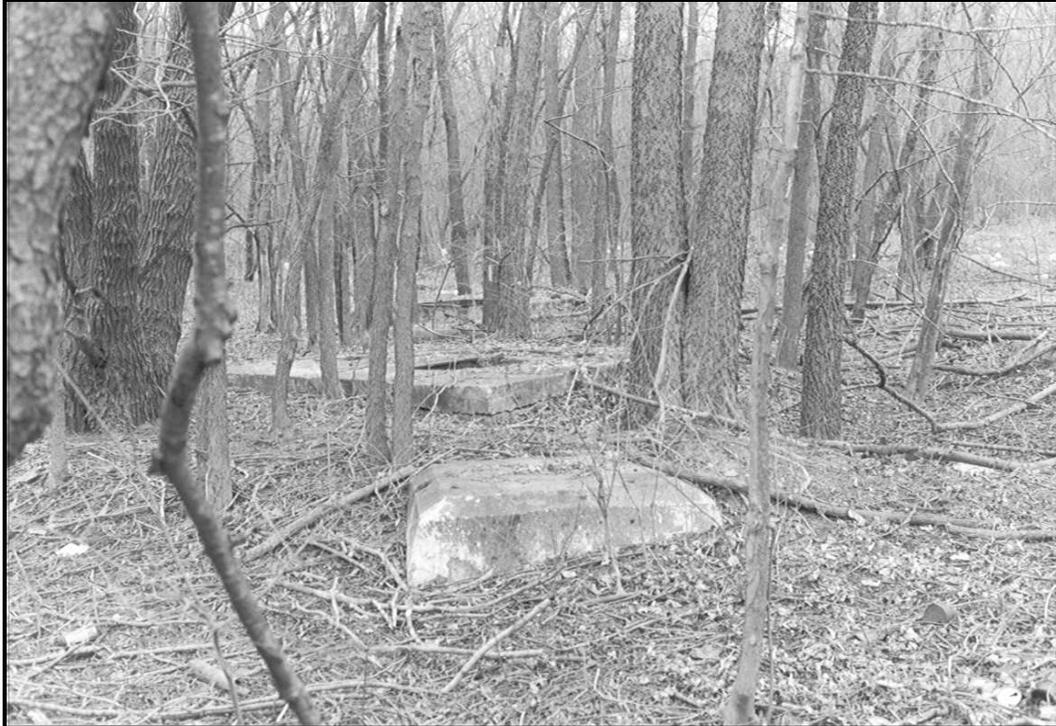
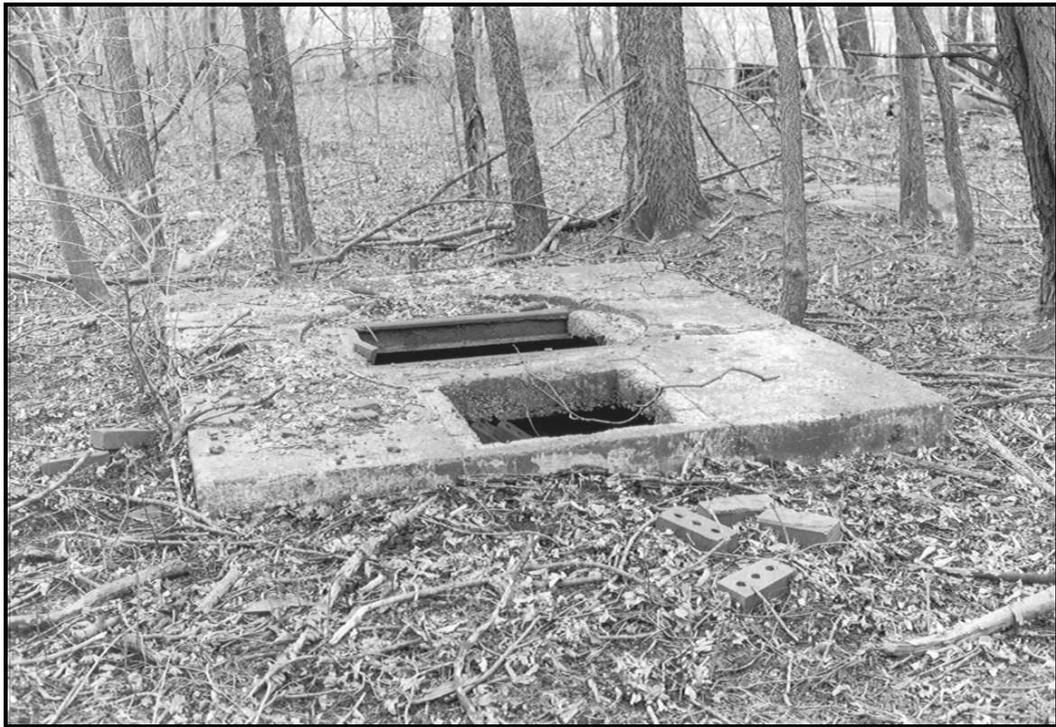
Figure 40. Two views of the foundations associated with the steel water tower (Feature 7) at the mine site (FRR February 2002).

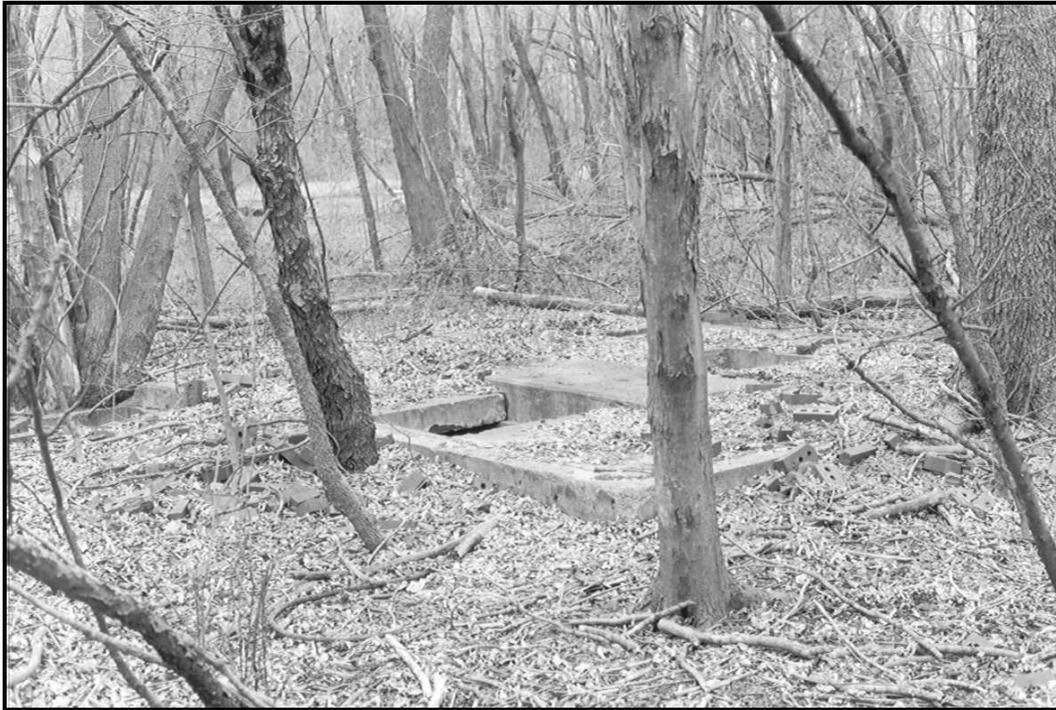
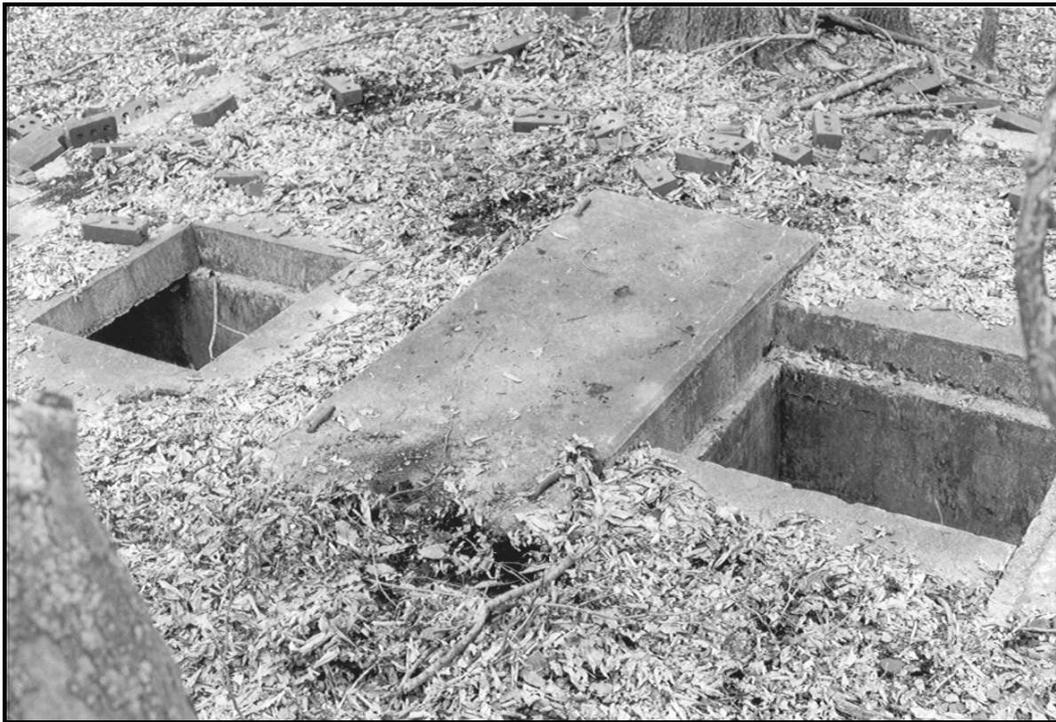
Figure 41. (TOP) The pump house (Feature 8), looking southeast. (BOTTOM) Interior of the pump house, showing the concrete pump mounting and the passageways for pipes beneath the floor (FRR February 2002).

Feature 8 is a pump house located near the water tower. This building originally had 8" brick walls, but these have been demolished down to the concrete foundations, which measure 13'-6" (north/south) by 17'-7" (east/west) on their exterior. A large concrete mounting, presumably intended for a pump, is located on the interior of the building. Passageways for pipes are located beneath the concrete floor (see Figure 41).

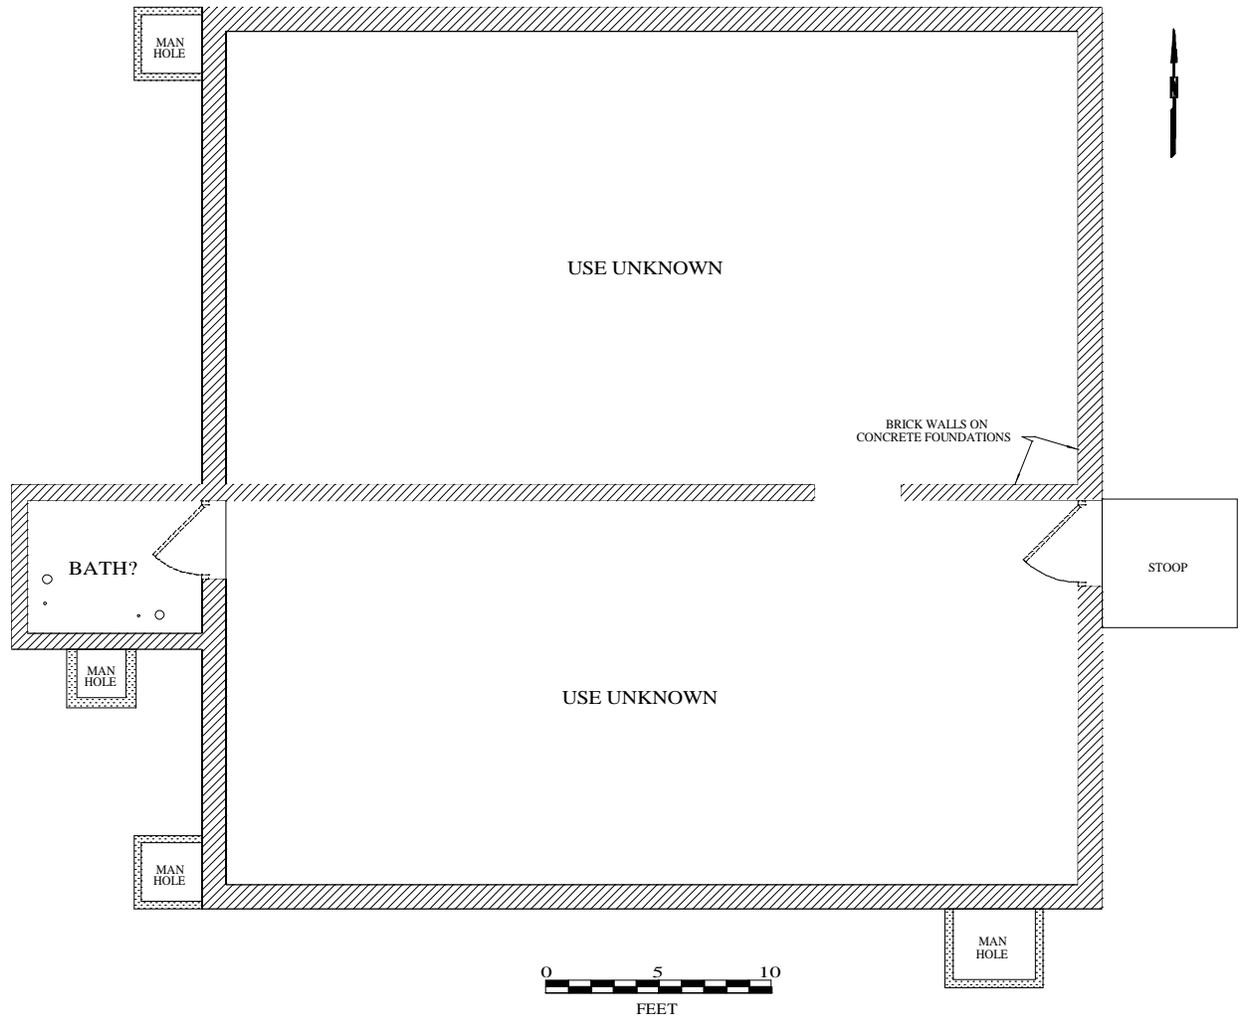
Figure 42. Floor plan of Feature 9, a large brick building located on the western edge of the site. The function of this building has not been determined (FRR 2002).

Feature 9 is the foundation remains of a large brick building located south of the stable. This building appears on the abandoned mine map for the Bunsenville Mine but is not identified, which is surprising given its large size. The main block of the structure measures 39'-8" square and is divided in half by an interior brick wall running east/west. A small wing, believed to be a bathroom (based on the plumbing present), extends off the west end of the building. A concrete pad, meant for an entrance porch or stoop, is located on the east side of the building (see Figures 42 and 43).

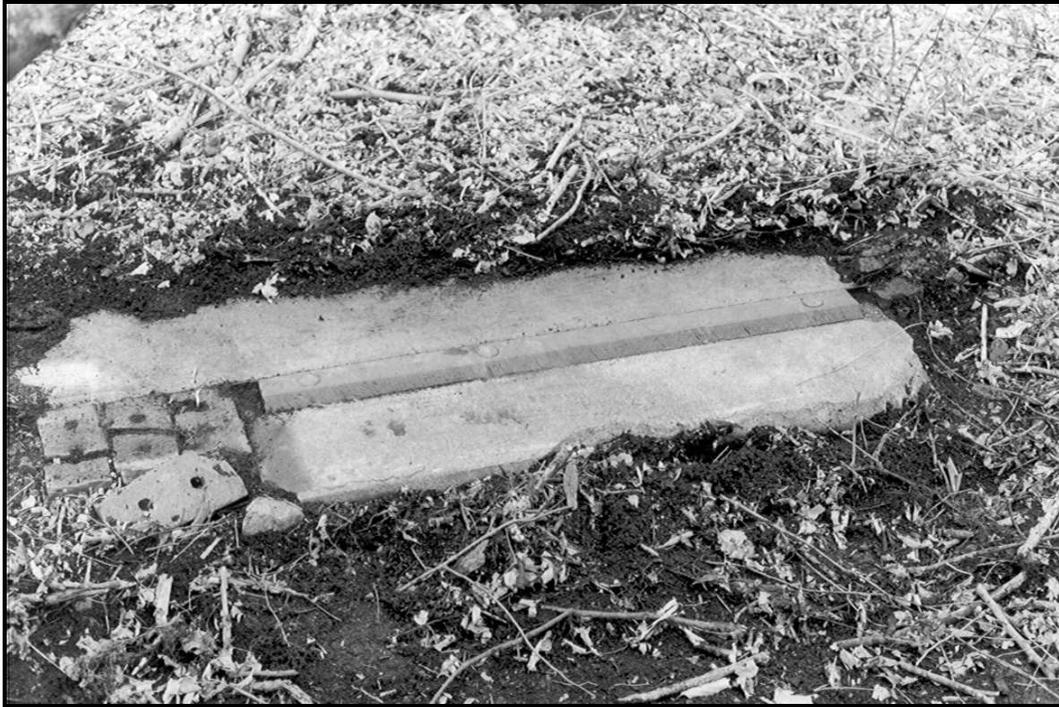
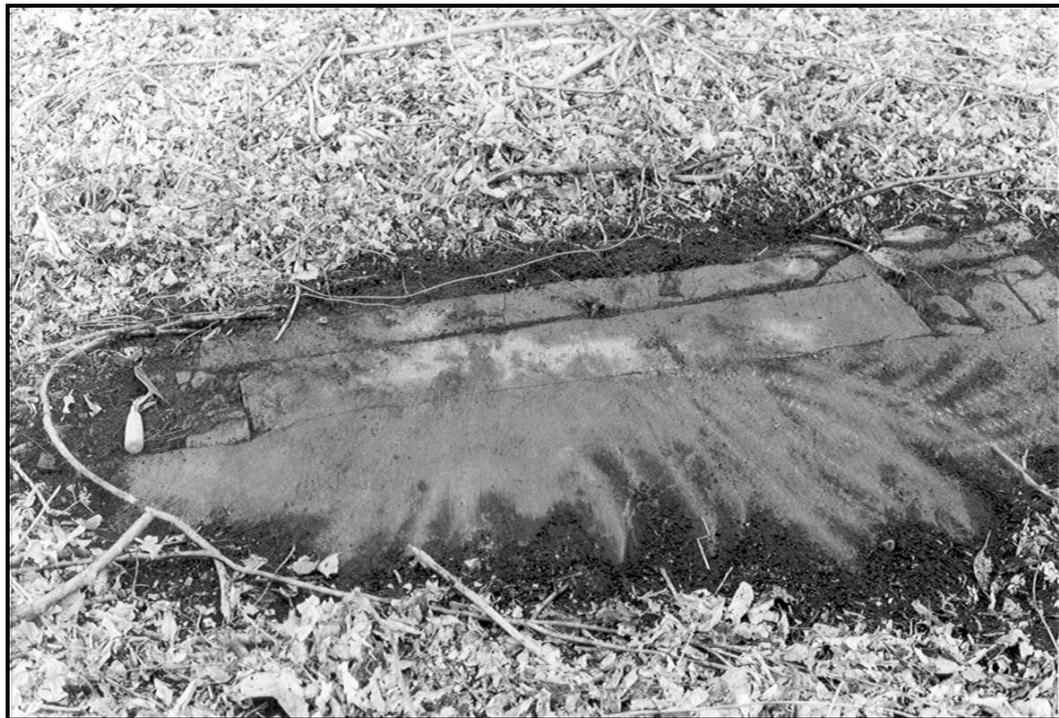
Figure 43. Even though Feature 9 was demolished down to its foundations, the building remains still contained evidence of the door openings and interior partition walls. The top photograph shows a threshold at one of the exterior entrances to the building. Note also the exterior brick wall. The lower photograph illustrates an interior doorway location (FRR February 2002).

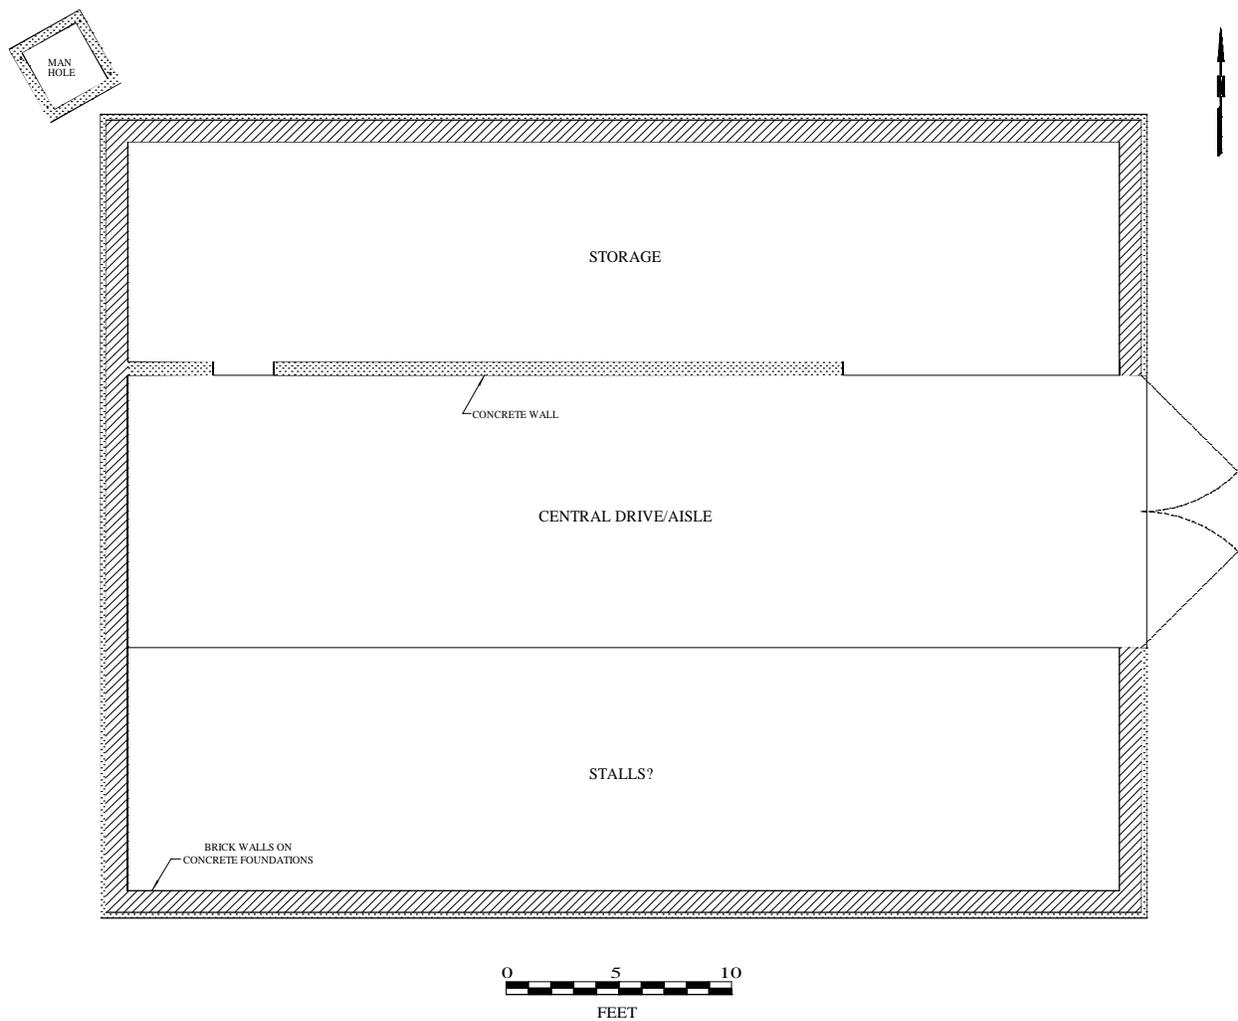
Figure 44. Floor plan of the stable (Feature 10) at the mine. Used to shelter mules, the stable was brick and was divided on its interior into three aisles (FRR February 2002).

Feature 10 represents the remains of a stable measuring 35'-5" (north/south) by 46'-4" (east/west). The stable had brick walls and concrete foundations and was divided into three aisles on its interior. The central aisle measured 12' wide and had a wide doorway (probably holding paired doors) at its east end. The north aisle measured 11' wide and was separated from the central aisle by a concrete wall along part of it. In contrast, the south aisle, which also was 11' wide, had no masonry wall dividing it from the central aisle. It is possible that the aisle on the north was used for storage, while the south aisle was divided into stalls for mules. The foundations of small frame structure (3'-6"x3'-8") are located off the northwest corner of the stable. This structure may have functioned as a manhole or valve house. Both it and the stable have been razed to their foundations (see Figures 44 and 45).

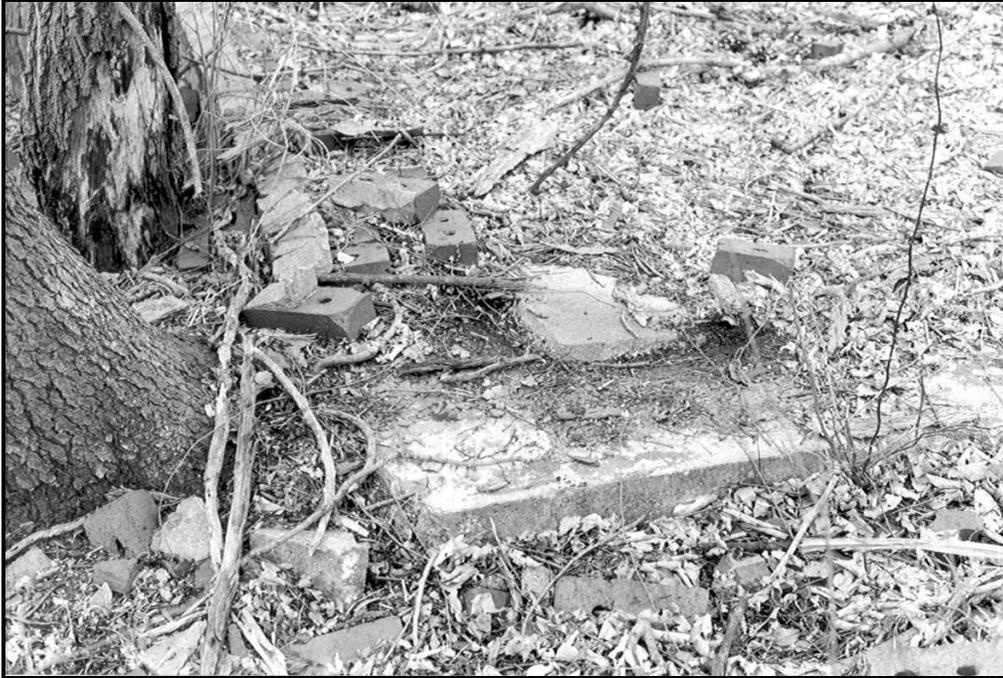
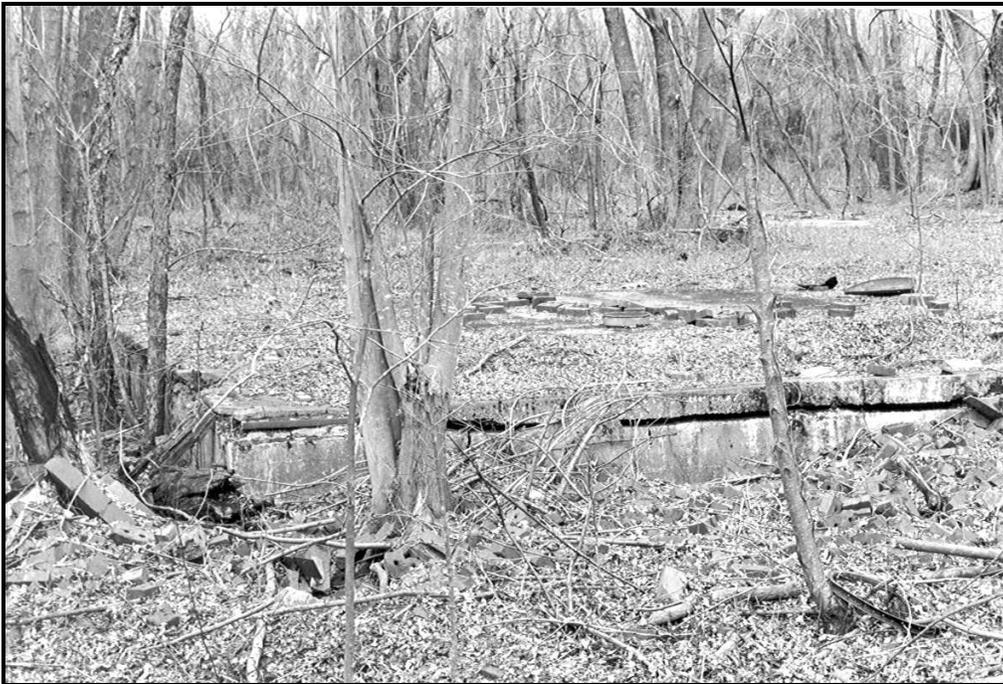
Figure 45. (TOP) Southwest corner of the stable (Feature 10), illustrating the character of construction. The barn had brick walls, concrete foundations, and a concrete floor (FRR February 2002). (BOTTOM) View of the concrete pad once occupied by Feature 11, a multi-purpose building which served as a store room, office, and hospital. This photograph looks northeast, from the southwest corner of the frame wing that was added to the building (FRR March 2002).

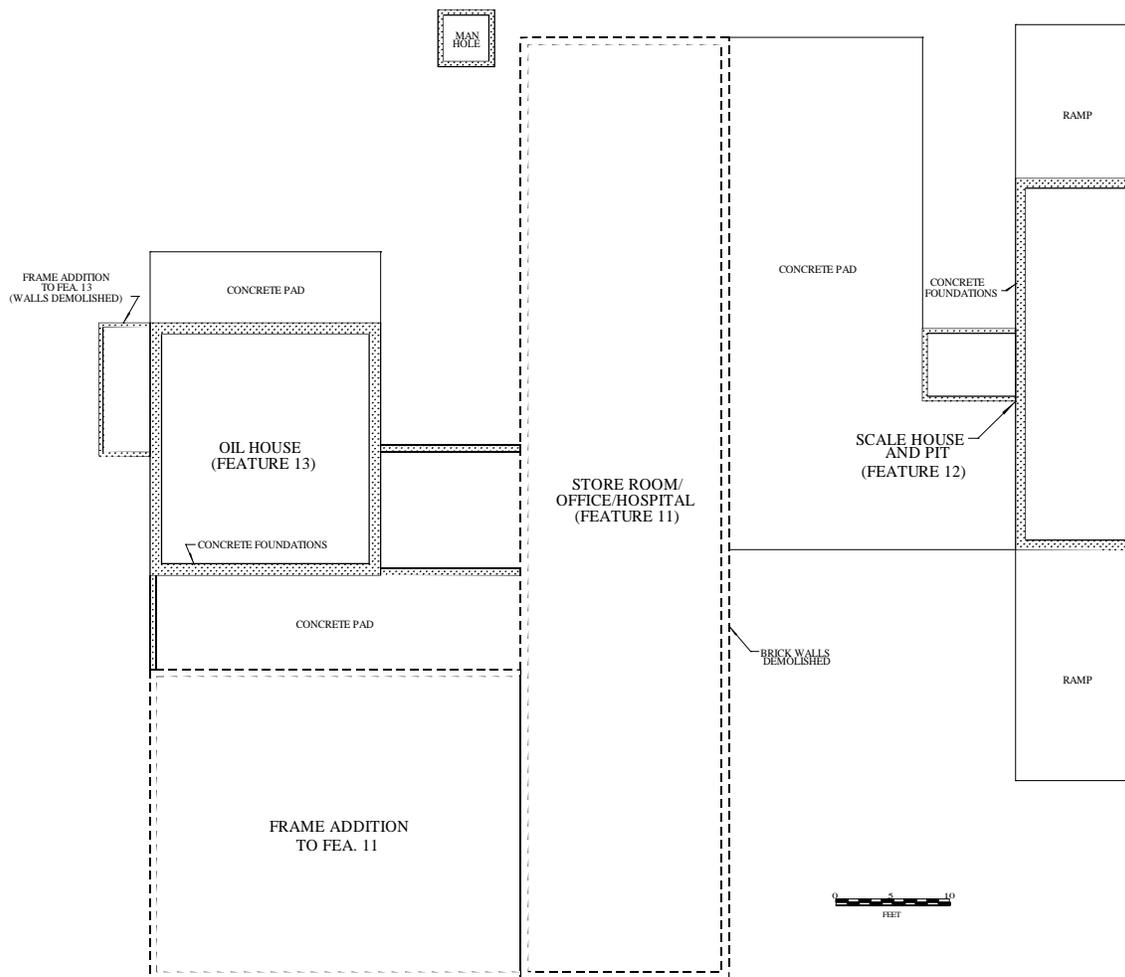
Figure 46. Plan illustrating the remains of Features 11, 12, and 13 (FRR 2002).

Feature 13 is positioned directly behind Feature 11 and is identified on the 1947 mine map as an oil house. It presumably was used to store fuel or heating oil. The building measures 22'-0" (north/south) by 20'-0" (east/west), has concrete foundations, and originally had brick walls. A 6'-2"-wide concrete pad extends across the north side of the building, which suggests that it was entered on this side. A frame addition, with concrete foundations, was added along the west side of the oil house at some point (see Figure 46).

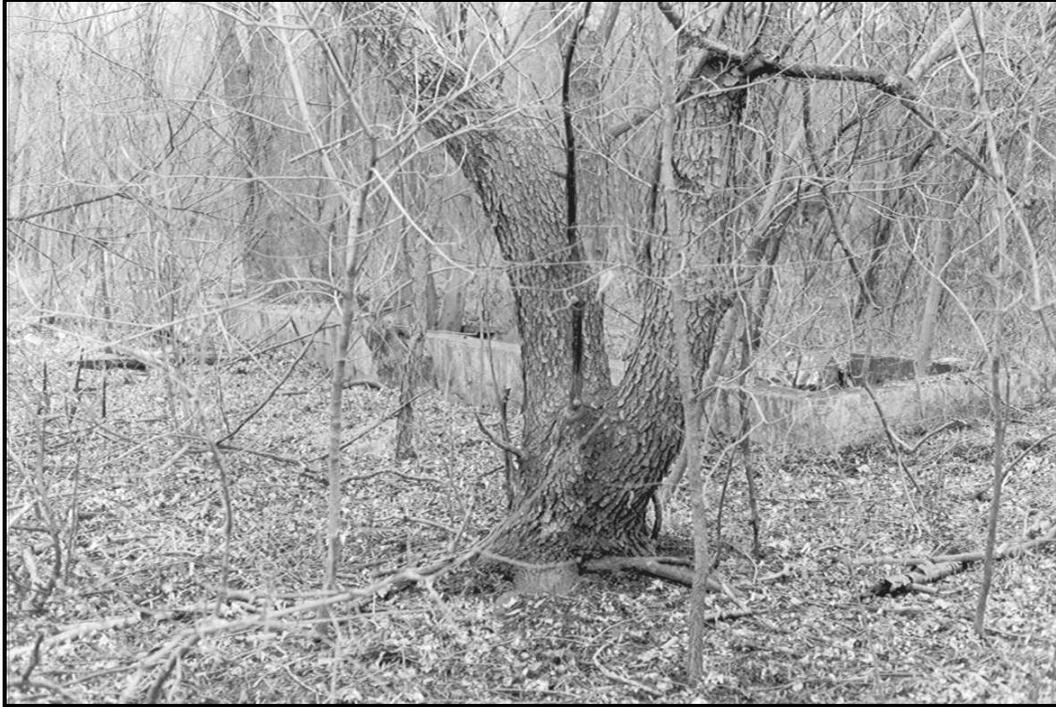
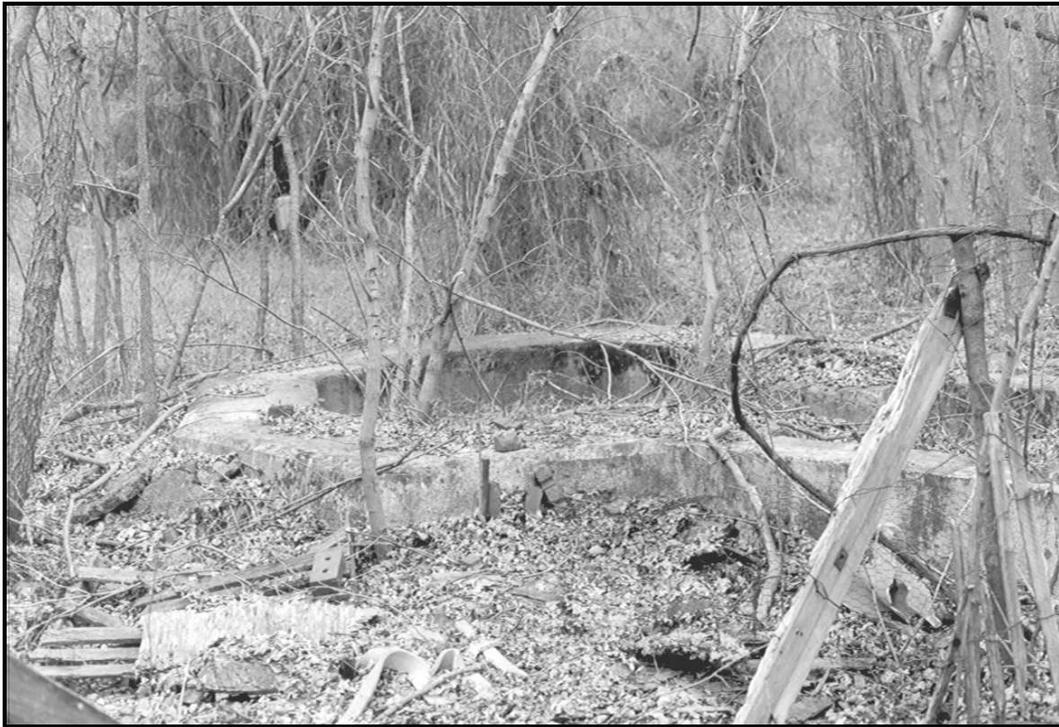
Figure 47. Two views of the water softener (Feature 15) foundations. The lower photograph shows the octagonal-shaped chamber located at the eastern end of the feature (FRR February 2002).

Feature 15 is the concrete foundations to a water softener. This odd shaped structure measures 57'-6" long (east/west) and is narrow and rectangular for most of its extent but has an octagonal chamber on its east. On the interior, the foundations are divided into three chambers. The presence of sawn-off 1"-square bars, spaced 7'-4" on-center, on the top of the foundations suggests that part of the softener's superstructure was of steel-frame construction. The specific utility of having a large water softener at the mine is not understood, though it may have been necessary to soften the water being used by the boilers in order to reduce buildup on pipes and valves (see Figures 47 and 48).

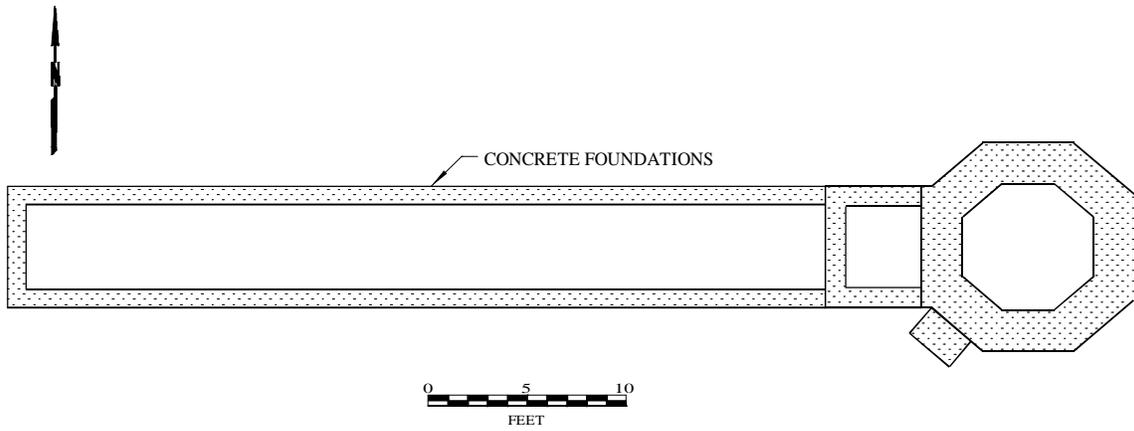
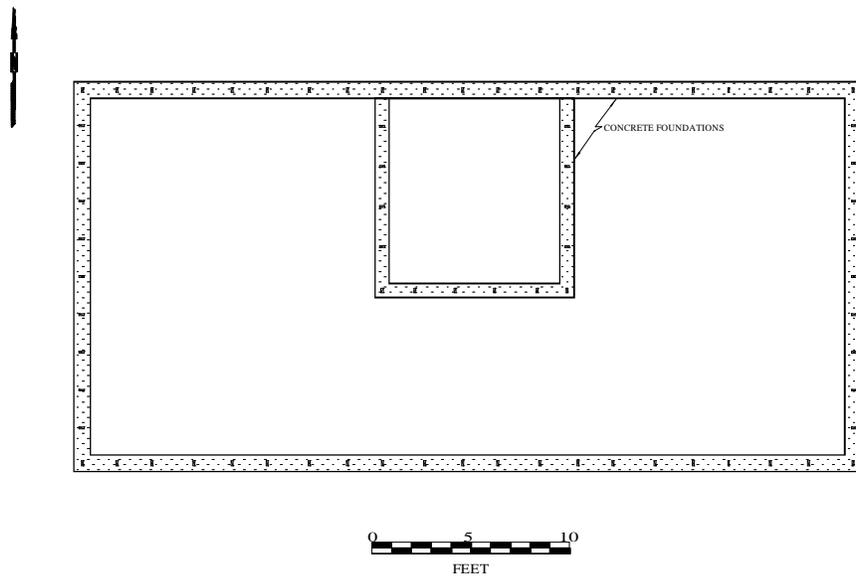
Figure 48. (TOP) Plan view of the water softener (Feature 15). (BOTTOM) Plan of the sand drier building (Feature 16) (FRR 2002).

Feature 16 is the remains of a building the 1947 mine map identifies as a "sand drier" (DMM 1947). The building was of concrete construction and measured 19'-8" (north/south) by 40' (east/west) on the exterior. A separate set of foundations, measuring approximately 10'x10' are located on the interior of the building. Narrow-gauge rails, set vertically, and steel cable were encased within the concrete walls, presumably for reinforcement. The exact purpose of a sand drier had not been determined (see Figure 48).

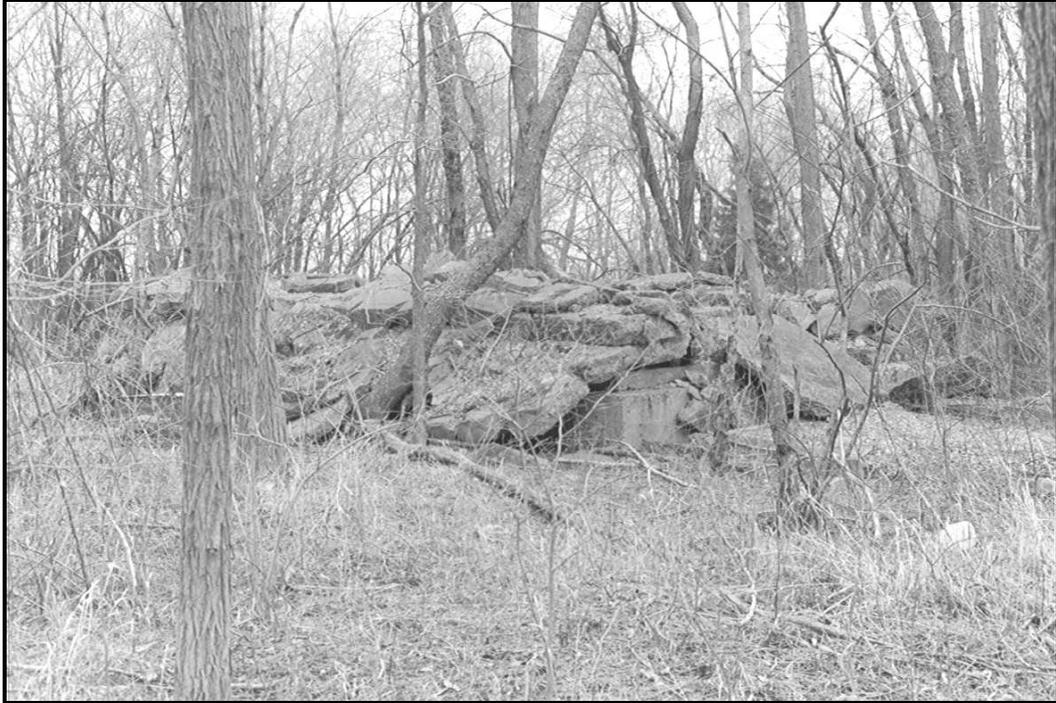
Figure 49. (TOP) The remains of the powder house (Feature 17), looking northeast. The building has been demolished in upon itself. (BOTTOM) Corner of the powder house, illustrating the materials use in its construction. The walls and roof of the structure were built with reinforced concrete (FRR February 2002).

Feature 17 is the remains of a powder house. This building was a front-gabled structure, measuring 25' (north/south) by 18' (east/west), and had raised concrete foundations and walls and roof of reinforced concrete. A doorway was positioned in both gable-end walls of the structure. The powder house has been demolished down to its foundations, though fragments remain sufficiently intact for its elevation to be deciphered (see Figures 49 through 51). Understandably, the building was positioned at the western end of the mine site in order to minimize the damage in the event of an explosion. A railroad spur ran along the south side of the powder house, allowing the direct unloading of explosives from the rail cars into the building. Coal reports indicate that a variety of explosives were used at the mine during its history, starting with black powder, then dynamite and pellet powder, and finally permissible explosives.⁵

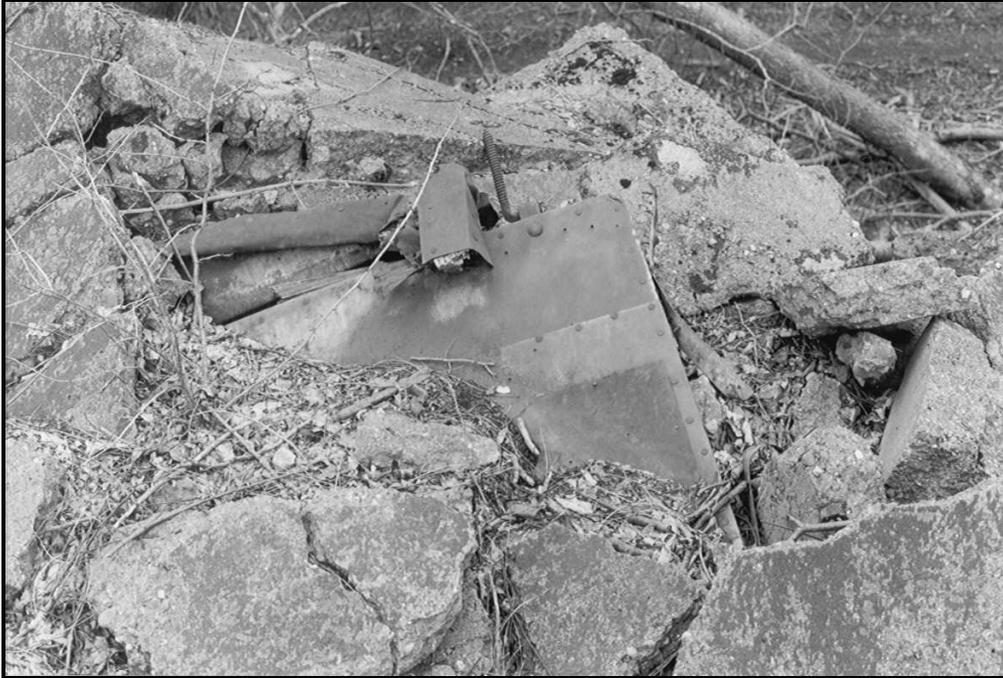
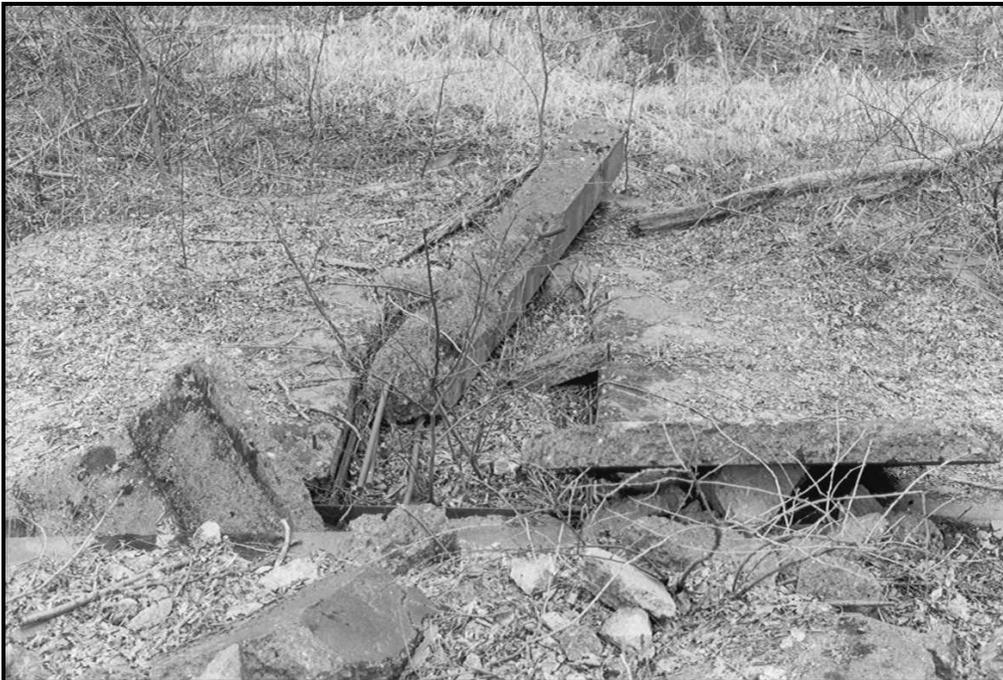
Figure 50. (TOP) One of the doors of the powder house still lies amongst the demolition debris. The door was framed with wood but was covered with steel plating. (BOTTOM) When the powder house was demolished, the south wall collapsed as a nearly complete unit, allowing for a reconstruction of the building's profile. Note the door opening centered in the wall. The thick beam of concrete lying on top of the wall served as a central support for the gable roof of the powder house (FRR February 2002).

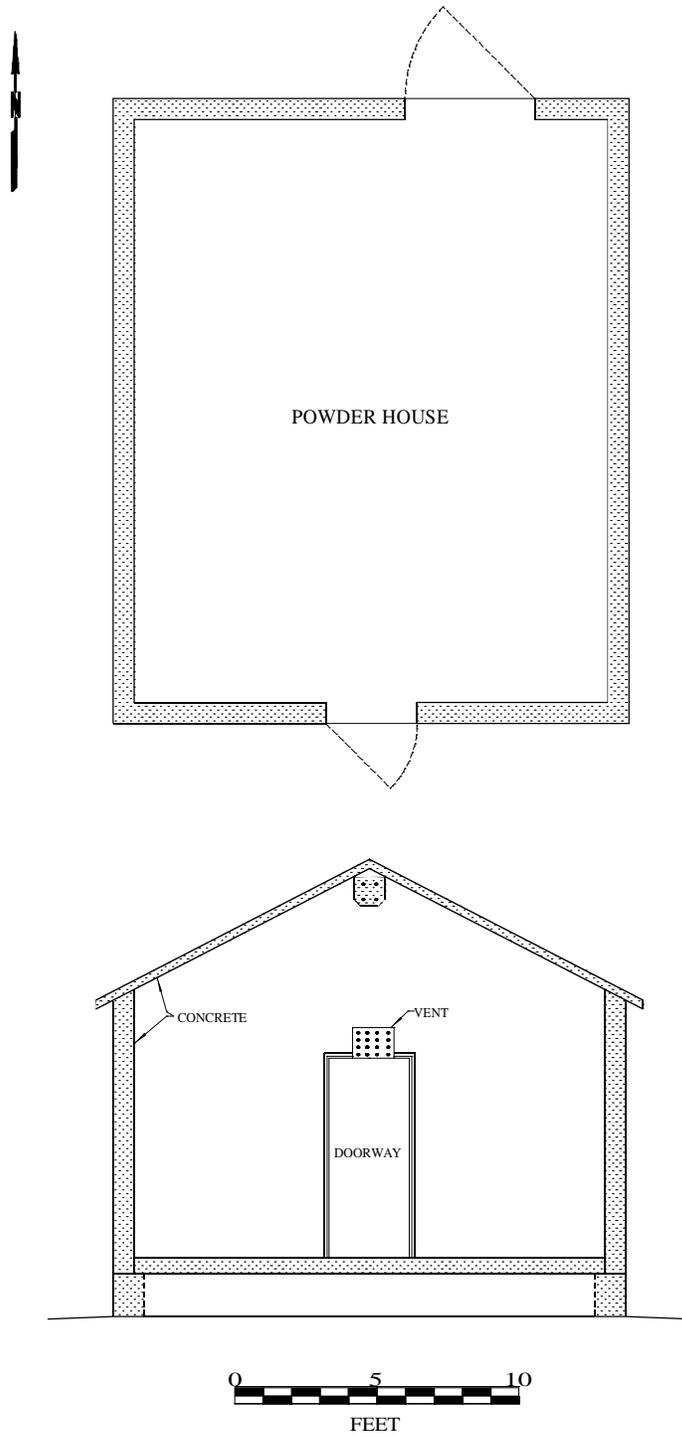
Figure 51. Plan and sectional views of the powder house (FRR 2002).

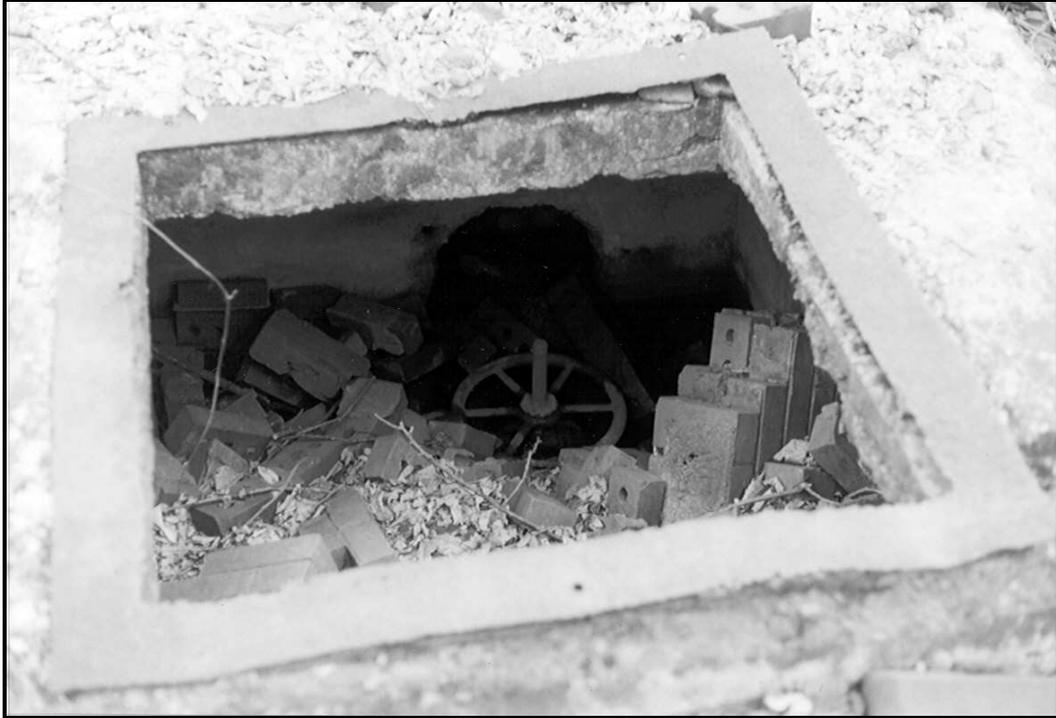
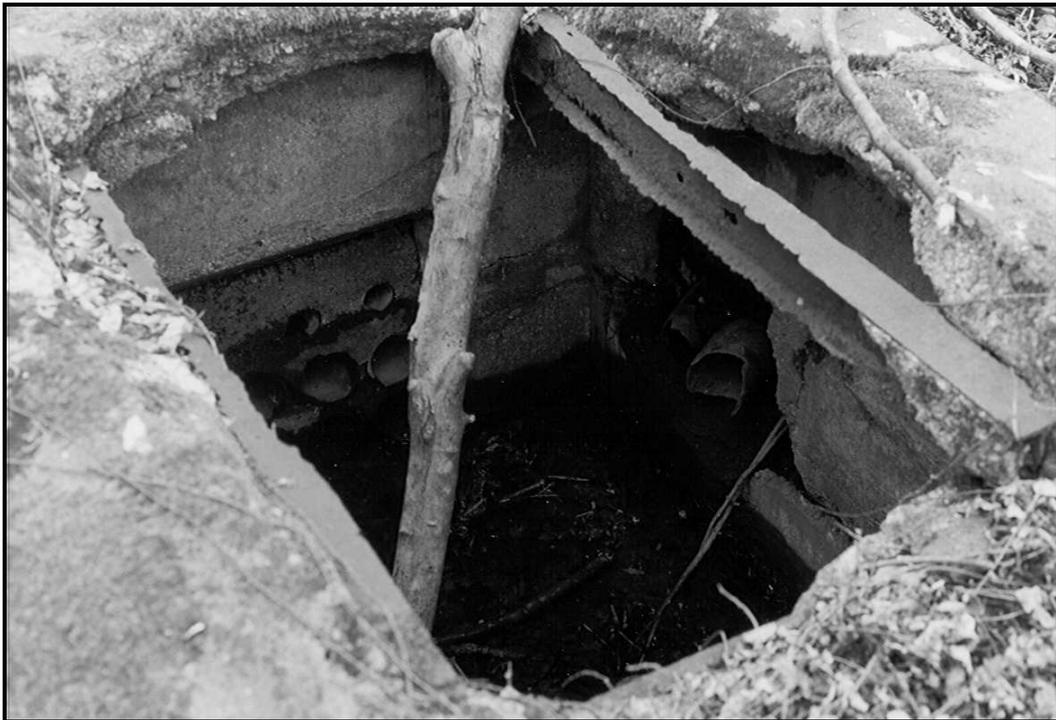
Figure 52. The Bunsenville Mine utilized steam-generated heat and electricity, and the buildings there were connected by a network of steam and water pipes. Several valve houses, such as the ones pictured above, are present at the site, but have not been assigned feature numbers.

The foundations of several small valve houses also were observed at the site; though photographed, they were not assigned feature numbers. The valves in these buildings controlled the extensive system of the water and steam pipes that extended between the buildings at the site. Each had a subterranean chamber that provided access to the piping (see Figure 52).

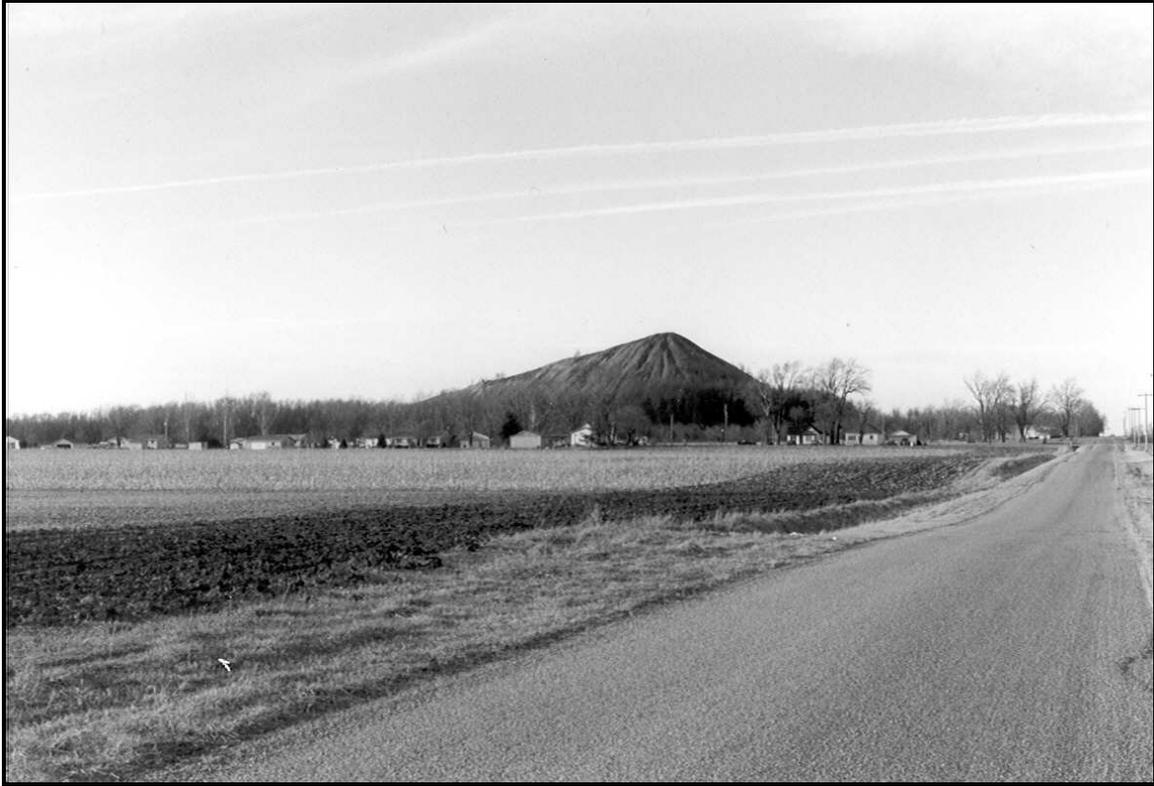
Figure 53. The large gob pile, which looms over the town of Bunsenville, represents the most significant—and certainly most impressive—landscape feature associated with the mine (FRR February 2002).

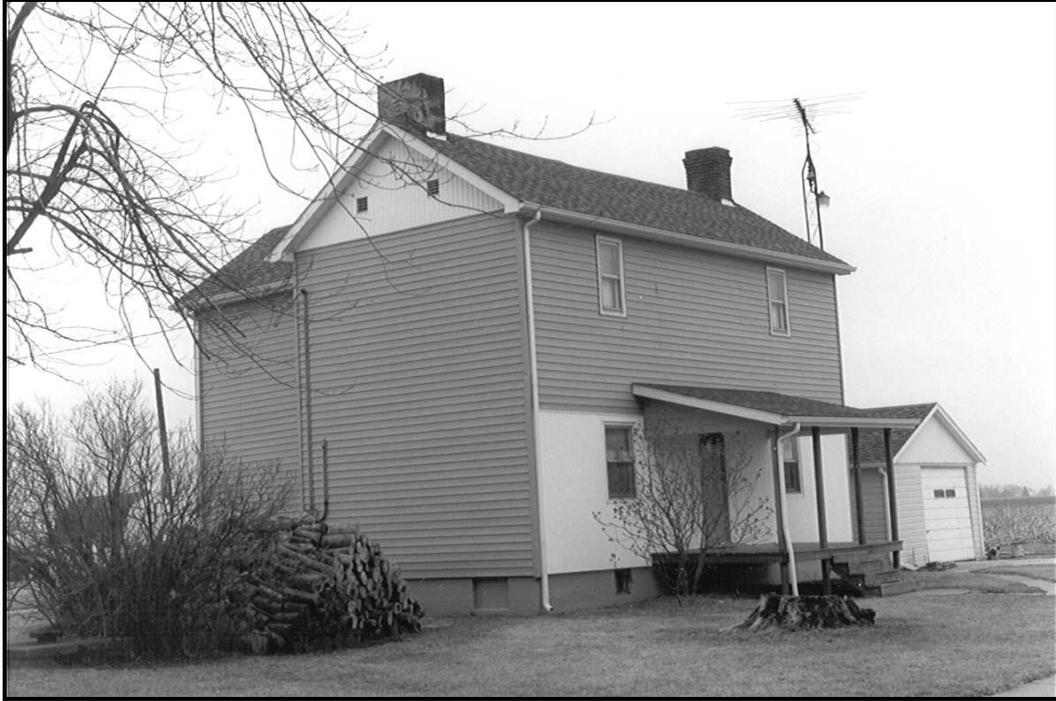
Figure 56. Photographs of the two residences originally occupied by the superintendent and assistant superintendent at the mine. The lower dwelling is no longer extant. The original photo was taken ca. 1970 and is on file at the Vermilion County Assessor's office.

As discussed above, the U. S. Fuel Company constructed a small residential development, located immediately southwest of the mine site, whose housing was reserved for the managerial staff employed at the mine. The development originally was comprised of eight two-story, frame dwellings, arranged four-to-a-side along the same street. Five of these houses are still extant (see Figures 54 and 55). There were four different housing types, whose size, interior finishes, and placement reflected the corporate/social hierarchy at the mine. The superintendent and assistant superintendent of the mine occupied the largest houses, which were T-shaped, side-gabled dwellings and were located opposite one another at the west end of the street, farthest away from the mine entrance. The main block of these dwellings resembled an I-house, being two-rooms wide and one-room deep, while the rear wing was a full two-stories in height. Both had a full-length front porch and provided approximately 1,472 square feet of living space. Only one of the superintendents' houses is still standing (see Figure 56). Next in line were two L-shaped houses intended for the mine managers. The main block of these manager's houses resembled those occupied by the superintendent and assistant superintendent but had smaller front porches and single-story rear wings. One house is
