**ILLINOIS DEPARTMENT OF NATURAL RESOURCES
CULTURAL RESOURCE MANAGEMENT PROGRAM
ABANDONED MINED LANDS RECLAMATION
CULTURAL RESOURCES EVALUATION**

**U. S. FUEL COMPANY, BUNSENVILLE MINE
BUNSENVILLE, ILLINOIS**

May 2002

Project Type/Title: Phase II archaeological survey of U. S. Fuel Company Bunsenville Mine reclamation project (AML-GveE-0107).

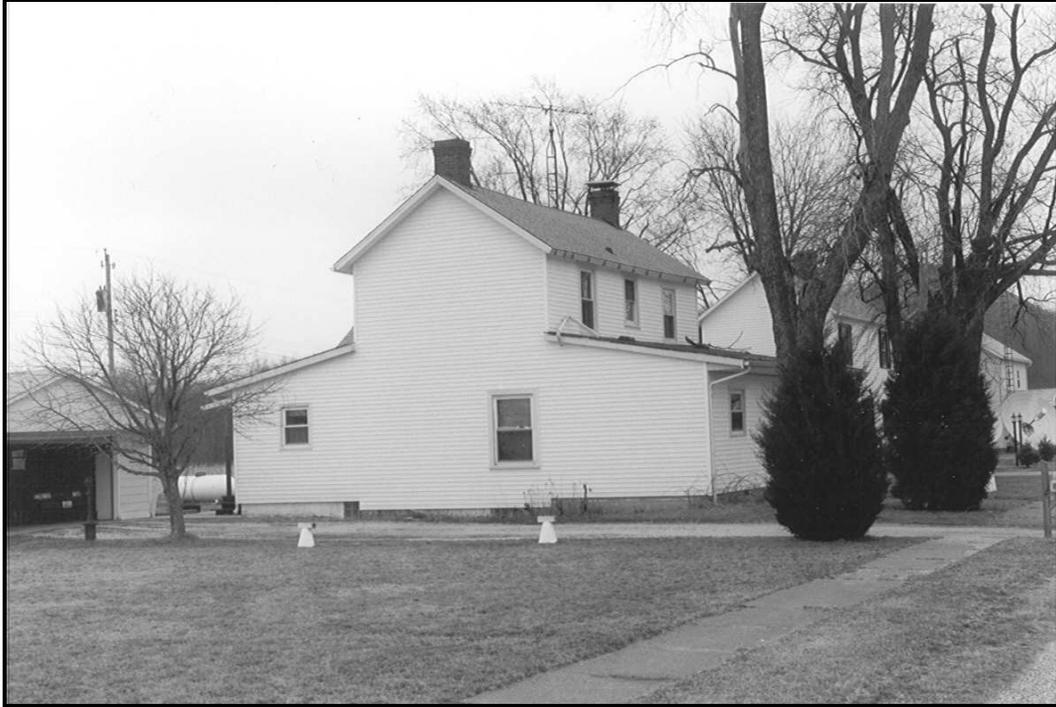
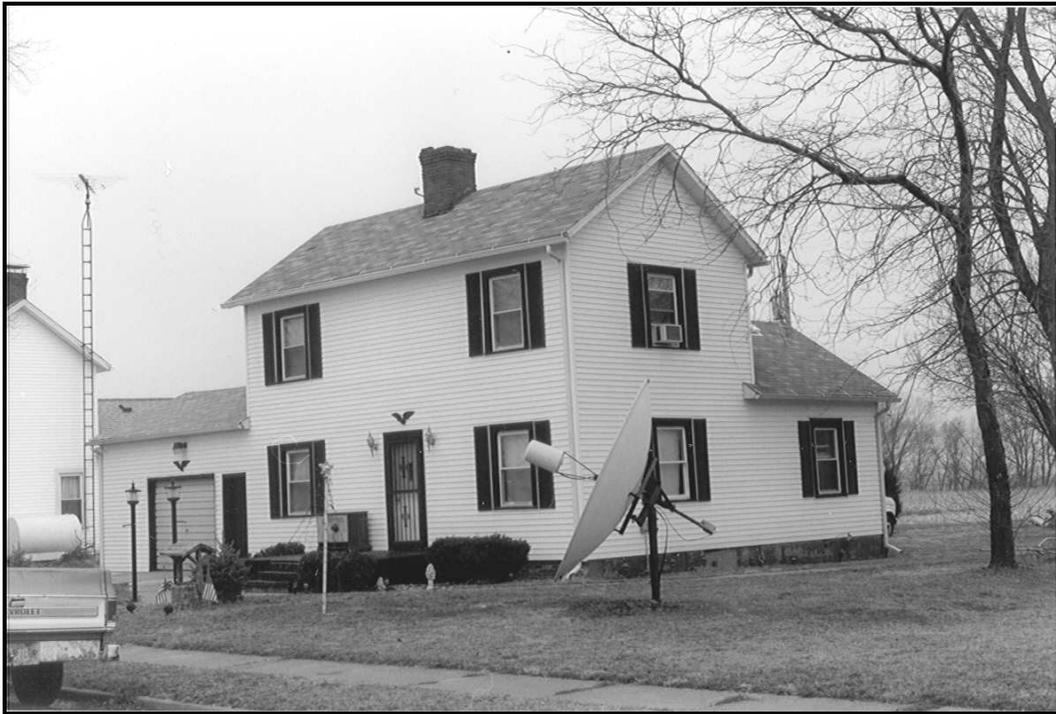
Figure 57. Surviving examples of the two house types occupied by the mine managers (FRR February 2002).

As discussed above, the U. S. Fuel Company constructed a small residential development, located immediately southwest of the mine site, whose housing was reserved for the managerial staff employed at the mine. The development originally was comprised of eight two-story, frame dwellings, arranged four-to-a-side along the same street. Five of these houses are still extant (see Figures 54 and 55). There were four different housing types, whose size, interior finishes, and placement reflected the corporate/social hierarchy at the mine. The superintendent and assistant superintendent of the mine occupied the largest houses, which were T-shaped, side-gabled dwellings and were located opposite one another at the west end of the street, farthest away from the mine entrance. The main block of these dwellings resembled an I-house, being two-rooms wide and one-room deep, while the rear wing was a full two-stories in height. Both had a full-length front porch and provided approximately 1,472 square feet of living space. Only one of the superintendents' houses is still standing (see Figure 56). Next in line were two L-shaped houses intended for the mine managers. The main block of these manager's houses resembled those occupied by the superintendent and assistant superintendent but had smaller front porches and single-story rear wings. One house is

still extant. They contained approximately 1,248 square feet of living space (see Figure 57). The next two houses on the street were three-bay, single-pile structures nearly identical to the two west of them, but having one central chimney rather than two gable-end chimneys—an orientation that also allowed for more windows on the gable ends. Mine managers reportedly occupied these residences as well (a total of four managers were employed at the mine) (see Figure 57). The last two dwellings in U. S. Fuel's residential development were double-houses and were reserved for foremen. Since they contained two units, the foremen's houses were double-pile (two rooms deep) and had two interior chimneys. Each dwelling was approximately 1,788 square feet in size, allowing 896 square feet per unit, and had full-length front porches. Both of the double houses occupied by the foremen are still extant (see Figure 58). Aside from the difference in living space, the social hierarchy of the mine also expressed through the interior finishes in the houses. The superintendent and assistant superintendent's houses were the only ones supplied with interior bathrooms. They also had the finest trimwork and mantle pieces, and the quality of these materials diminished slightly in each successive house type, moving down the chain of command (Delores Rice, pers. comm., 26 February 2002).

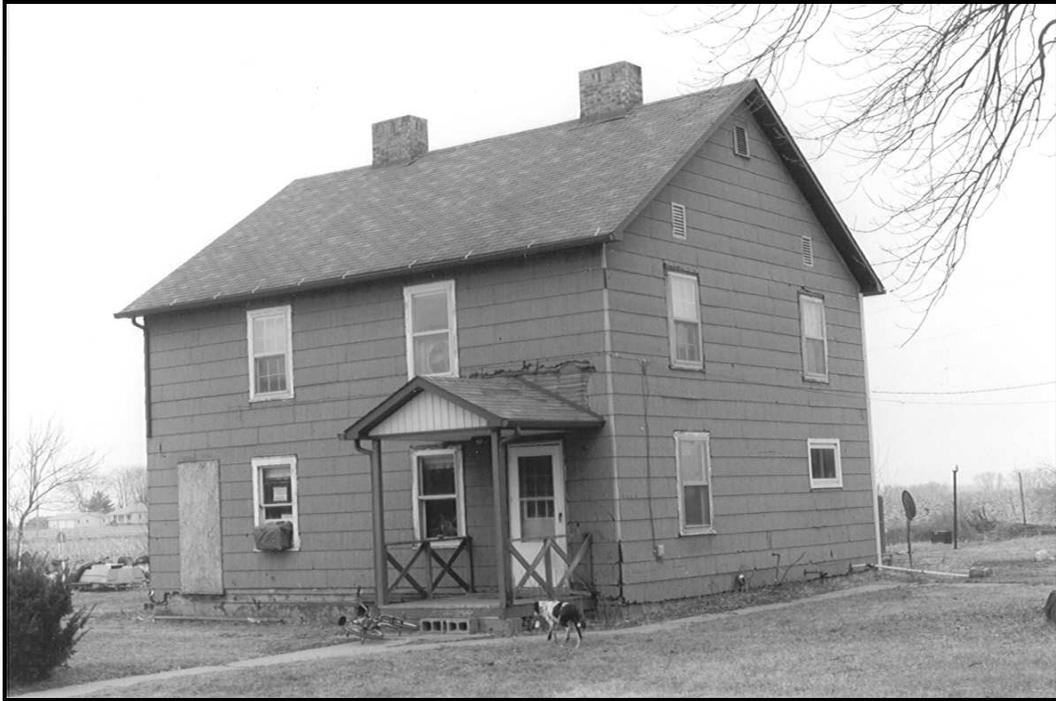
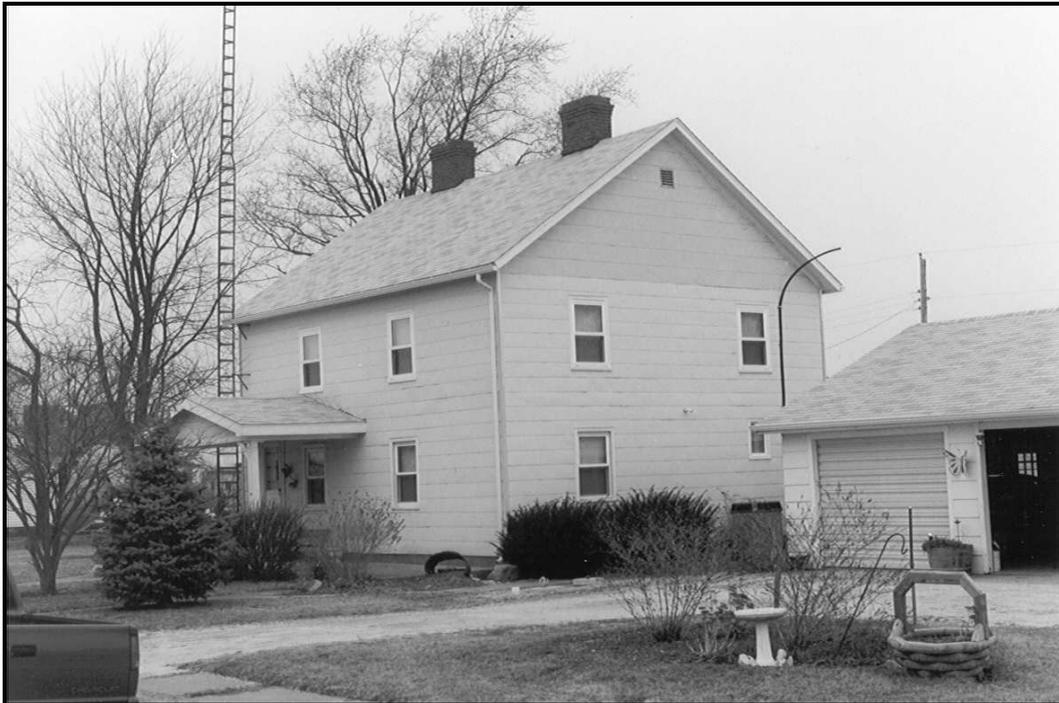
Figure 58. Both of the double-houses in the housing development have survived. These were reserved for mine foremen and their families (FRR 2002).

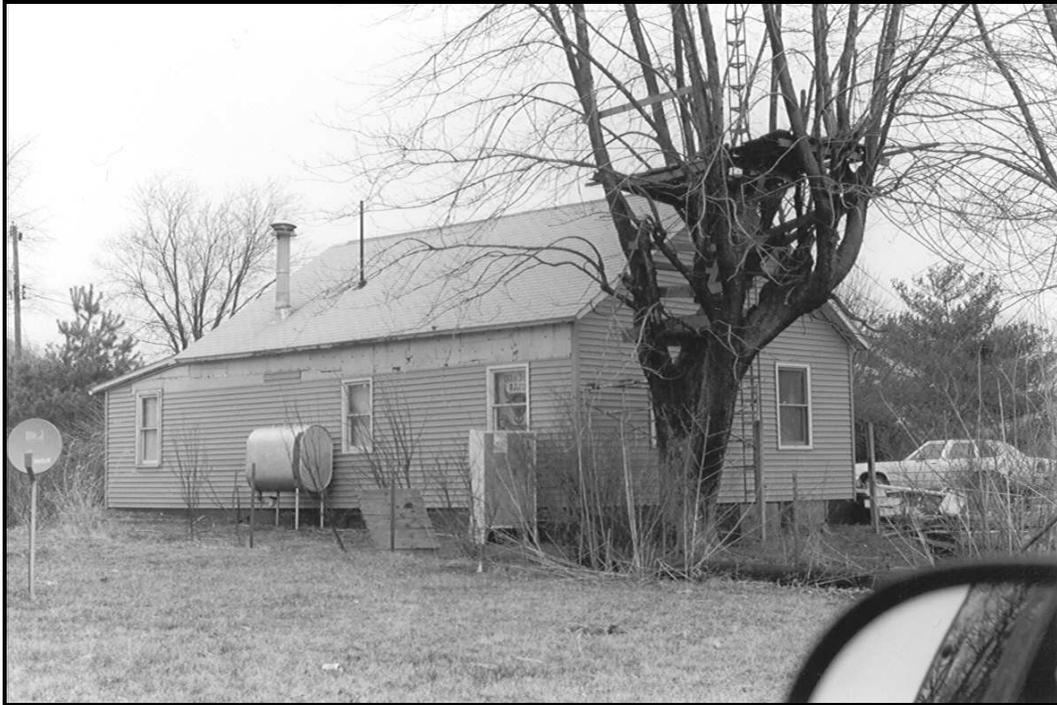
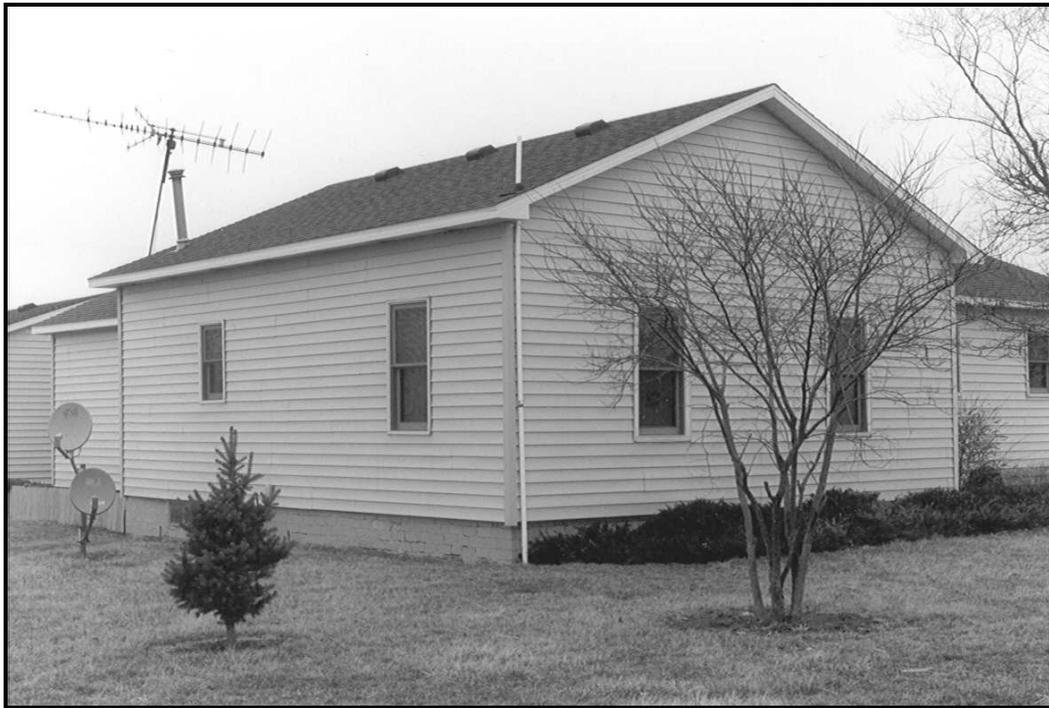
Figure 59. Two examples of gabled cottages in Bunsenville proper. These residences represent the most diminutive of housing type in town dating from the period that the mine was in operation (FRR February 2002).

There are a number of houses in Bunsenville that date from the period that the mine was in operation. These homes are smaller than those occupied by the managerial staff. Except for one dwelling (which originally was two stories but has been reduced to one), all of the houses in town were single story and were frame. They range in character from diminutive gabled cottages to pyramidal-hip-roofed cottages and more fashionable Craftsman-inspired bungalows (see Figures 59 through 61).

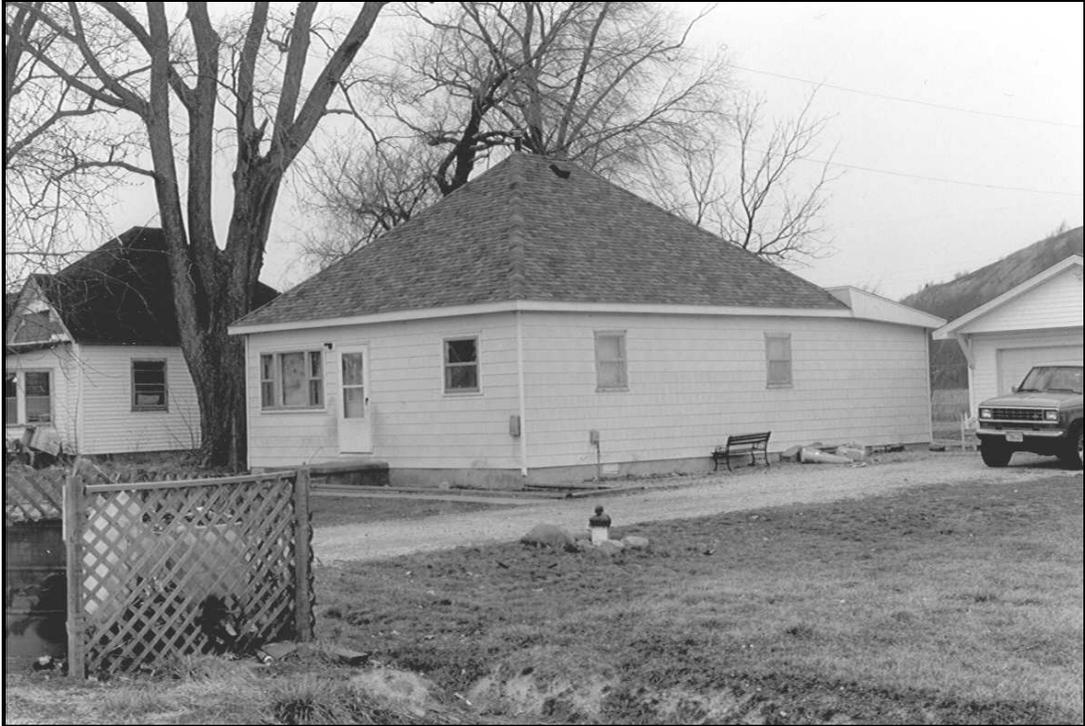
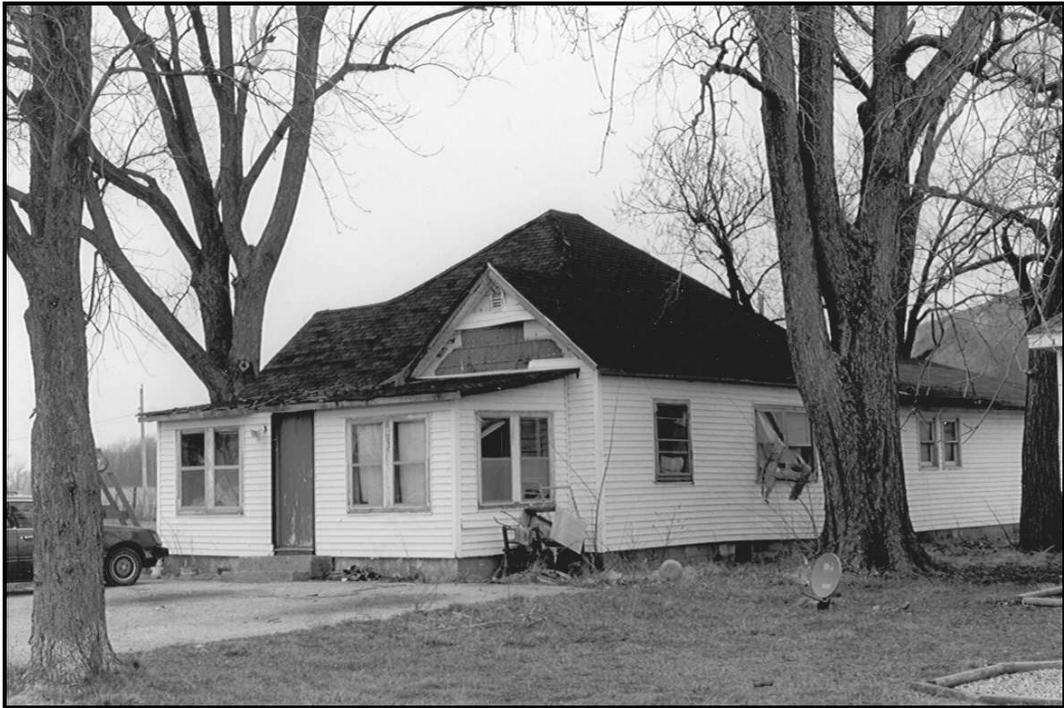
Figure 60. Two pyramidal-hip cottages in Bunsenville (FRR February 2002).

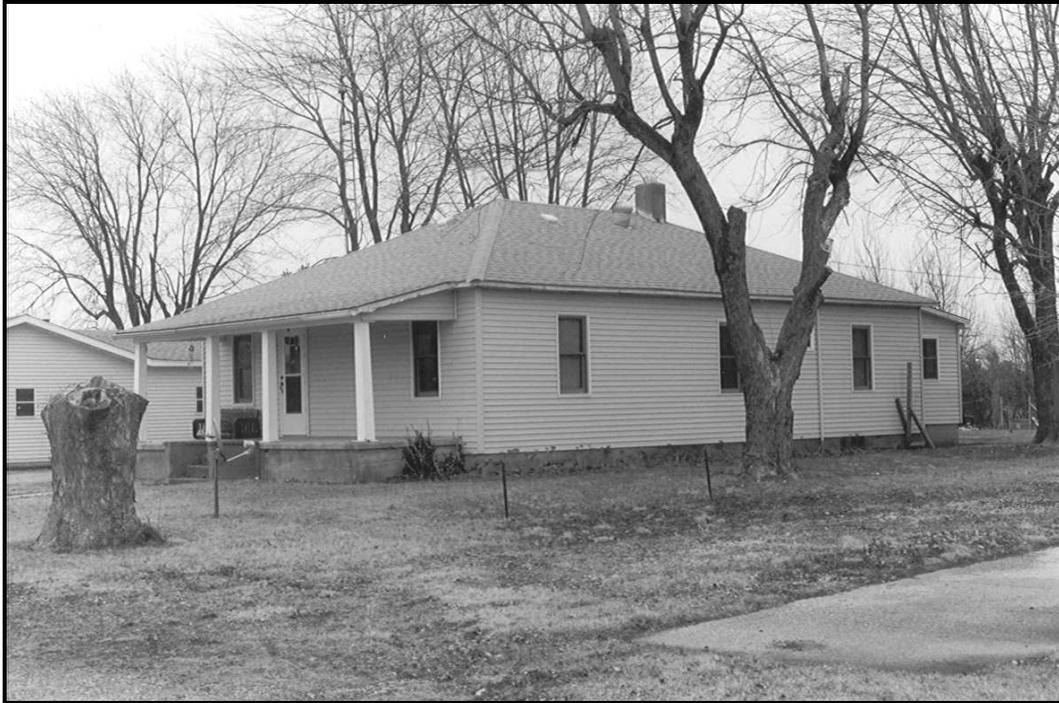
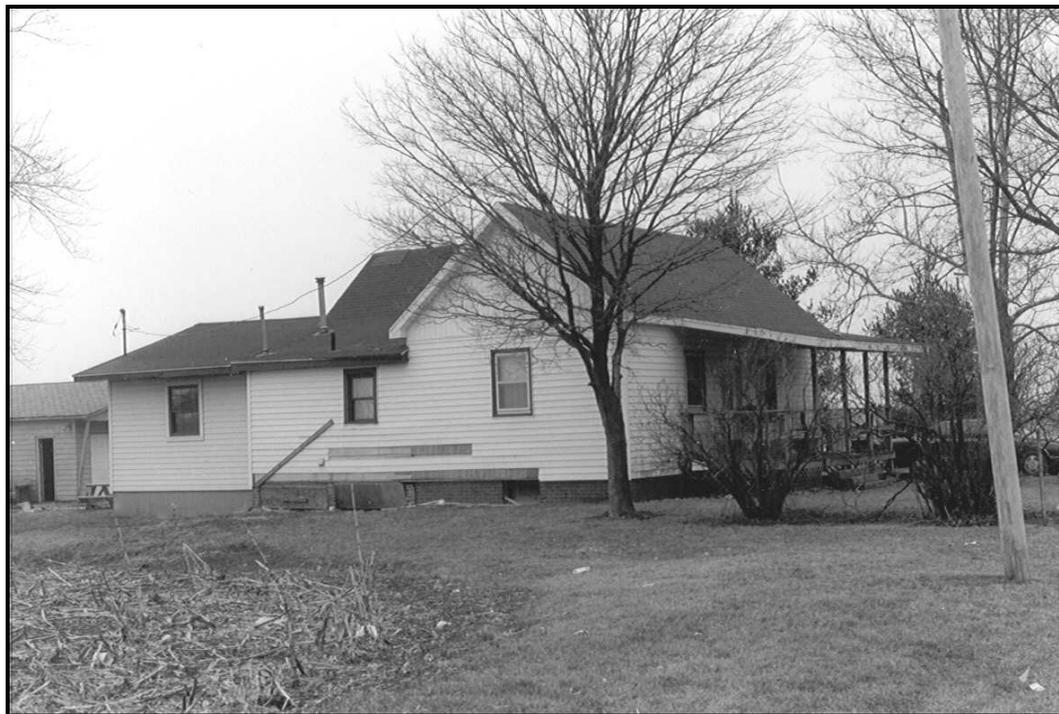
Figure 61. (TOP) A vernacular hip-roofed Bungalow in Bunsenville. Possibly constructed in the 1920s, this residence is one of the larger homes in the community. (BOTTOM) The lone house located on the south side of Bunsenville Avenue. This dwelling originally was two-stories and resembled those occupied by the mine managers. The second story was removed after a fire.
