**A HISTORIC STRUCTURE ASSESSMENT
OF
THE ZEINE CABIN,
WILDLIFE PRAIRIE STATE PARK,
PEORIA COUNTY, ILLINOIS**

by
Christopher Stratton

Fever River Research
Springfield, Illinois

December 2001

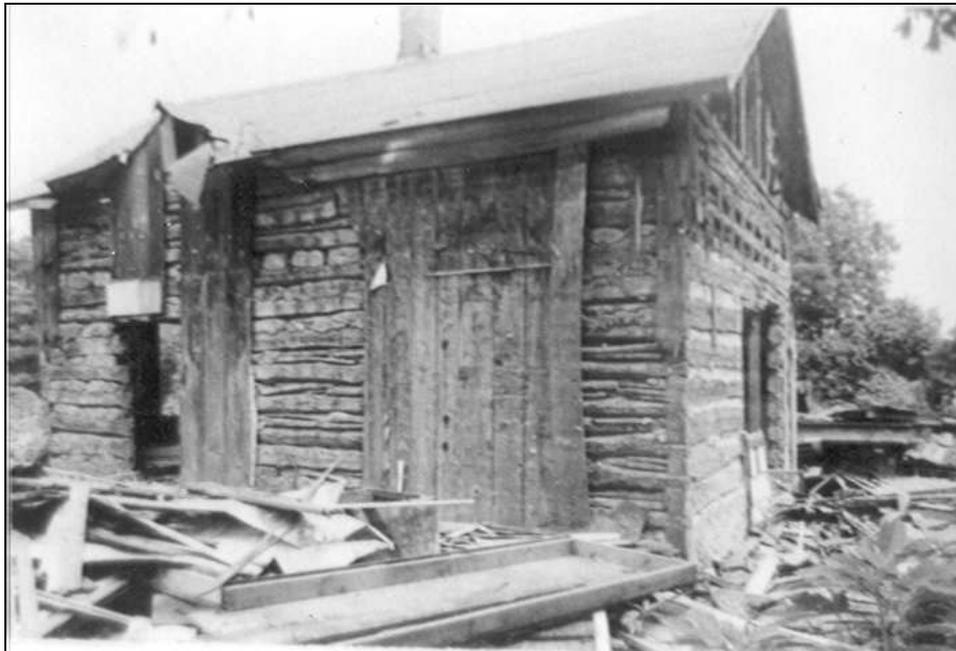
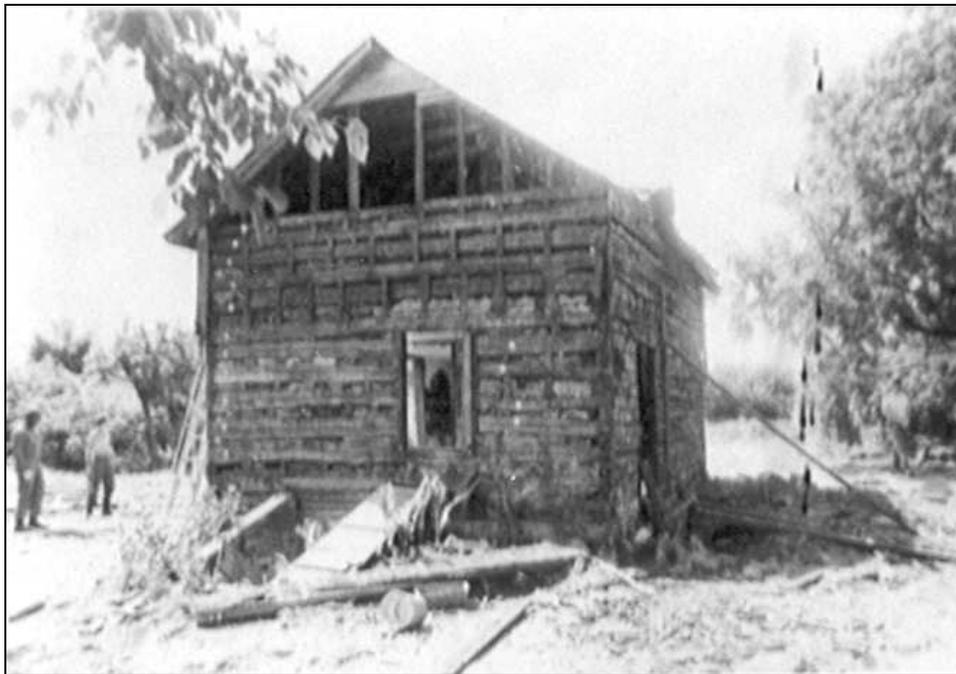
At later date one, if not two, frame additions were made to the Zeine Cabin. One of these additions was built along west side of the cabin and was demolished when the original log dwelling was disassembled in 1974. A second frame wing may have been located on the opposite elevation. The possibility of an east frame wing being present is suggested by two things: 1) the presence of two of door openings in the east elevation (which seems excessive if both doors simply opened to the outdoors); and 2) the pile of debris that is visible on this side of the house in one of the photographs that was taken during the cabin's disassembly in 1974 (reference Figure 1).

Figure 1. Two views of the Zeine Cabin during the course of its dismantlement in 1974. (Top) Oblique view, showing the present west and south elevations of the cabin. The demolition debris in the foreground is from a later frame addition. (Bottom) View of the cabin after the partial clean up of demolition debris. The gable-end wall shown is now the north elevation of the building. Note the bulkhead entrance to the cellar (WPSP August 1974).

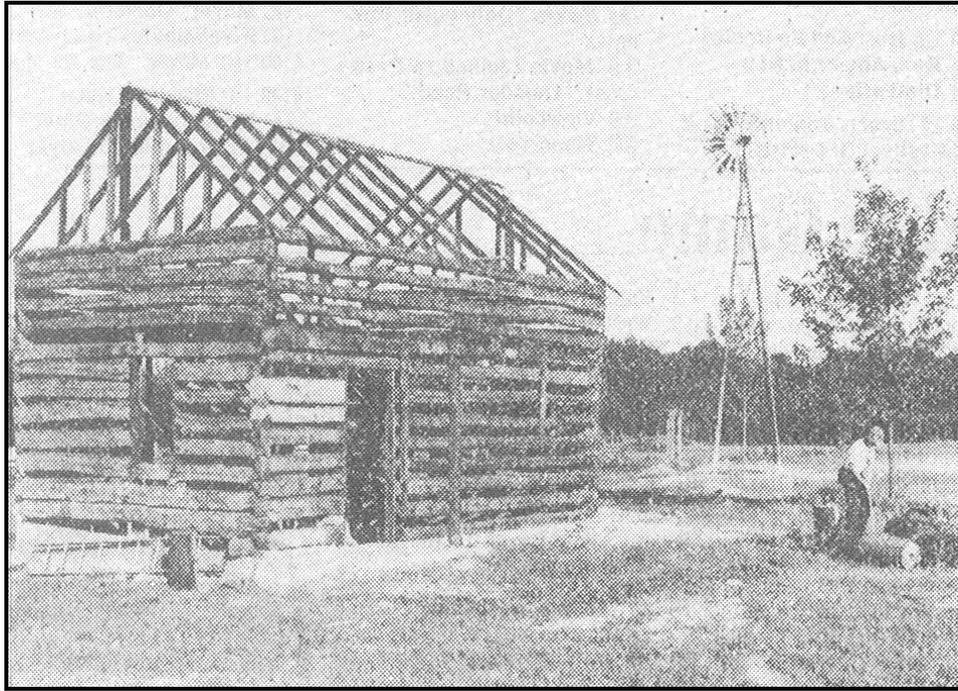
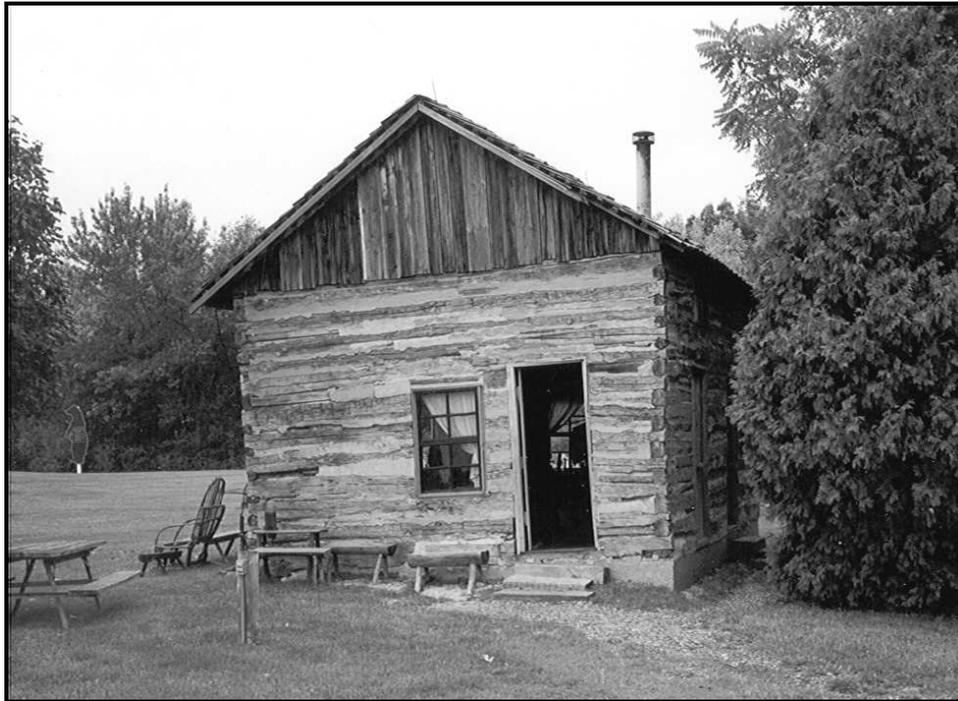
Figure 2. (Top) The Zeine Cabin during the course of its reconstruction in 1980. This view is looking toward the northeast (*Peoria Journal-Star* 25 August 1980). (Bottom) The south elevation of the cabin, showing existing conditions (FRR September 2001).

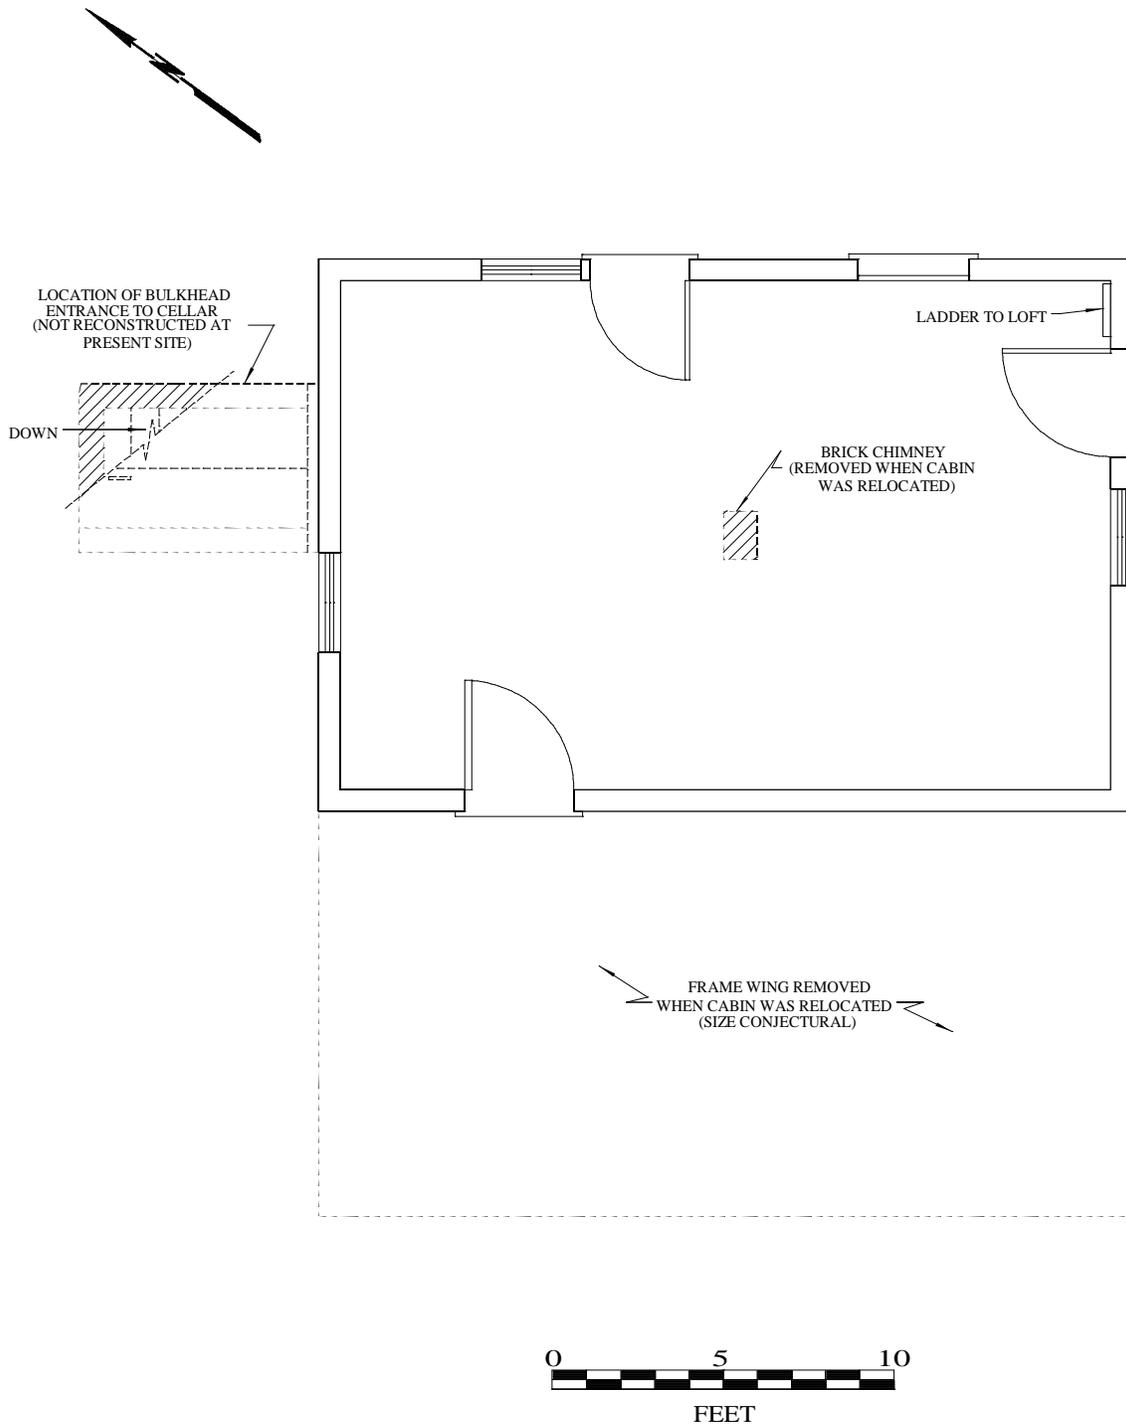
Figure 6. Floor plan of the Zeine Cabin, showing existing conditions. The dashed lines indicate features that were removed when the cabin was dismantled in 1973 (FRR 2001).

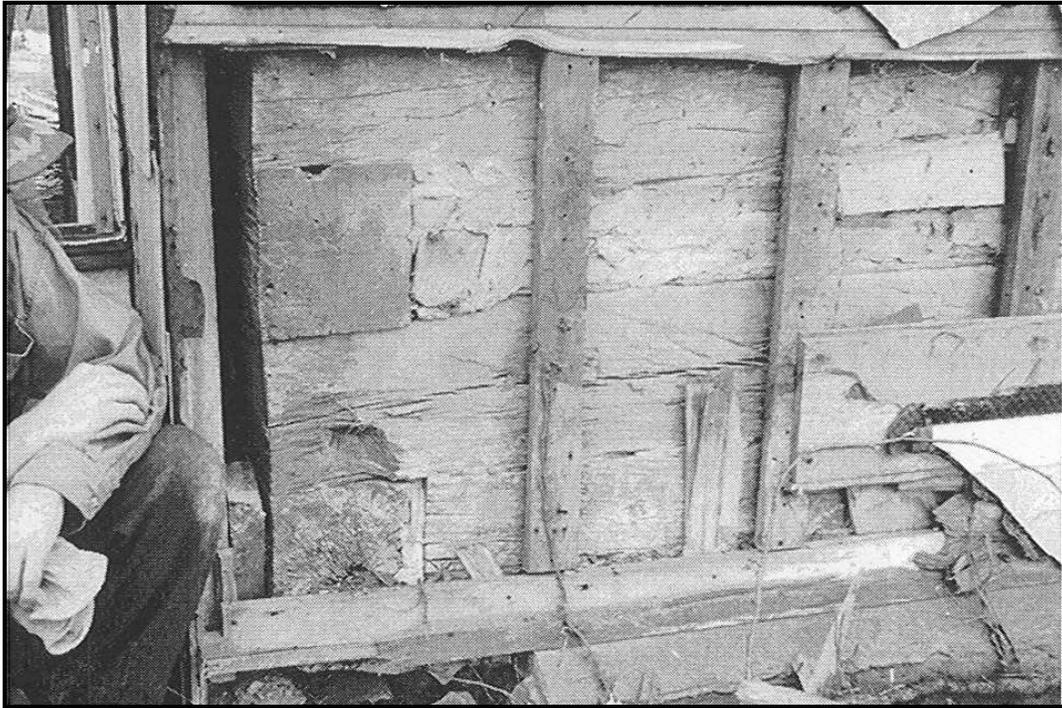
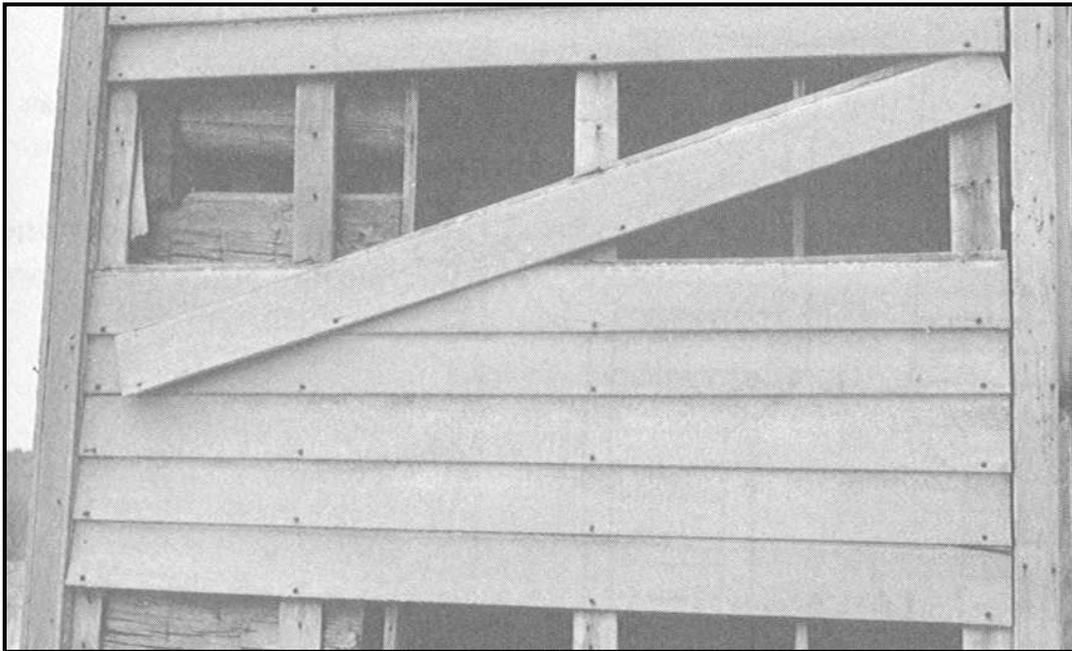
Figure 12. Two views illustrating the manner in which horizontal siding was attached to log buildings using vertical furring strips. A similar procedure should be used on the Zeine Cabin. (Top) The Barth House, in rural Carroll County, Illinois (Stratton and Mansberger 1998:39). (Bottom) A log house in southern Indiana (Roberts 1996:plate 14).

We recommended that the exterior of the cabin be covered with beveled horizontal weatherboard with a 4-1/2" exposure. This siding appears to be similar to that originally used on the cabin and also would be appropriate for the period of construction. The siding should be nailed to vertical furring strips in the same manner as was originally utilized on the cabin. Figure 11 provides representative illustrations of the application of horizontal siding on two other log houses. The vertical plank siding now in place on the gable ends should be removed and

replaced with horizontal weatherboard, as was the case prior to the cabin's dismantlement (see Figure 12). It would be appropriate to finish out the corners and openings with flat trim boards, perhaps 1"x4" or 1"x5" stock. The exterior siding should be primed and painted.
