**CANAL BOATS ALONG THE
ILLINOIS AND MICHIGAN CANAL:
A STUDY IN ARCHAEOLOGICAL VARIABILITY**

Fever River Research
Springfield, Illinois

1998

by
Floyd Mansberger
and
Christopher Stratton

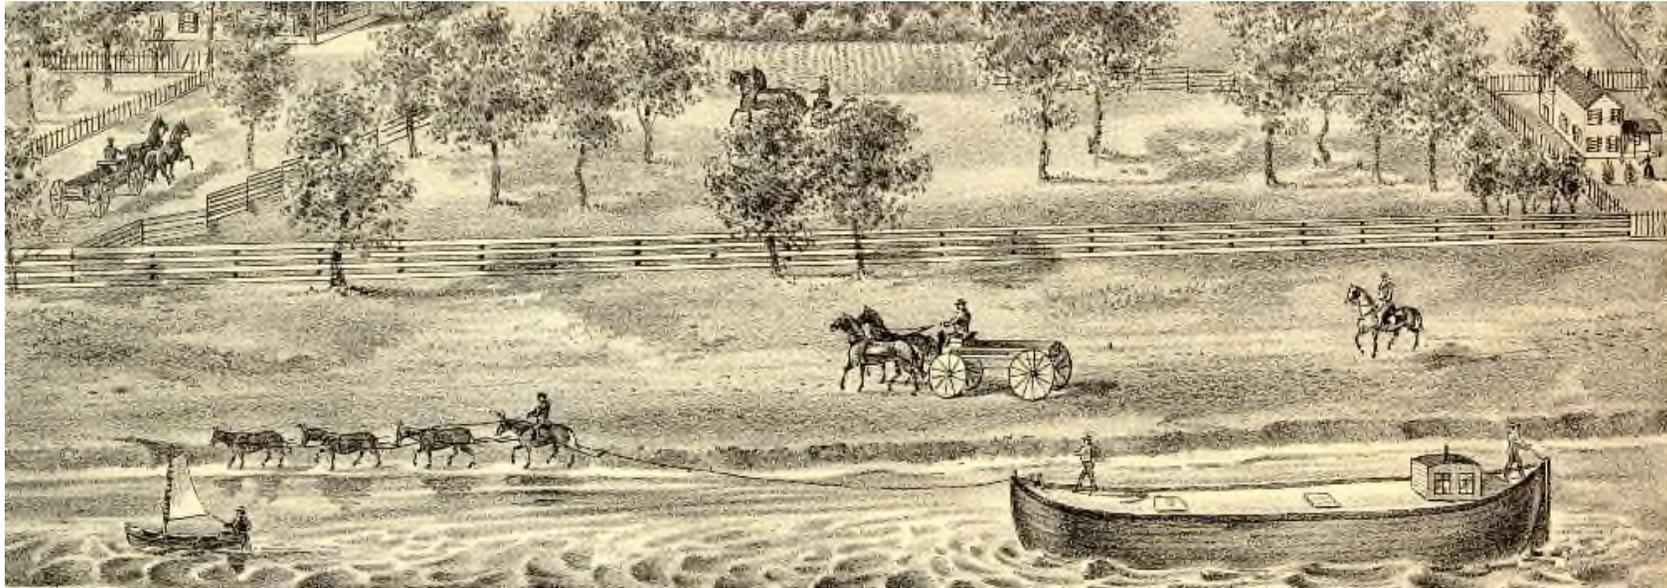
Figure 5. Flat bottomed canal boats with rounded bows and sterns were the work horse of the Illinois and Michigan Canal, transporting a wide range of bulk commodities such as lumber, grain, stone, and coal along the canal corridor. Unfortunately, none of these boats have survived to the present day, and little is known about their construction. This illustration of a mule-drawn canal boat along the Illinois and Michigan Canal was taken from Thompson Brothers and Burr (1873).

During the nineteenth century, several different varieties of commercial boats used the Illinois and Michigan Canal. These canal boats were characterized predominately by the type of cargo carried by the boats and included Lake boats, packet boats, stone boats, grain boats, and lumber boats. As Lamb (1978:219) notes, “the variety of boats using the canal was as diverse as those using the Great Lakes.” Nineteenth century plat and atlas illustrations note the variation in boat construction (see Figures 5 and 6).

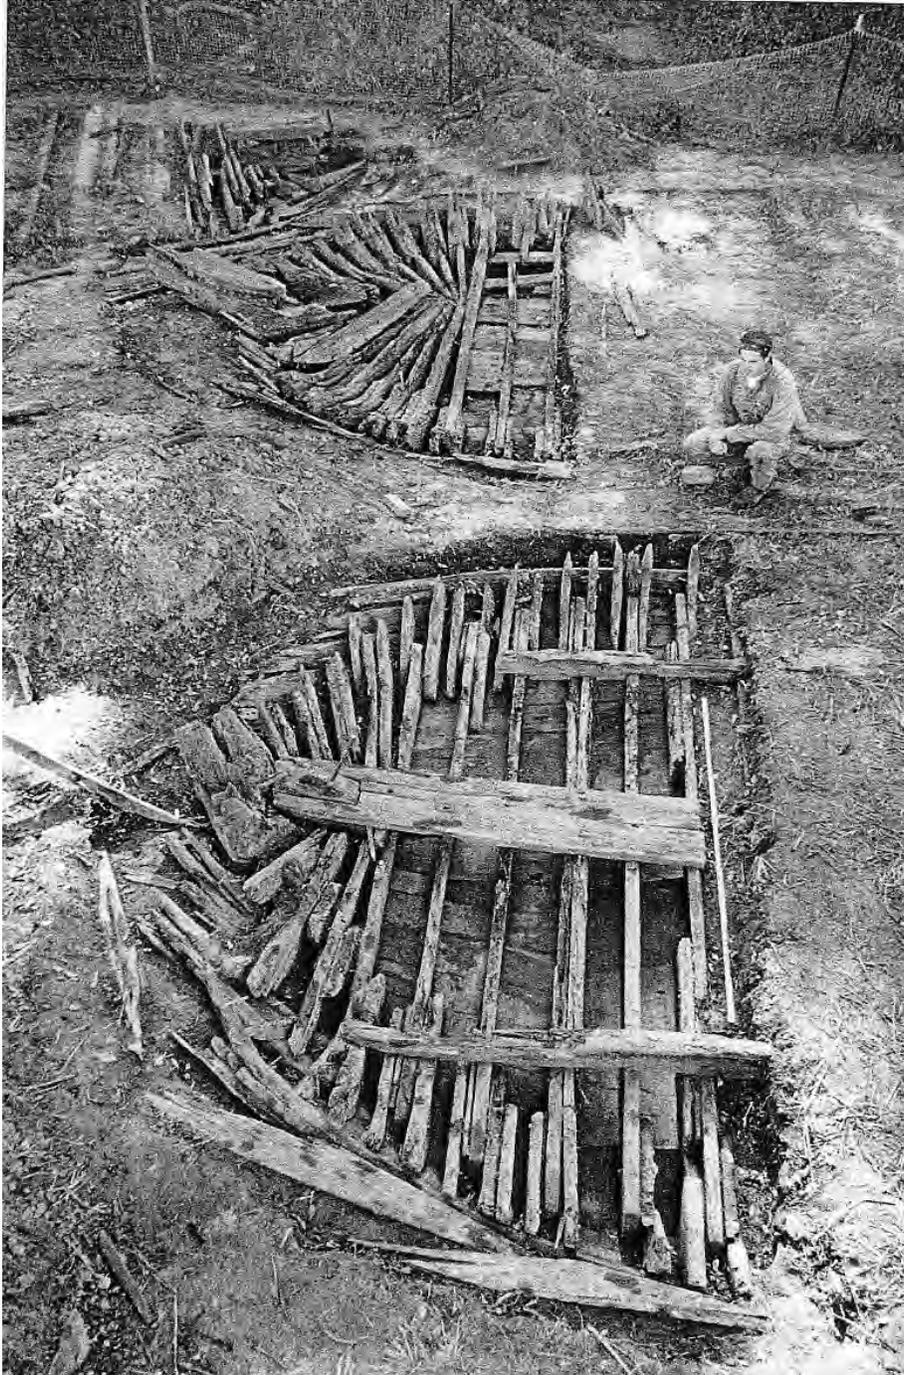
Figure 14. Bow detail of Boats 5 (top) and 6 (bottom) after excavation.

The excavations at the Morris Wide Water resulted in detailed mapping of three bows. The bows of Boats 5 and 6 were fully exposed while the bow of Boat 4 was only partially exposed (Figures 13 and 14). The bow of Boat 5 was constructed with a series of radiating floor or cant frames that fanned out from the last full-length floor frame (or first square frame) that formed the floor of the hull. The first six radiating cant frames on each side of the bow were approximately $6 \frac{1}{2}'$ in length. These cant frames had been shaped on their lower surface to approximate the shape of the curved hull of the bow and were nailed together at their opposite ends (which formed a tight cluster of planks nailed together near the center of the circle defined by the bow). The remaining four cant frames in the bow were of gradually decreasing length and were fastened into the deadwood which secured the bow's stem post in place. The majority of the cant frames in the bow had two futtocks –one on each side of the frame. This arrangement created a fairly well proportioned, securely constructed bow with a radius of approximately $6 \frac{1}{2}'$ to $7'$.

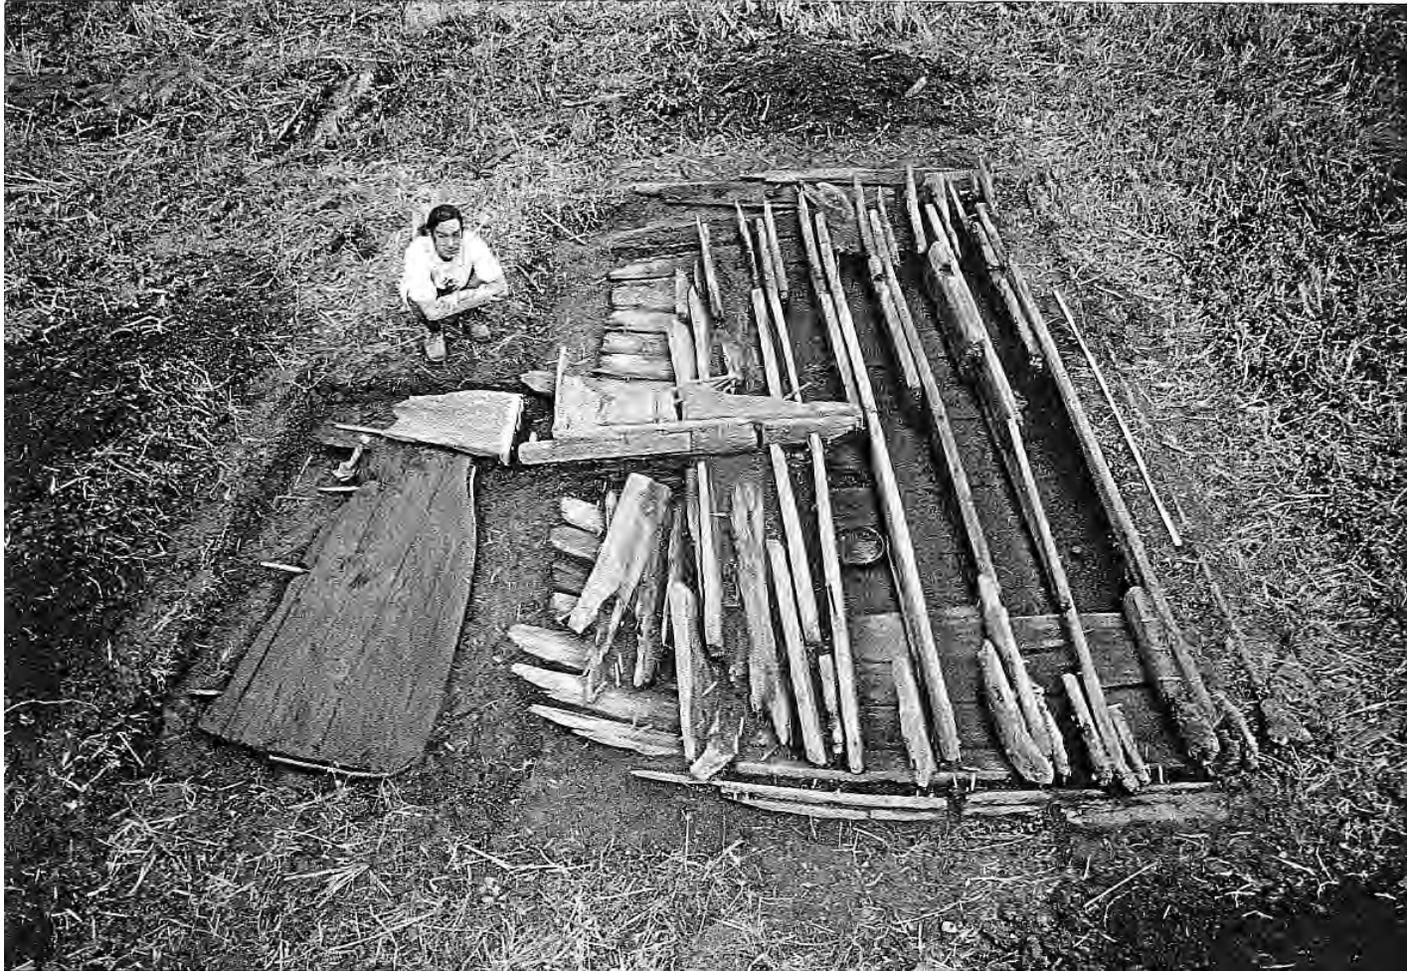
Figure 21. View of Boat 5 stern illustrating well preserved rudder in situ.
