**ARCHITECTURAL DOCUMENTATION
FOR
THE HALLSTEIN BARN,
HITTLE TOWNSHIP, TAZEWELL COUNTY, ILLINOIS**

by
Christopher Stratton
and
Floyd Mansberger

Fever River Research
Springfield, Illinois

November 2002

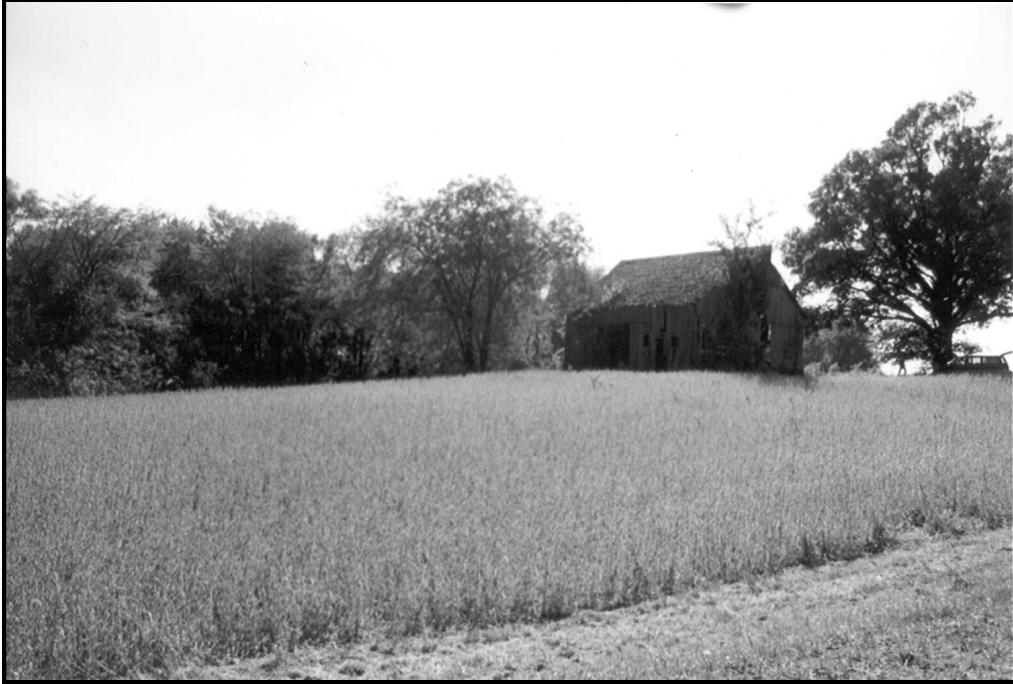
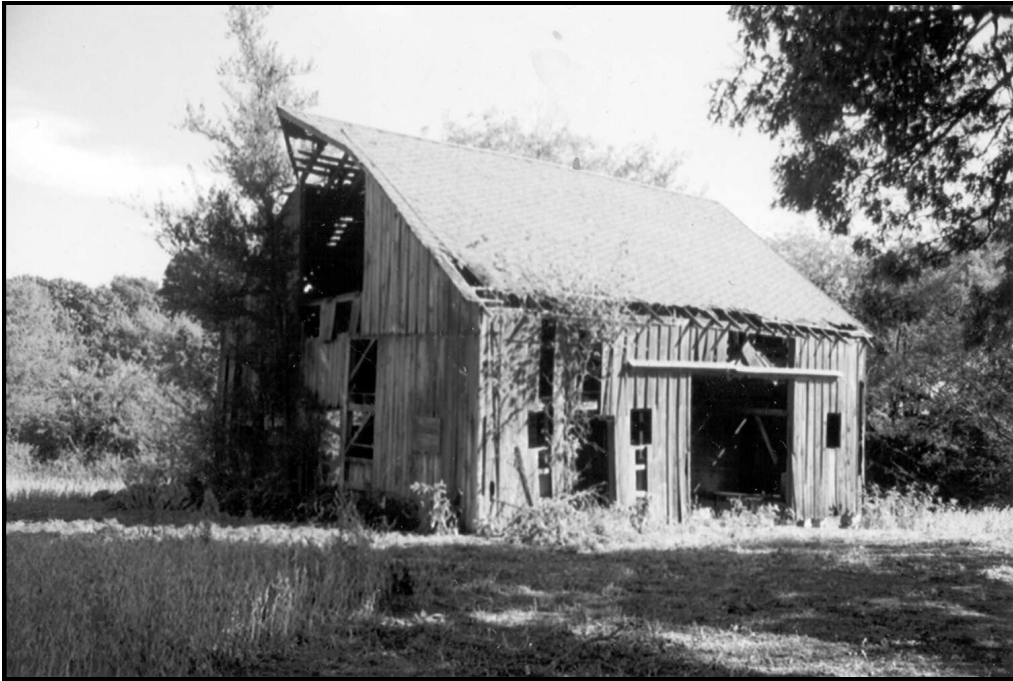
Figure 7. (TOP) View of the Hallstein Barn, looking southwest from the public road that passes by the site. Note the timber lying beyond the barn, which represents a remnant of the historic woodland along the West Fork of Sugar Creek. The terrain slopes down from the barn towards the creek. (BOTTOM) View of west and north elevations of the barn. Note the wide vehicle doorway in the west elevation and mow door in the north gable end (FRR October 2002).

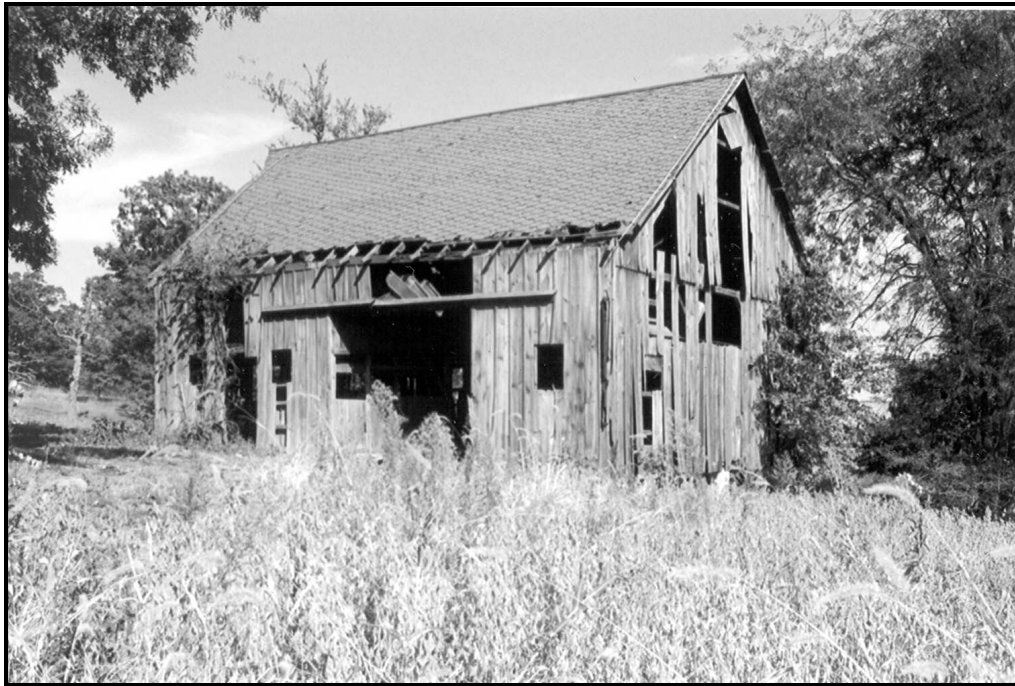
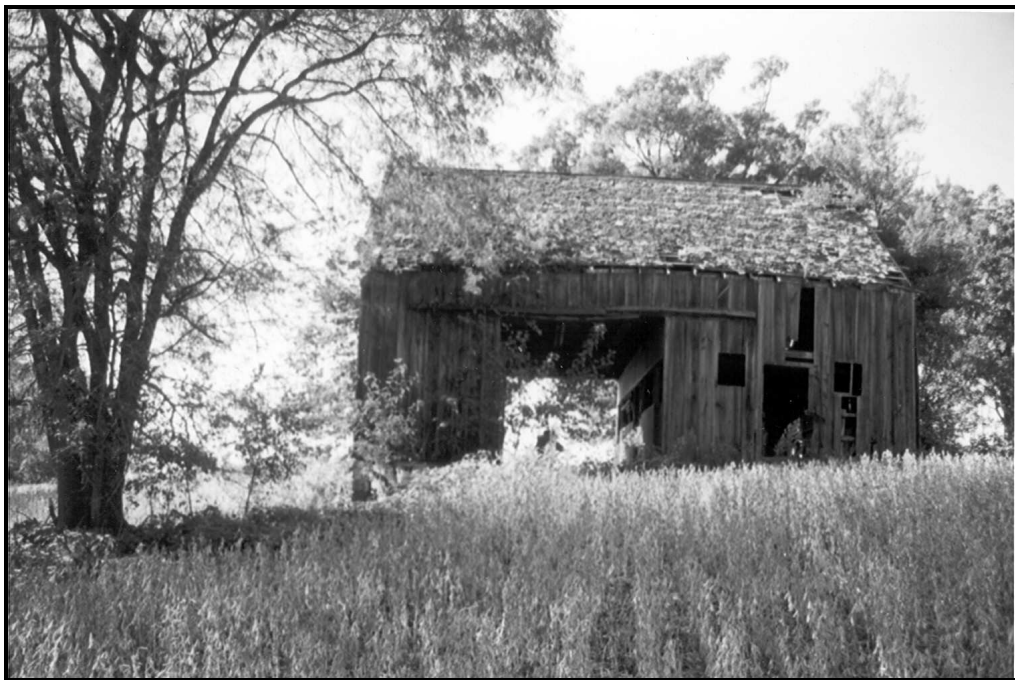
Figure 8. (TOP) View of the west and south elevations of the barn, looking northeast. (BOTTOM) View of the east elevation. This photograph illustrates the tripartite division of the barn, with livestock stalls on the right, a driveway in the center, and grain bins to the left. Note the wider width allowed for the livestock stalls compared to grain storage (FRR October 2002).

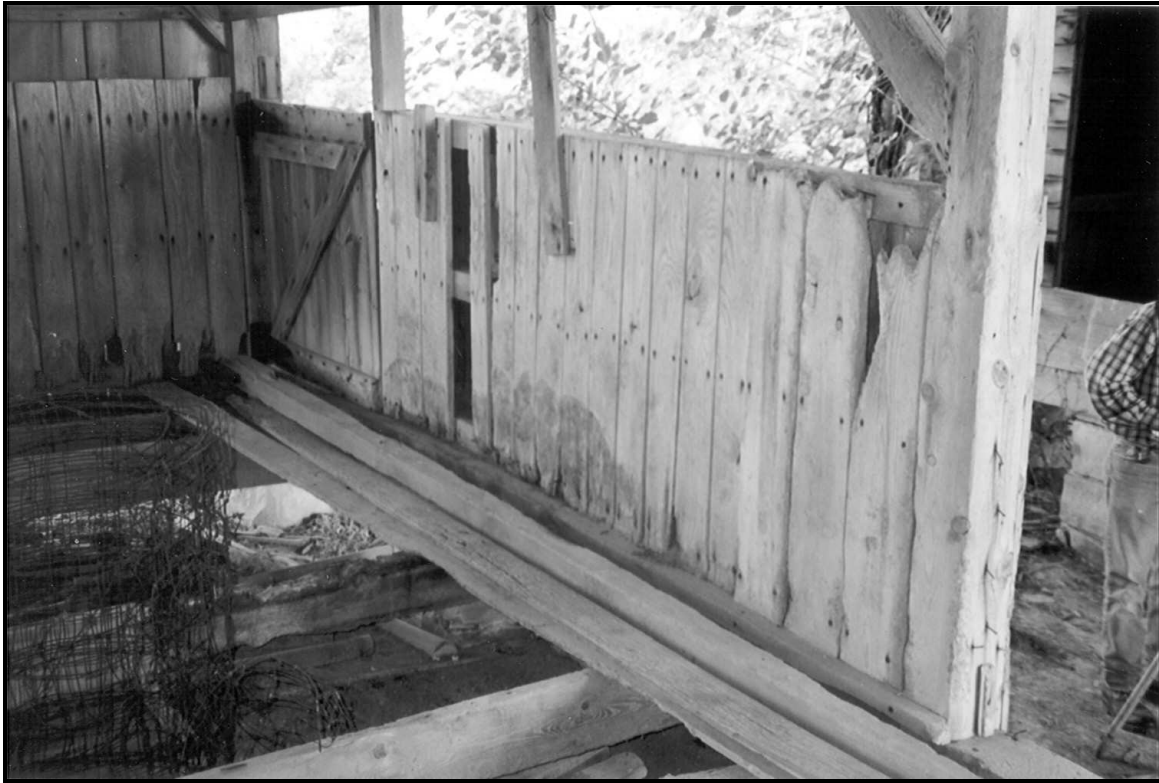
Figure 9. View of the eastern box stall, looking towards the southeast corner. Note the hinged livestock door in the background. The door opening at the far right is associated with a central service aisle that formerly divided the two box stalls. The partitions framing the aisle have been removed (FRR October 2002).

The Hallstein Barn is oriented north/south and measures 40'-2" (north/south) by 30'-2" (east/west).¹ Typical of a Three-Bay Barn, the structure has a tripartite division of its interior. But unlike many early examples of this barn form, which often have equal (or nearly equal) sized bays, the Hallstein Barn has bays with dramatically different widths. The north bay is the widest and takes up nearly half of the barn's entire length (see Figures 7 and 8). Although difficult to discern (due to the removal of much of the interior framing in this bay), the space in this bay appears to have been originally divided between two large box stalls separated by a personnel aisle. The partition walls separating the stalls and aisle have since been removed, but there is physical evidence of them, in the form of nails left behind after the central support posts had been removed. The box stalls each measure 17'-0"x15'-6" and are lined by 1"-thick, 4'-high vertical planking that extends around three of their sides. This planking protected the framing and exterior siding from being damaged by livestock rubbing or kicking against it. On the side facing the central aisle, the box stalls appear to have had a feed bunk; these, too, have been ripped out, but their presence is suggested by the thicker (2") wall planking found at the what would have been their ends. The bunks appear to have been approximately 2' wide. Livestock could enter either box stall through one of two points: exterior doors positioned on the east and west sides of the barn, and through interior doorways entered off the central drive. Each stall also had three windows. These windows consisted of a single sideways sliding 4-light sash. Additionally, each stall had a series of tack hooks (consisting of both formal cast iron hooks and more expeditious nails) located along the back walls of the box stalls (opposite the feed bunks). These tack hooks probably served for hanging harness and bridles upon when not in use, and strongly suggests that horses were kept in these box stalls. Although it is possible that other livestock, such as cattle, may have been housed in these stalls at some point in time, it would appear that these stalls were constructed to house draft horses for a working farm complex. The aisle dividing the two stalls ran north/south and had doorways at both ends. It was intended for farm personnel and would have been used to feed livestock (with feed being dumped into the feed bunks flanking the aisle) and also a general passageway through the barn (see Figures 9 and 10). Access to the loft was located over the north end of this aisle.

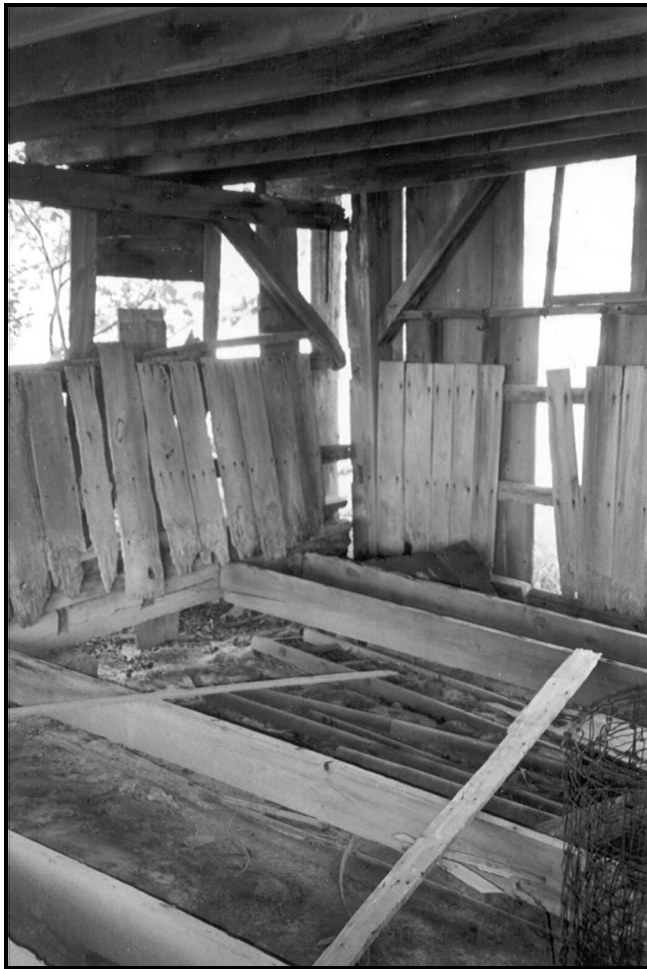
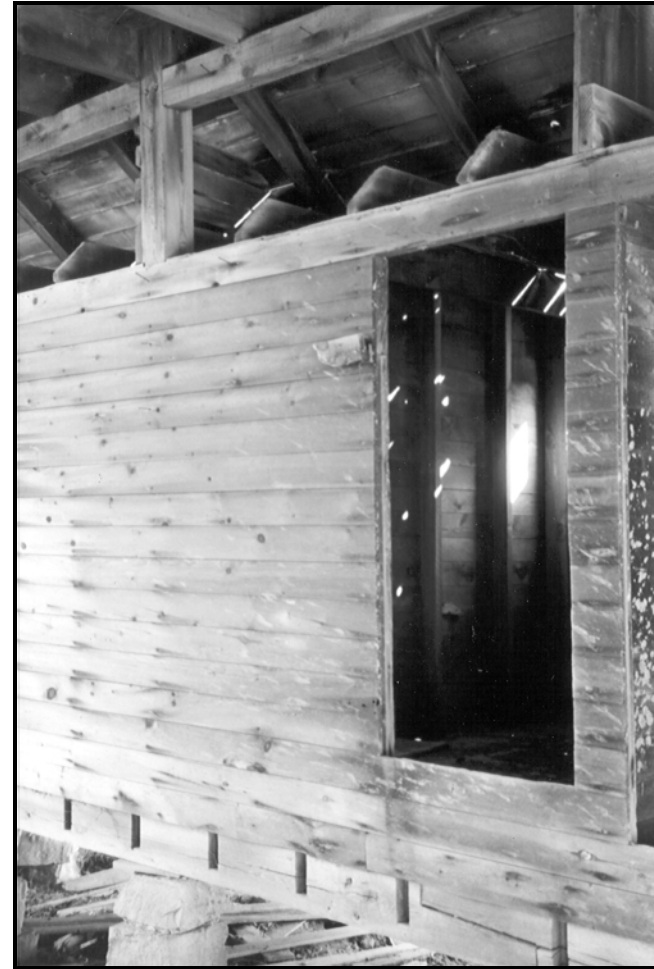
Figure 10. (LEFT) Interior view of the eastern box stall in the north bay of the barn. The vertical planking nailed around the lower part of the walls served as a rub guard, protecting the main framing and exterior siding from wear or damage by livestock. The flooring in this part of the barn also has been removed, as have many of the joists. (RIGHT) View of one of the grain bins located in the south bay of the barn. The ceiling and wall adjacent to the central drive was left open in order allow grain to be tossed into the bins. Tight siding used to enclose the grain bins is indicative of small-grain storage, in contrast to the spaced-out slats typical of corncribs. (FRR October 2002).

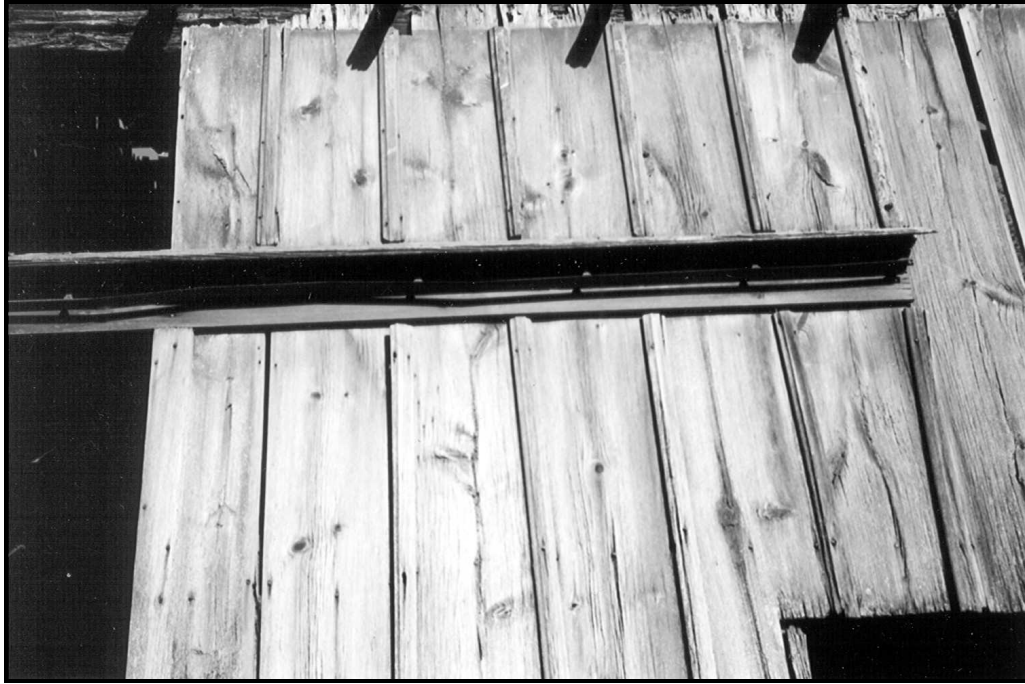
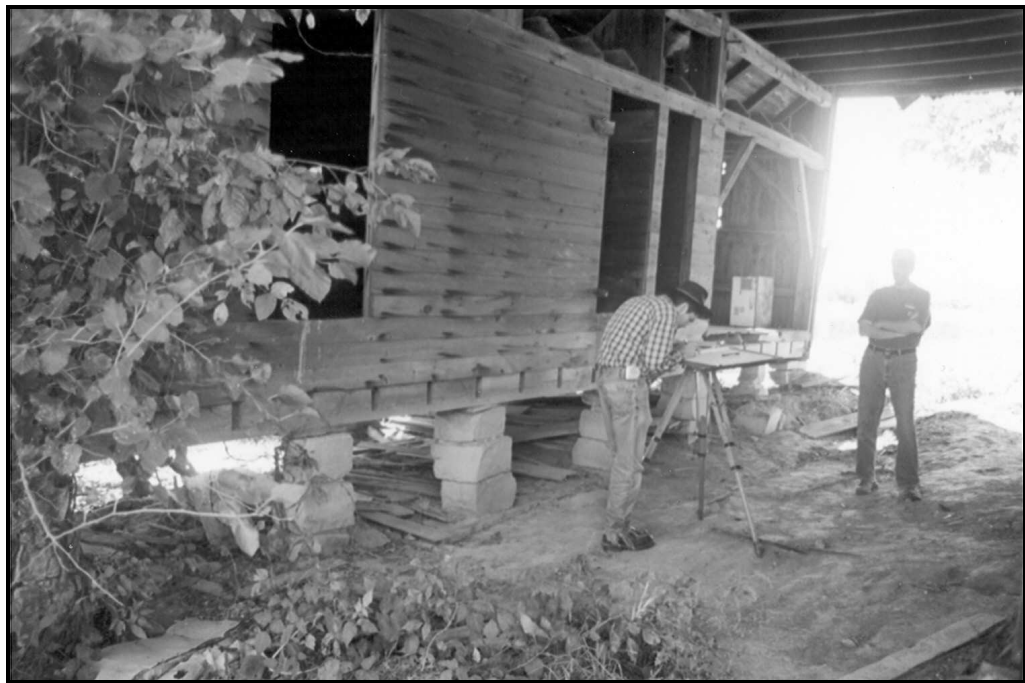
Figure 11. (TOP) Rather than having traditional hinged doors that swung outward on its central bay, the Hallstein Barn was equipped with sliding doors on a track. This is one of the “modern” features original to the barn. Also note the vertical board-and-batten siding used to cover the exterior walls. **(BOTTOM)** Interior view of the central drive, showing the storage bins for small grains in the south bay. The floor joists and flooring of the driveway have been removed (FRR October 2002).

originally had a frame floor consisting of floor joists and floorboards. This floor system has recently been removed (apparently in an effort to salvage lumber from this “abandoned” structure) (see Figure 11). Due to the fact that this barn was constructed on a prominent hill with the ground sloping sharply to the east, the central aisle was raised substantially above the ground level necessitating ramps leading into the driveway. It is suspected that frame ramps were located on each end of the central driveway of the building. The ceiling in the drive is higher than either of the end bays and allows for the additional headroom for unloading of grain into bins in the south bay. The bins were filled from the top, so the elevated ceiling height allowed a farmhand to stand in a wagon and still have room to shovel grain over the wall into the bins. The flooring over the bins was constructed to allow for the grain to be pitched over these walls into the bins. In addition to this use, the central drive likely was used to store agricultural equipment, such as wagons.

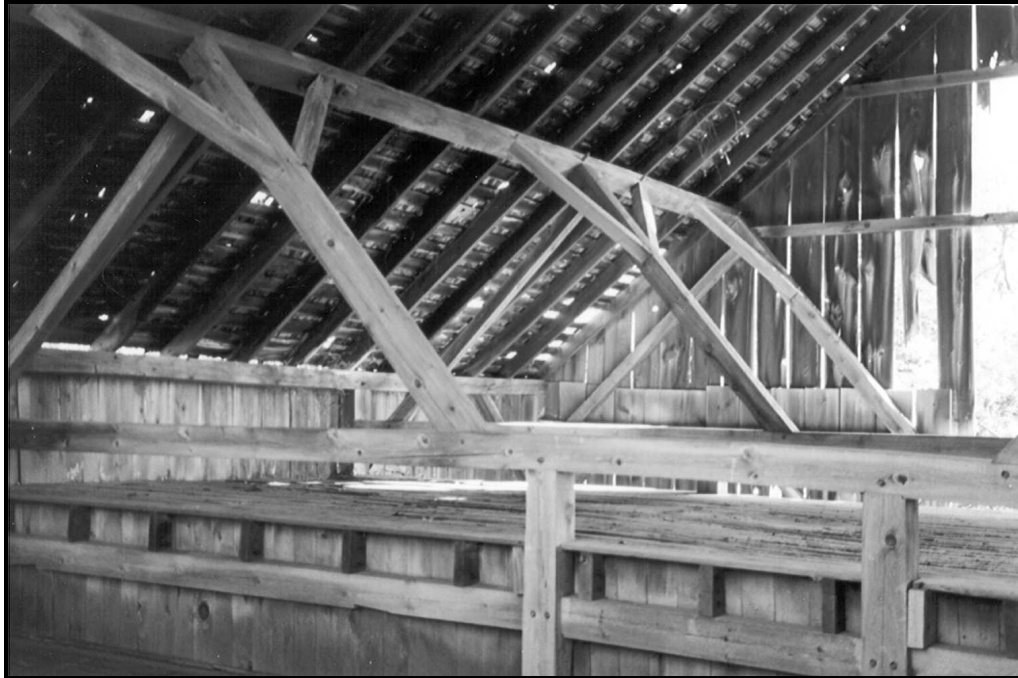
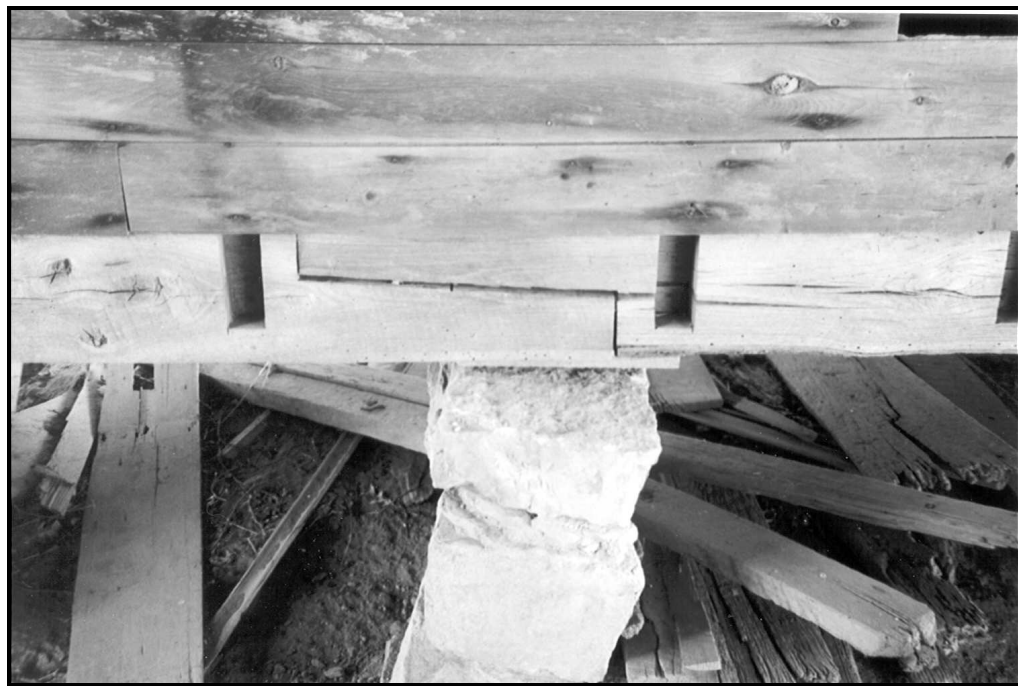
Figure 12. (TOP) View of the hay loft in the upper floor of the barn, looking towards the south gable end. The floor in the center in the loft is raised to accommodate a higher ceiling in the central drive below, thereby allowing the grain bins to be filled from their tops. **(BOTTOM)** Detail of one of the cut-stone piers on which the barn sits. This photograph also shows the sill plat along the south side of the central drive. Note the scarf joint that bridges the two halves of the sill plate and pockets in which the removed floor joists formerly rested (FRR October 2002).

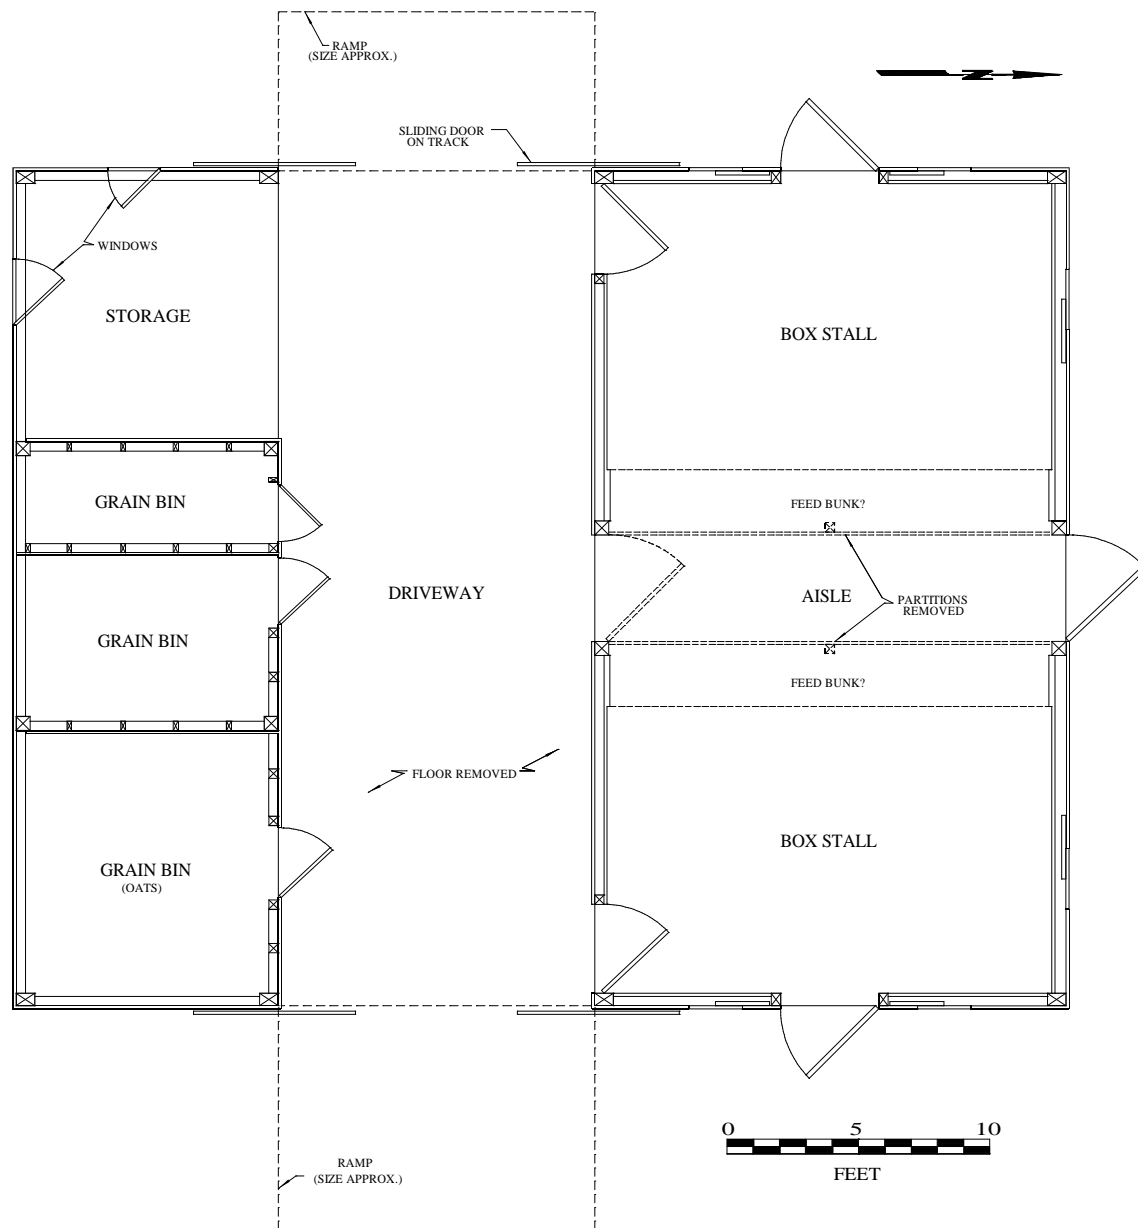
Figure 13. First floor plan of the Hallstein Barn. Conjectural and approximated features are dashed (FRR 2002).

in the central drive. It was for this reason that the central bay in earlier Three-Bay Barns was left open between the first floor and the rafters, rather than being bridged by a permanent loft as is the case of the Hallstein Barn. A hay bonnet is present over the mow door. The distinctive splayed queen post structure of the roof framing allowed the unencumbered access of the hayfork to the loft space. Floor plans and section views of the barn are attached as Figures 13 through 15.

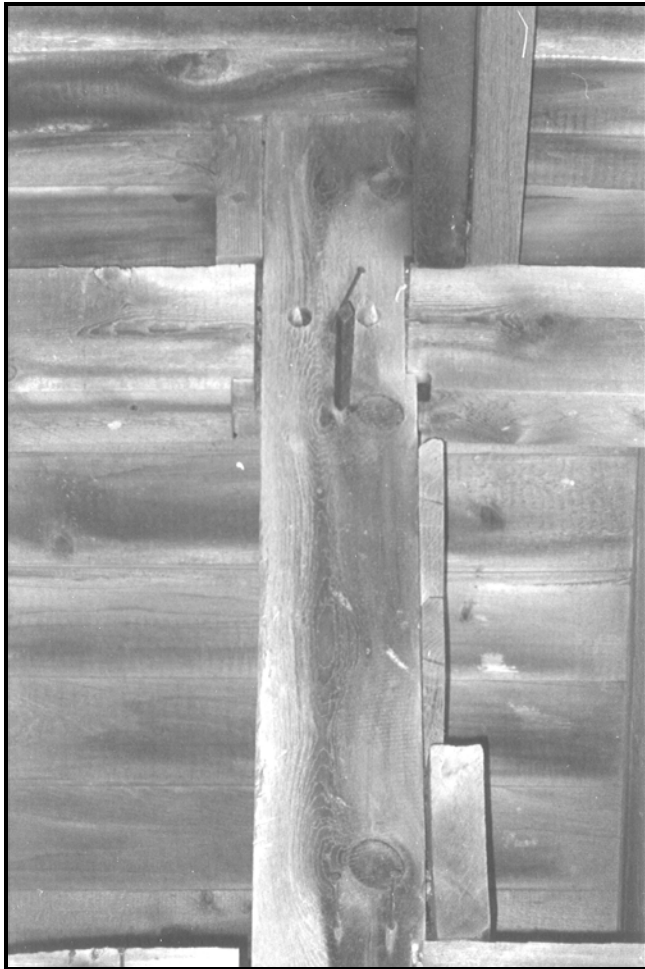
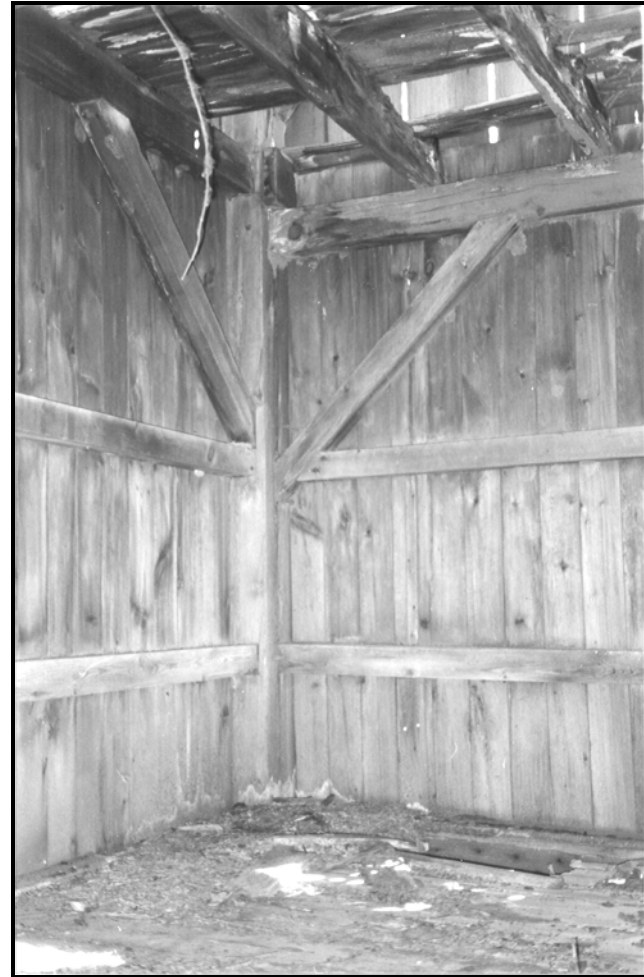
Figure 16. Framing details in the south bay of the barn. (LEFT) Larger framing members in the barn are joined with mortise-and-tenon joints, such as the pictured here, which connects a post and two girts in the interior bent along the south side of the central drive. (RIGHT) Interior view of easternmost grain bin, showing the framing at the southeast corner of the barn. The corner posts are supported by diagonal braces, set at 45-degrees, and by horizontal braces that double as nailers for the exterior siding (FRR October 2002).

In respect to its method and materials of construction, the Hallstein Barn is in many ways a very traditional structure. The barn, for example, rests on dry-laid, cut-stone piers, even though concrete was in relatively common use as a foundation material when the building apparently was erected. “Square Rule” timber-framing also was heavily relied upon in the barn’s construction. The sills are 8”x8”, circular-sawn oak and are joined with half-lap joints at the corners and scarf joints in the middle of a span. The four bents of the barn are framed with 6”x8” corner posts, 6’x6” intermediate posts, and two sets of 4”x6” horizontal girts. The lower girts support the floor joists of the hayloft (which measure 2”x8”), while the upper girts tie the corner posts together. Diagonal braces, which measure 4”x4” and are set at a 45-degree angle, extend between the posts and girts. Additional 4”x4” bracing runs horizontally between the posts; these strengthen the frame but also serve as nailers for the exterior board-and-batten siding. The bents are joined together by an 8”x8” top plate that also support the lower ends of the rafters. The spacing of the posts in the northern two bents is different from those on the south, in order to accommodate the different uses of these areas (i.e. livestock versus grain storage). The roof framing is the same across the entire length of the barn. The rafters are 2”x6” with 2’ centers and are supported by a braced-purlin system. The purlins themselves measure 6”x6” and are supported by 6”x6” splayed queen posts that extend diagonally off the upper girt of the bents. As in the bents, 4”x4” diagonal braces run between the posts and purlins. The purlin posts also are supported by a separate 4”x4” brace that set at a 90-degree angle to them and extends off the same upper girt as they do. Lighter interior partitions, such as the walls of the grains bins are framed with 2’x4” studs. The roof originally was covered with sawn-wood shingles, but these later were overlain with asphalt shingles. All of the larger framing in the barn is joined with mortise-and-tenon joints, while secondary framing materials are attached with wire-drawn nails. Except for the sill plats, which are oak, the lumber in the barn appears to be yellow (or southern) pine and is a mixture of circular-sawn and band-sawn stock typical of the late nineteenth and/or early twentieth centuries (see Figures 15 through 18).

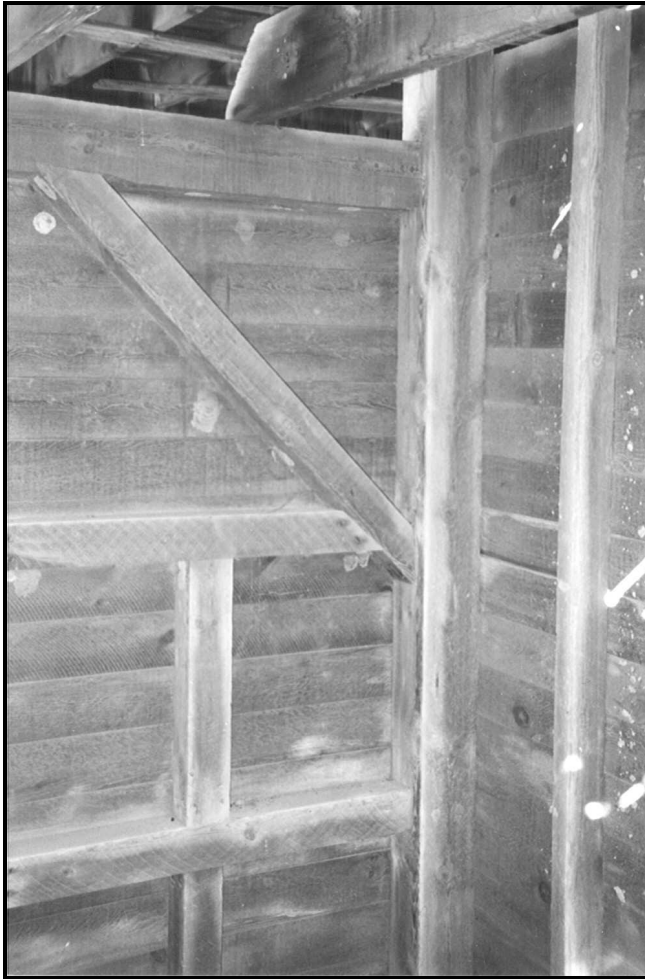
Figure 17. Additional framing details on the interior of the grain bins. In contrast to the north and south bents, the diagonal bracing on the two center bents are nailed together, rather than being connected with mortise and tenon. Note the heavy cross bracing used on the walls of the grain bins. The walls bore a great deal of weight and pressure when the bins were filled with grain (FRR October 2002).

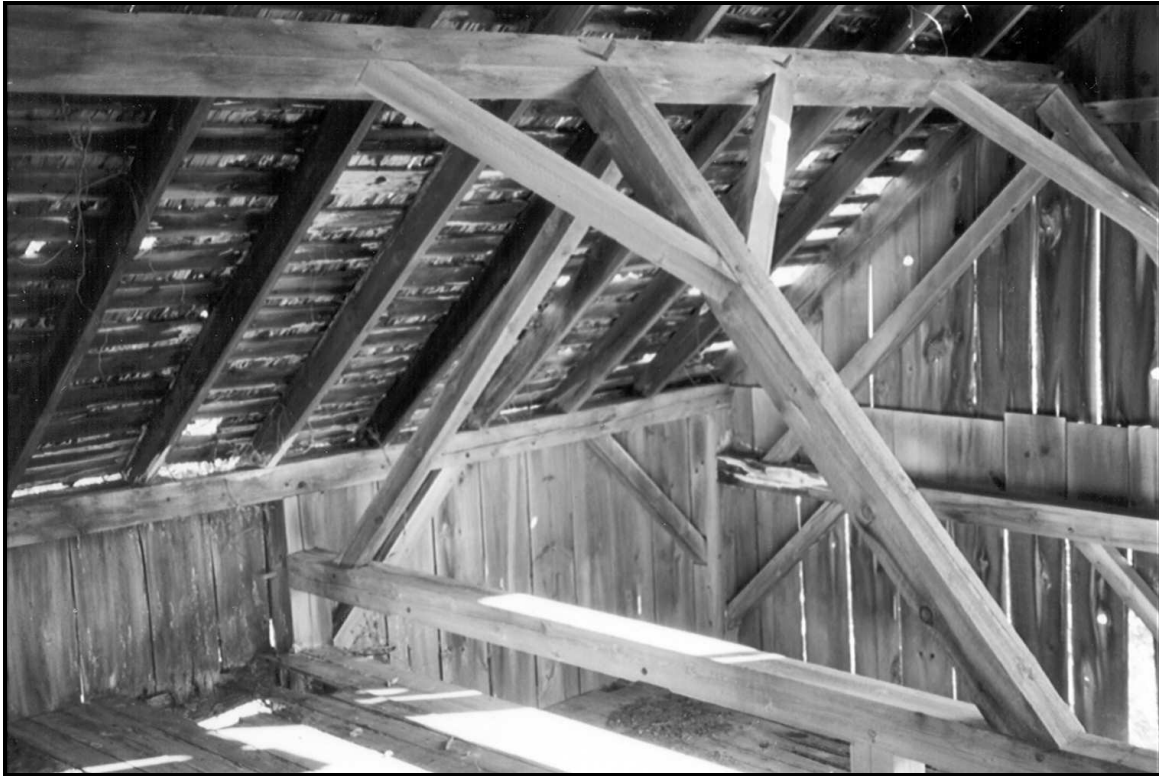
Figure 18. The roof of the barn is supported by a braced purlin system formed by heavy timbers joined with mortise and tenon. The diagonal positioning of the purlin bracing frees the center of the barn of framing, thus allowing the hay fork to pass unobstructed down the length of the loft (FRR October 2002).
